Waukegan Generating Station

2024 Structural Stability Assessment for East Ash Pond & West Ash Pond

October 13, 2024

Project No.: A12661.187

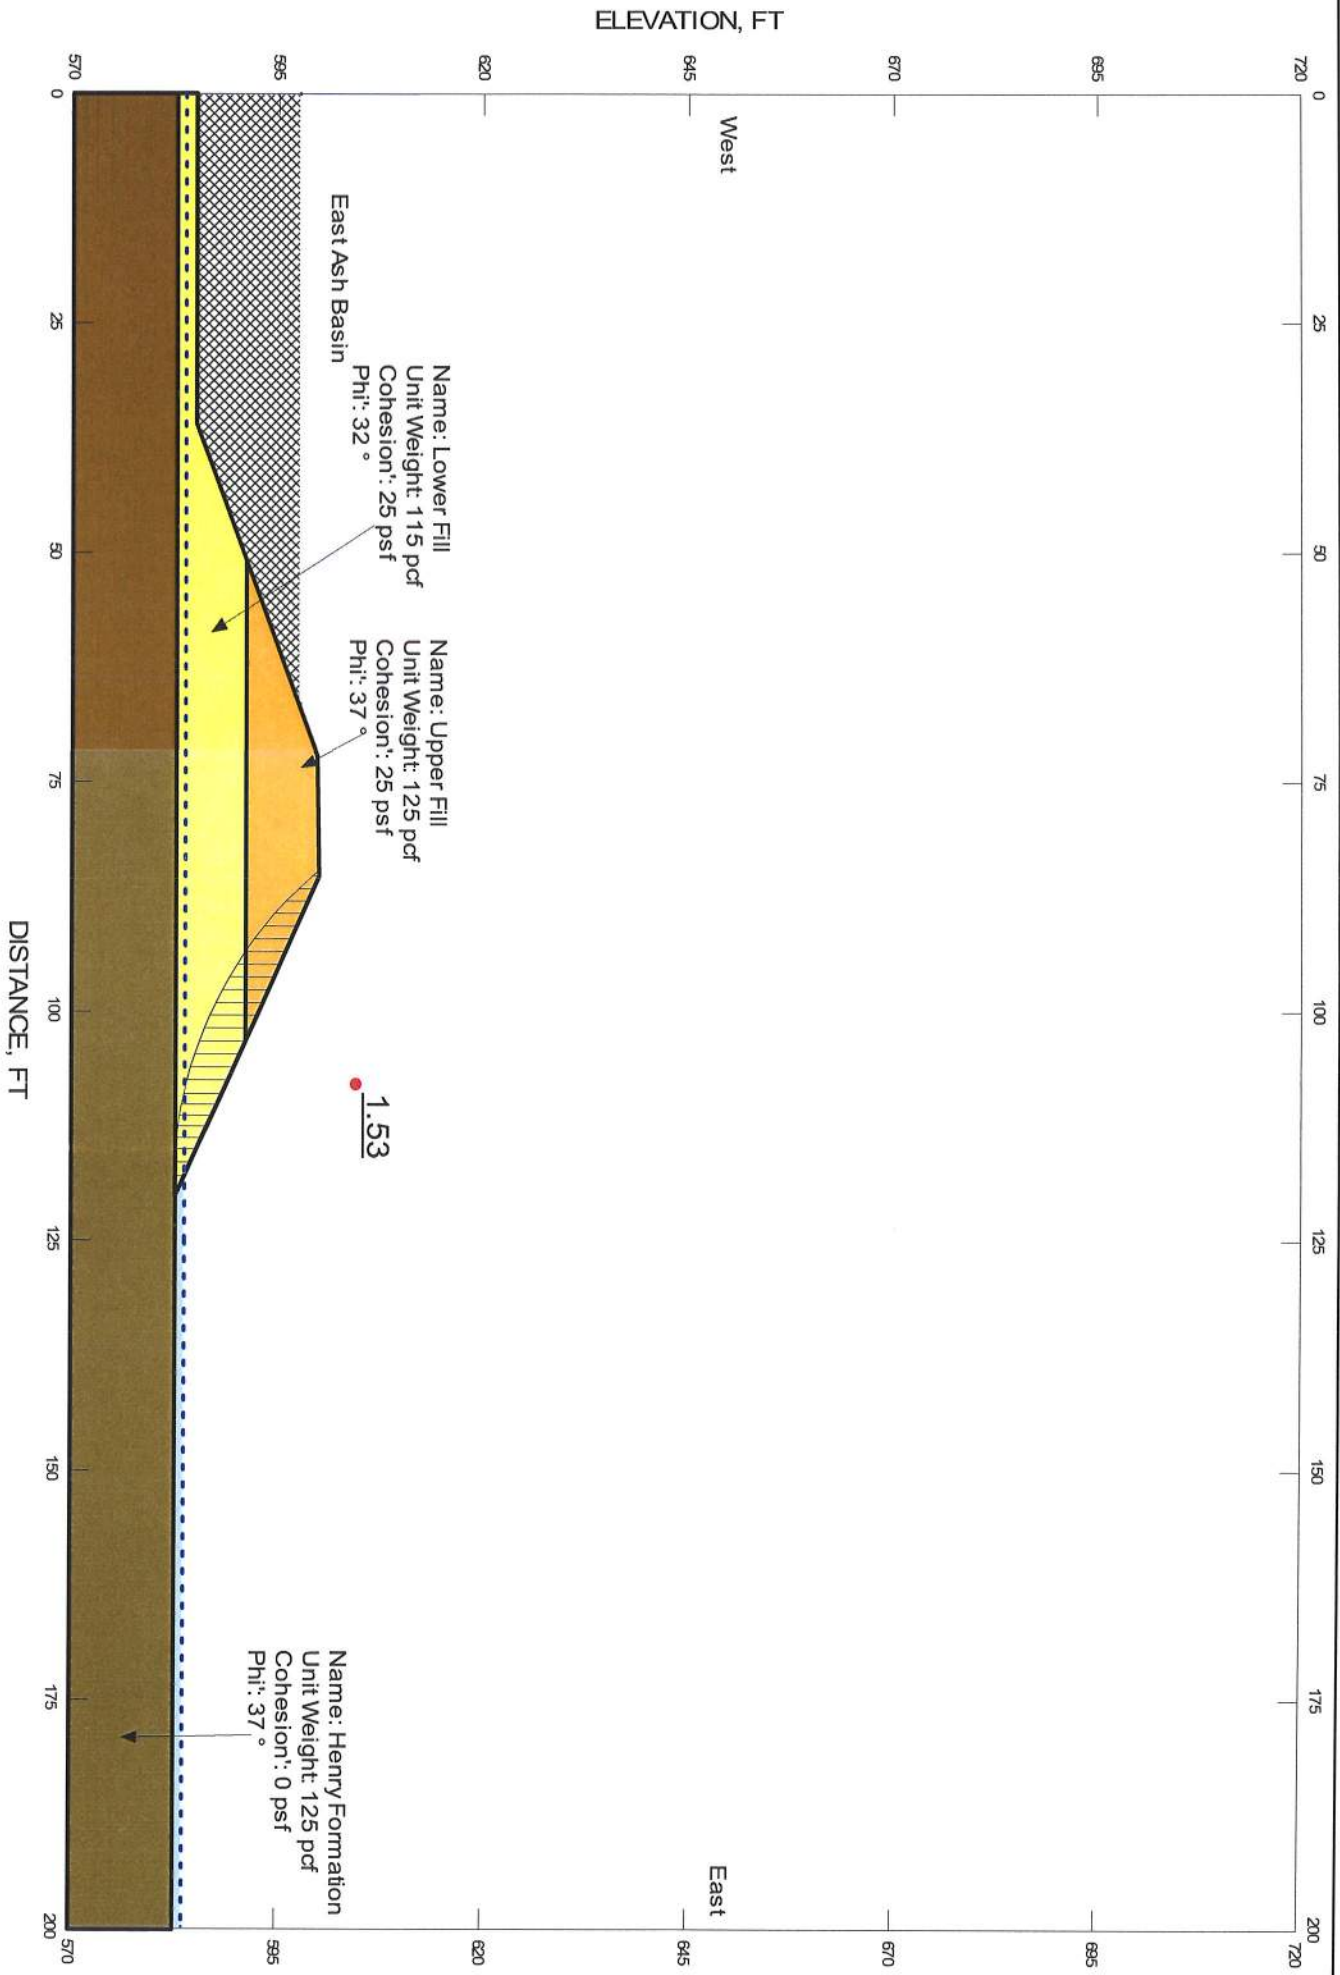
FIGURE 6

Analysis	Section 1 - §257.73(e)(1)(iii): Long Term, Maximum Storage Pool Loading with Seismic	Analysis By	Jay Griffin
Project	Waukegan East and West Ash Basins	Date	October 2016
File Name	Waukegan Section 1.gsz
