Midwest Generation, LLC

Waukegan Generating Station

2025 Structural Stability Assessment for East Ash Pond & West Ash Pond

October 13, 2025

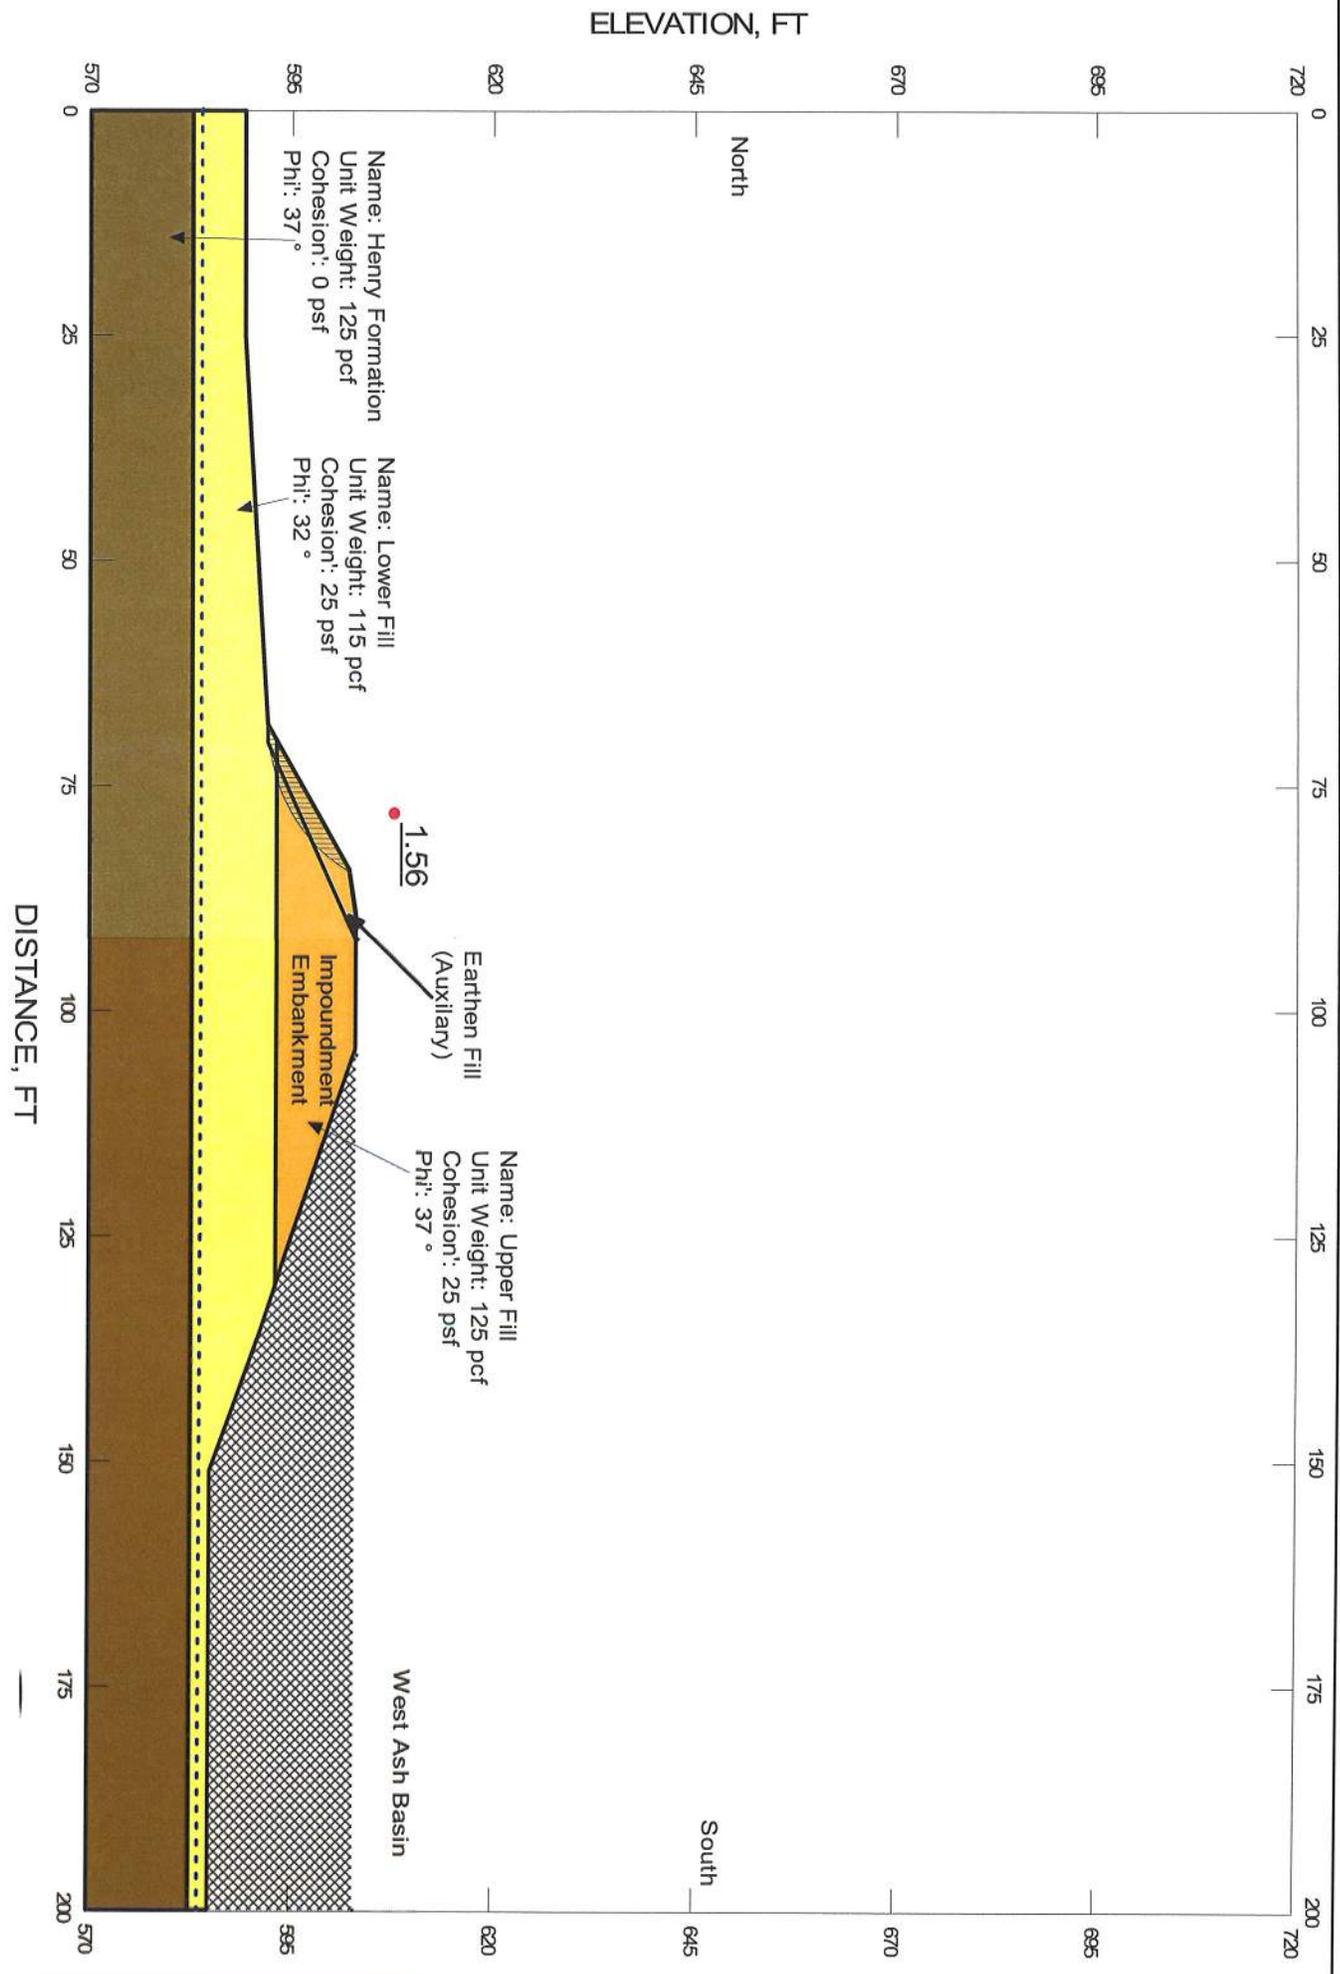
FIGURE 5

Section 1 - §257.73(e)(1)(ii): Maximum Surcharge Pool Loading	
Analysis	Project	Analysis By	Date
	Waukegan East and West Ash Basins	Jay Griffin	October 2016
File Name	Waukegan Section 1.gsz

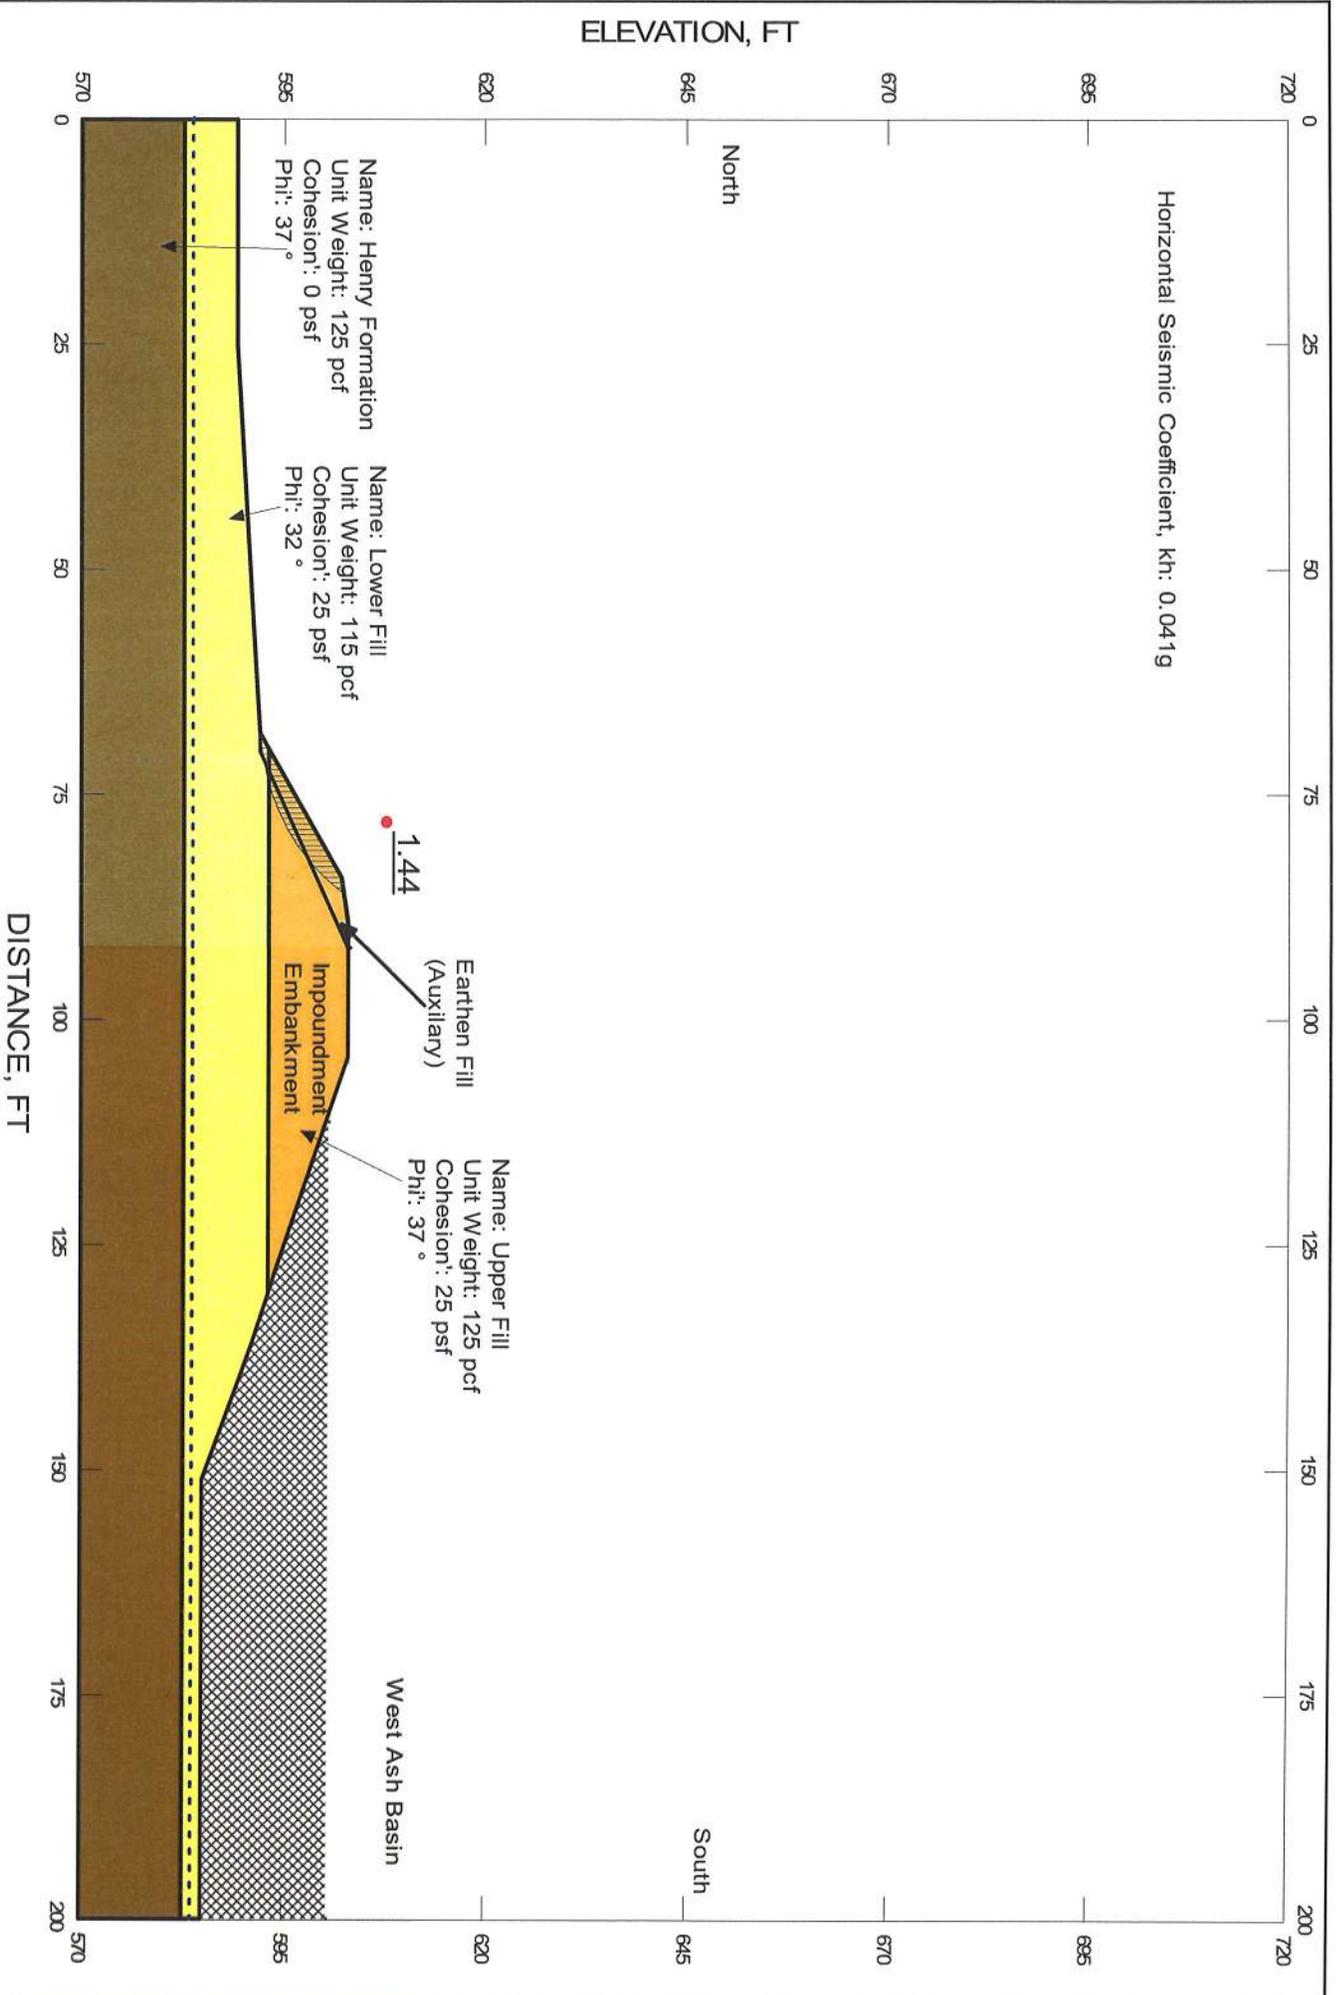
FIGURE 6

Analysis	Section 1 - §257.73(e)(1)(iii): Long Term, Maximum Storage Pool Loading with Seismic
Project	Waukegan East and West Ash Basins
File Name	Waukegan Section 1.gsz
Analysis By	Jay Griffin
Date	October 2016
