October 6, 2023
File: 21.0056984.00

Re: CCR Landfill 2023 Annual Inspection
Dunkirk Generating Station
Van Buren Road
Pomfret, New York

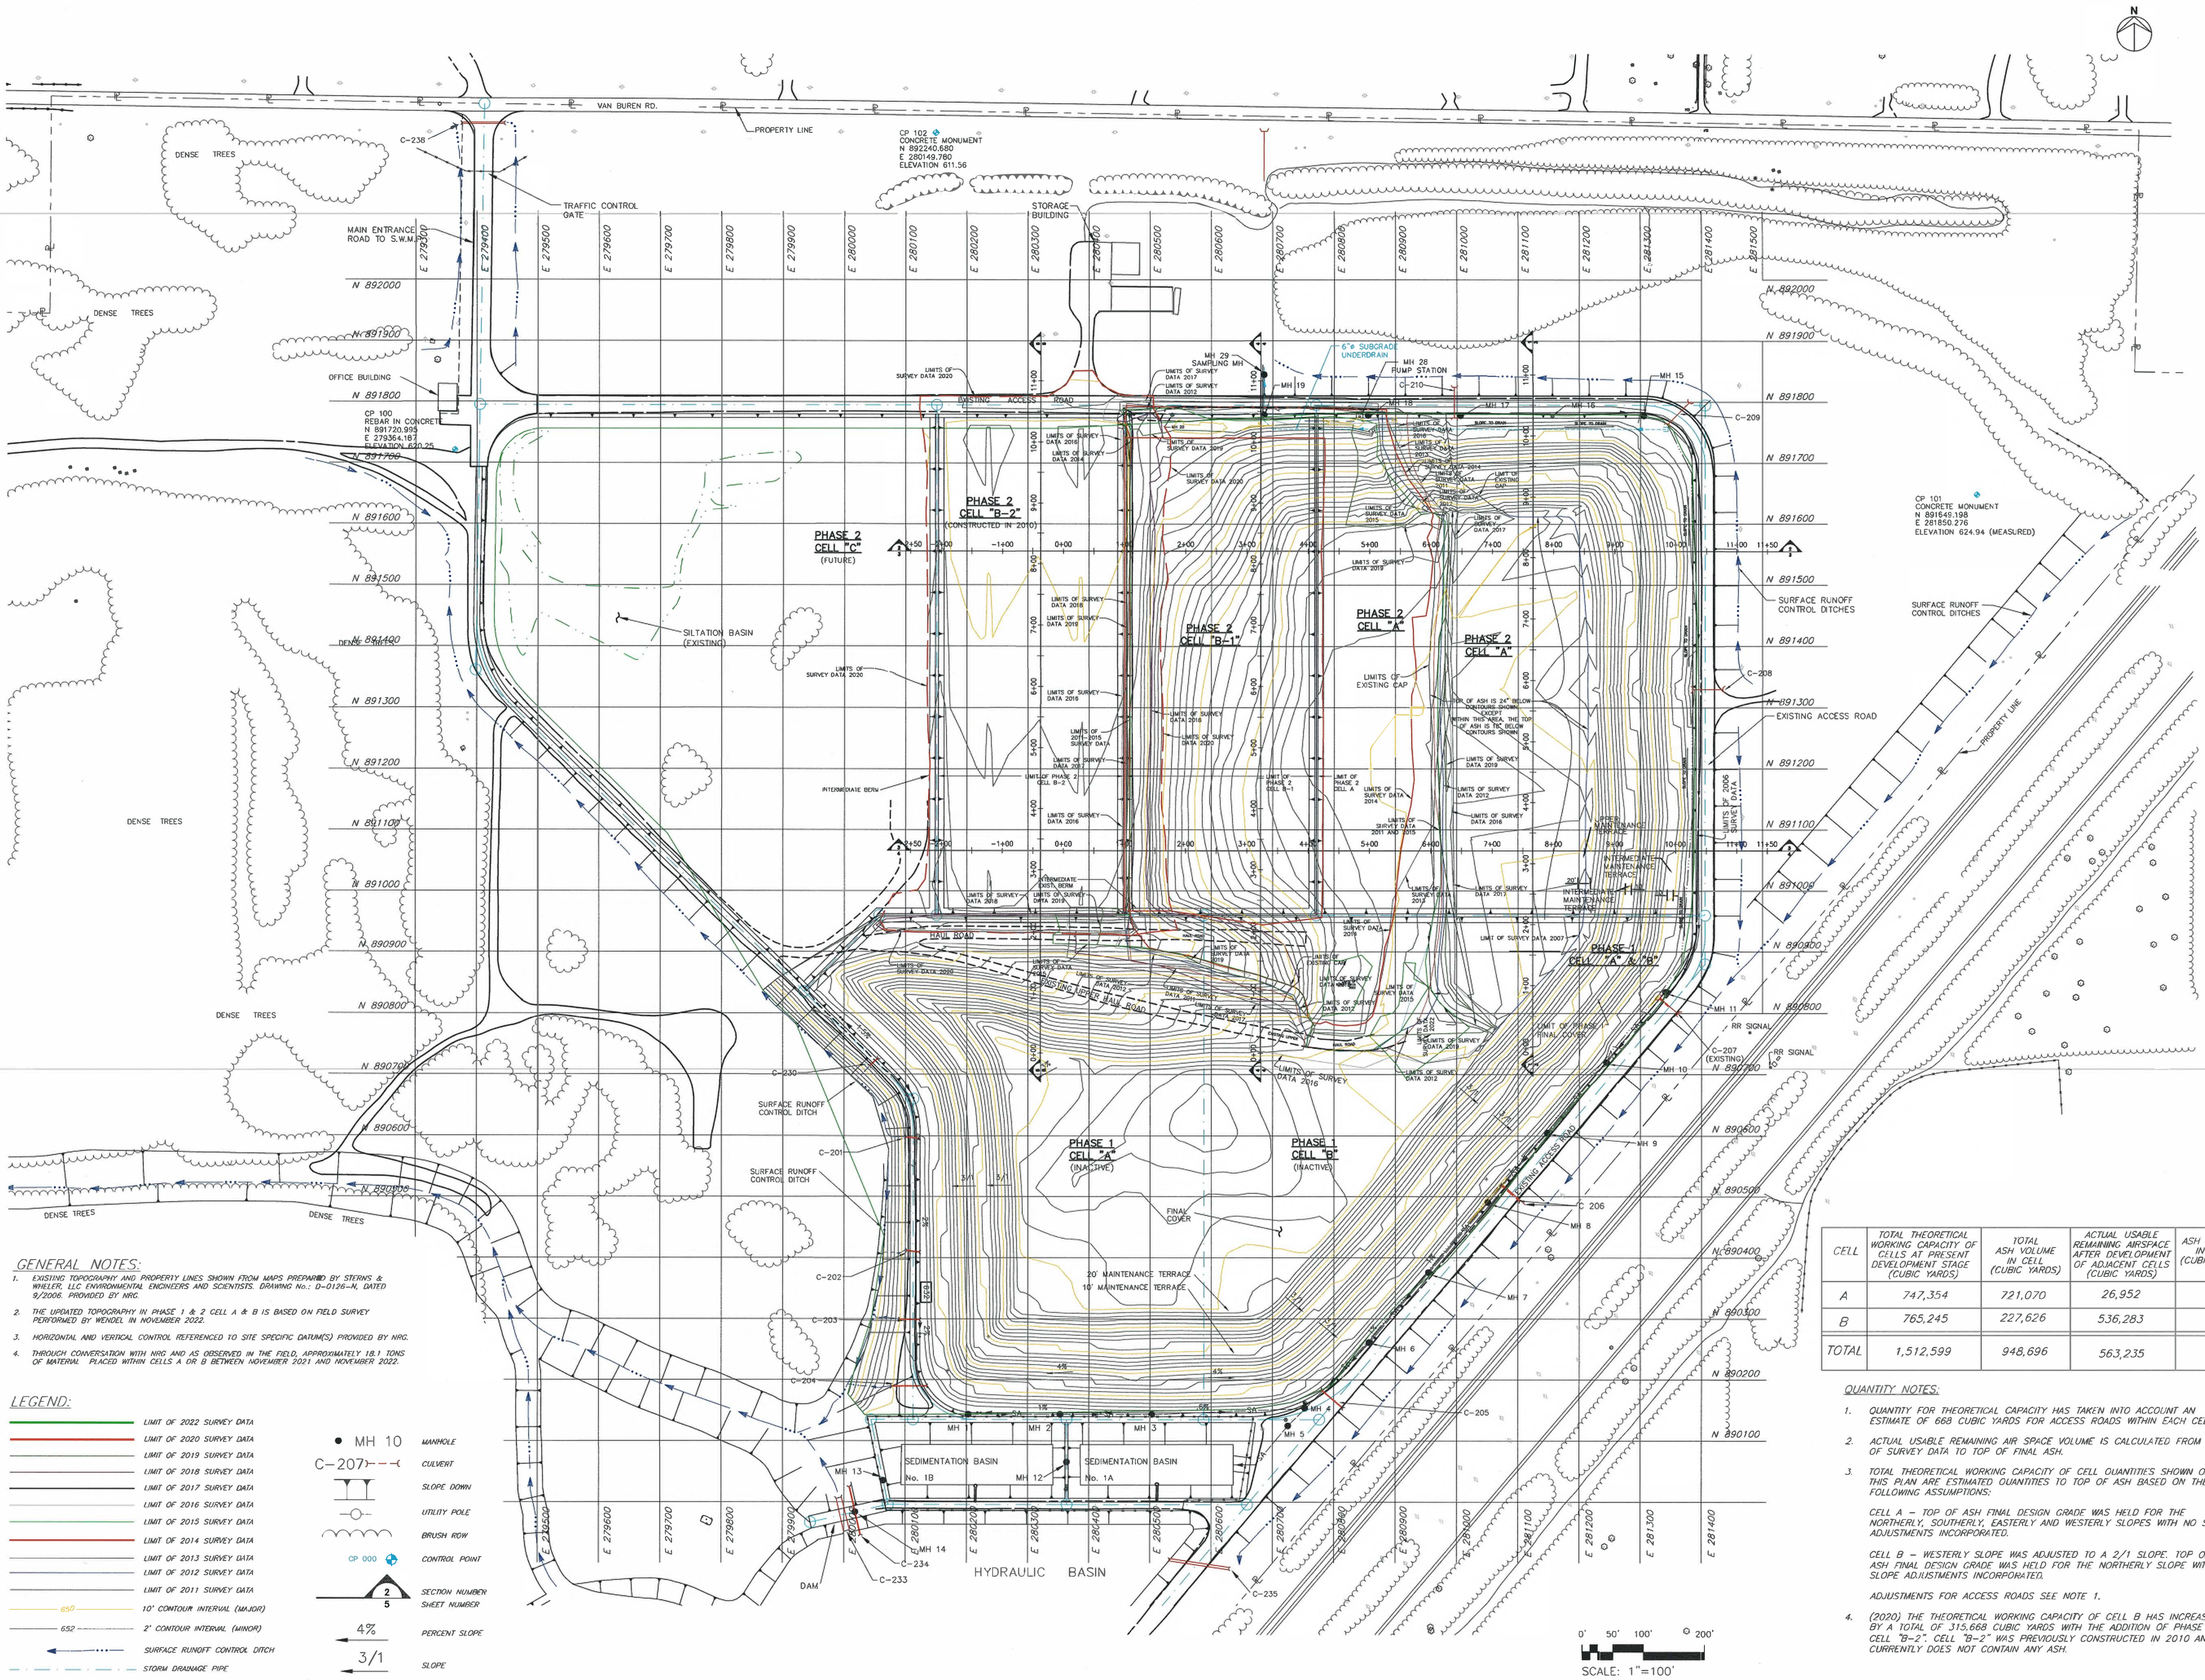
Attachments: Figure 1 - Dunkirk 2022 Fill Progression Survey – Site Plan

of the active cells requiring this annual inspection report are shown on the attached figure prepared by Wendel for the 2022 fill progression survey (see **Figure 1**).
