**EMERGENCY ACTION PLAN
ASH POND 2
JOLIET 29 STATION
UPDATED NOVEMBER 2022**

This Emergency Action Plan (EAP) was initially prepared pursuant to Title 40 of the Code of Federal Regulations (40 CFR) Part 257, Subpart D, §257.73(a)(3) for Ash Pond 2 at Midwest Generation, LLC (MWG) Joliet 29 Station (Station) in Joliet, Illinois. An October 2021 update of the initial EAP was prepared to comply with 35 Illinois Administrative Code (35 IAC) Part 845, Subpart E, §845.520(b)(3) by revising the code references. This November 2022 update includes an updated contact list provided as Table 5. The EAP is presented as follows:

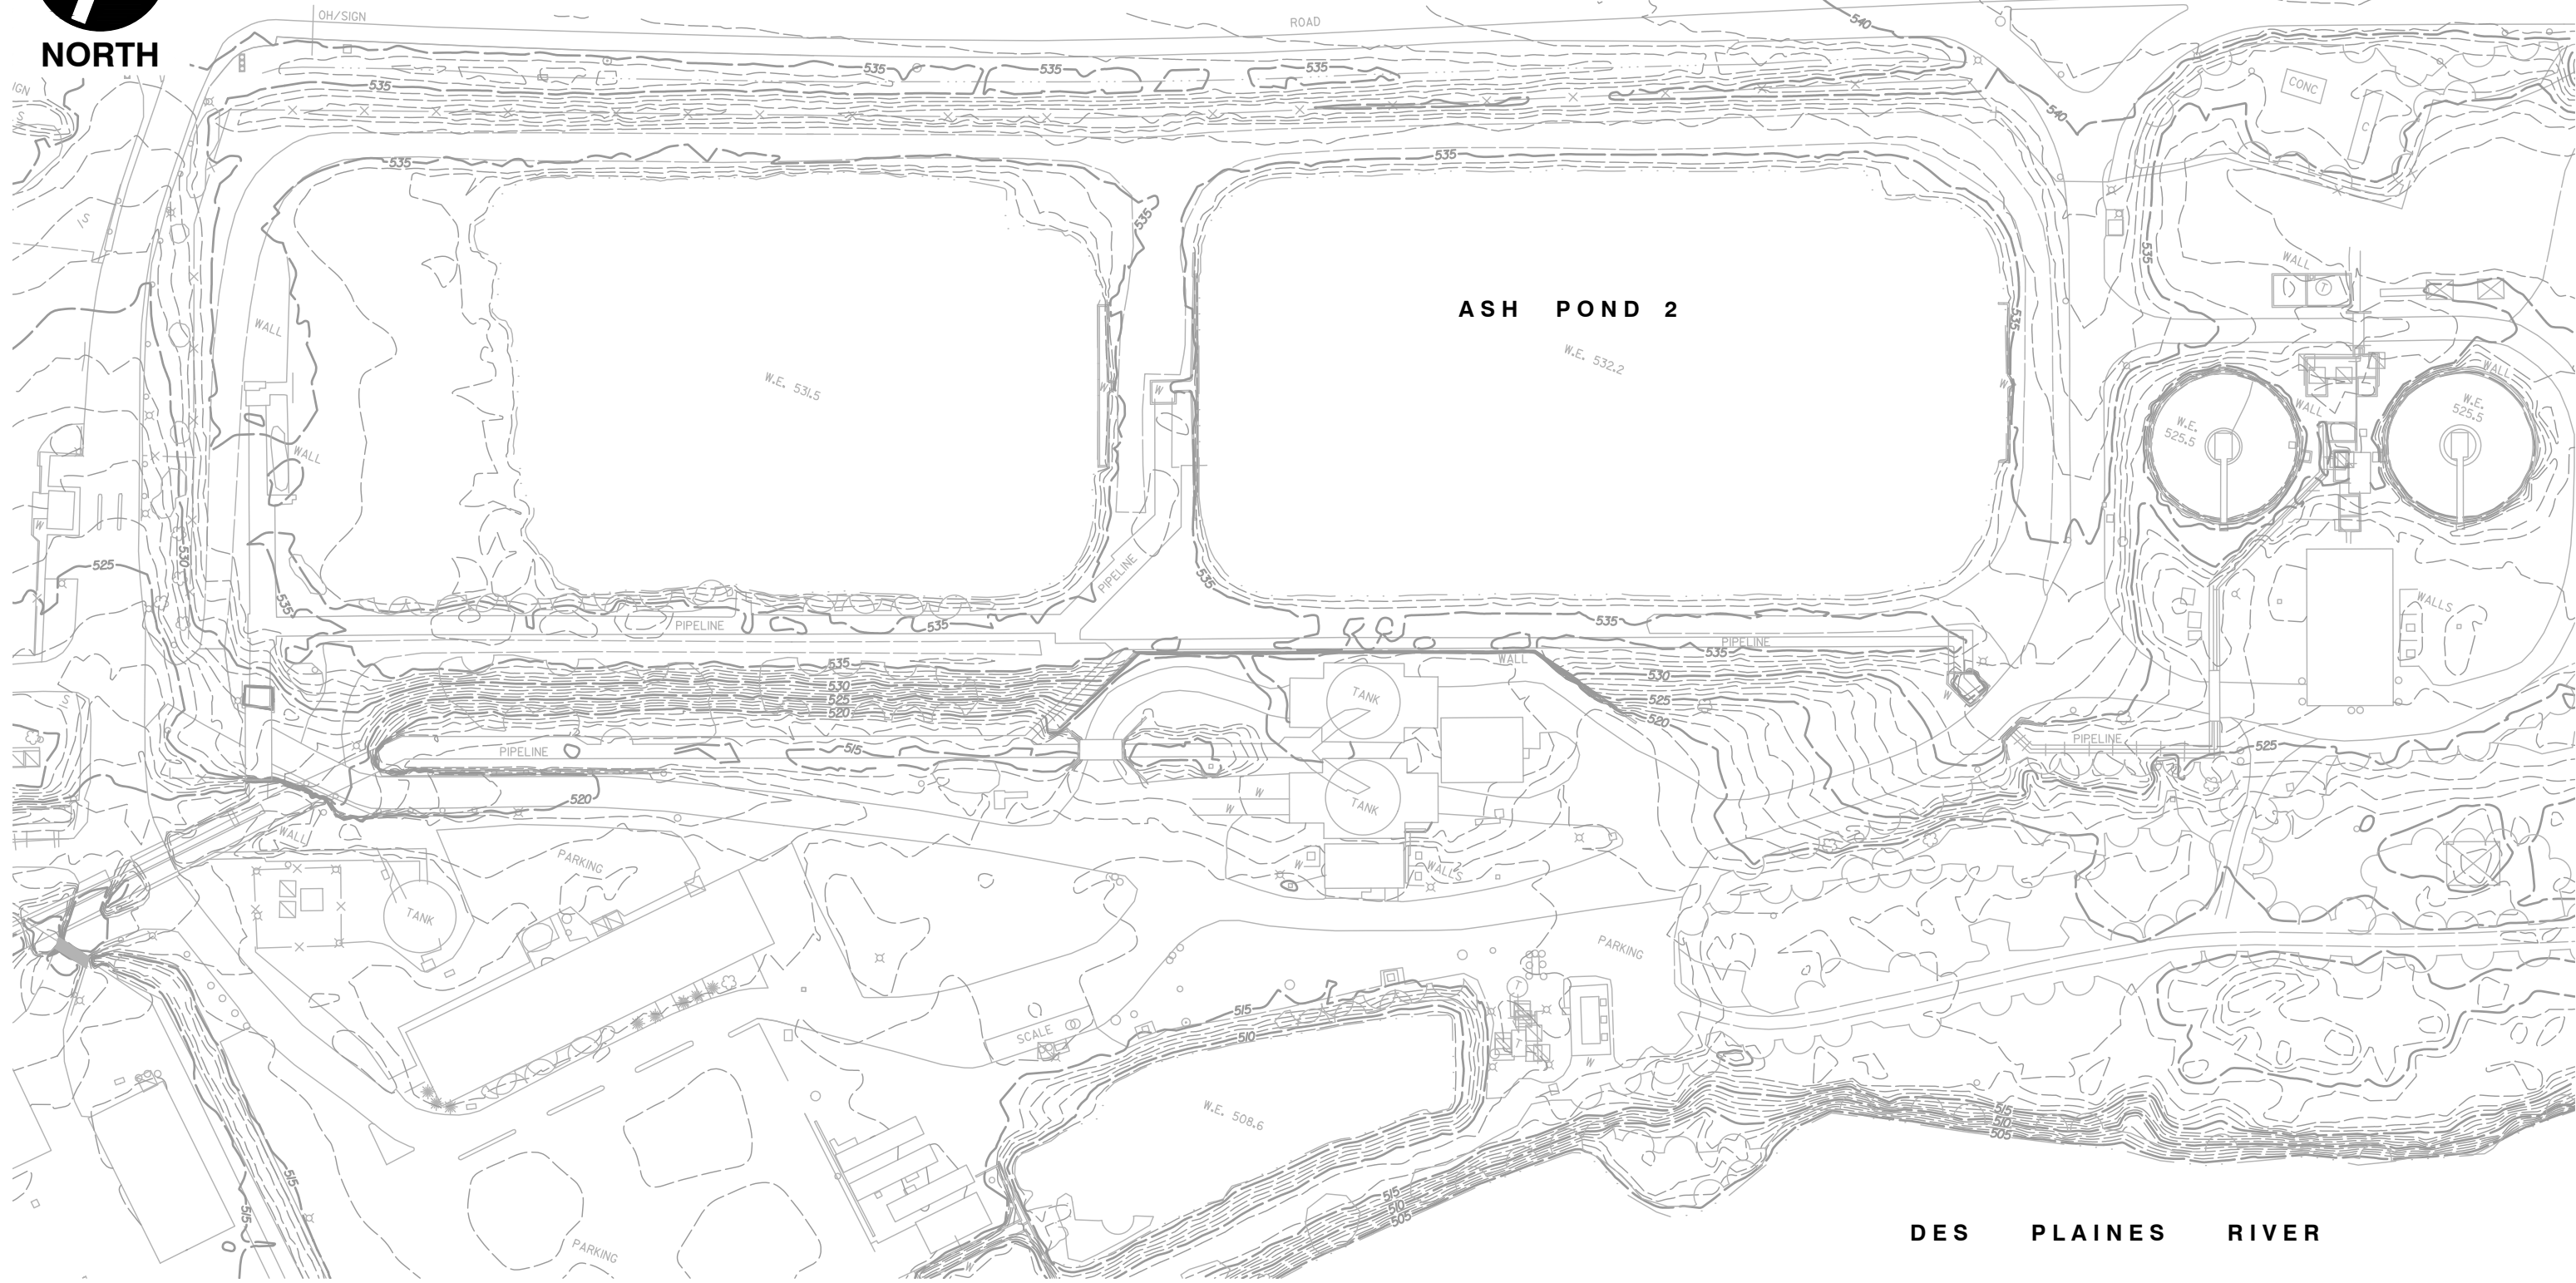
CHANNAHON ROAD (U.S. ROUTE 6)

DES PLAINES RIVER

The following section provides a physical description of Ash Pond 2. A site vicinity map is provided as Figure 1, and a site plan is provided as Figure 2, attached. Drawings depicting the locations of, and the downstream areas affected by, a potential failure of Ash Pond 2 were prepared by Geosyntec in October 16, 2016 and are provided in Appendix A.

The physical address for Joliet Station 29 is Illinois & Michigan Canal State Trail, 1800 Channahon Road (U.S. Route 6) in Joliet, Illinois. As shown in Figure 1, the Station is bound by Channahon Road on the north and the Des Plaines River on the south. Ash Pond 2 is situated east of the Station Entrance/Guard House and Pond 1, and west of the Wastewater Treatment Plant immediately adjacent to U.S. Route 6 (see Figure 2). Ash Pond 2 is situated northeast of the Main Power Block Building.

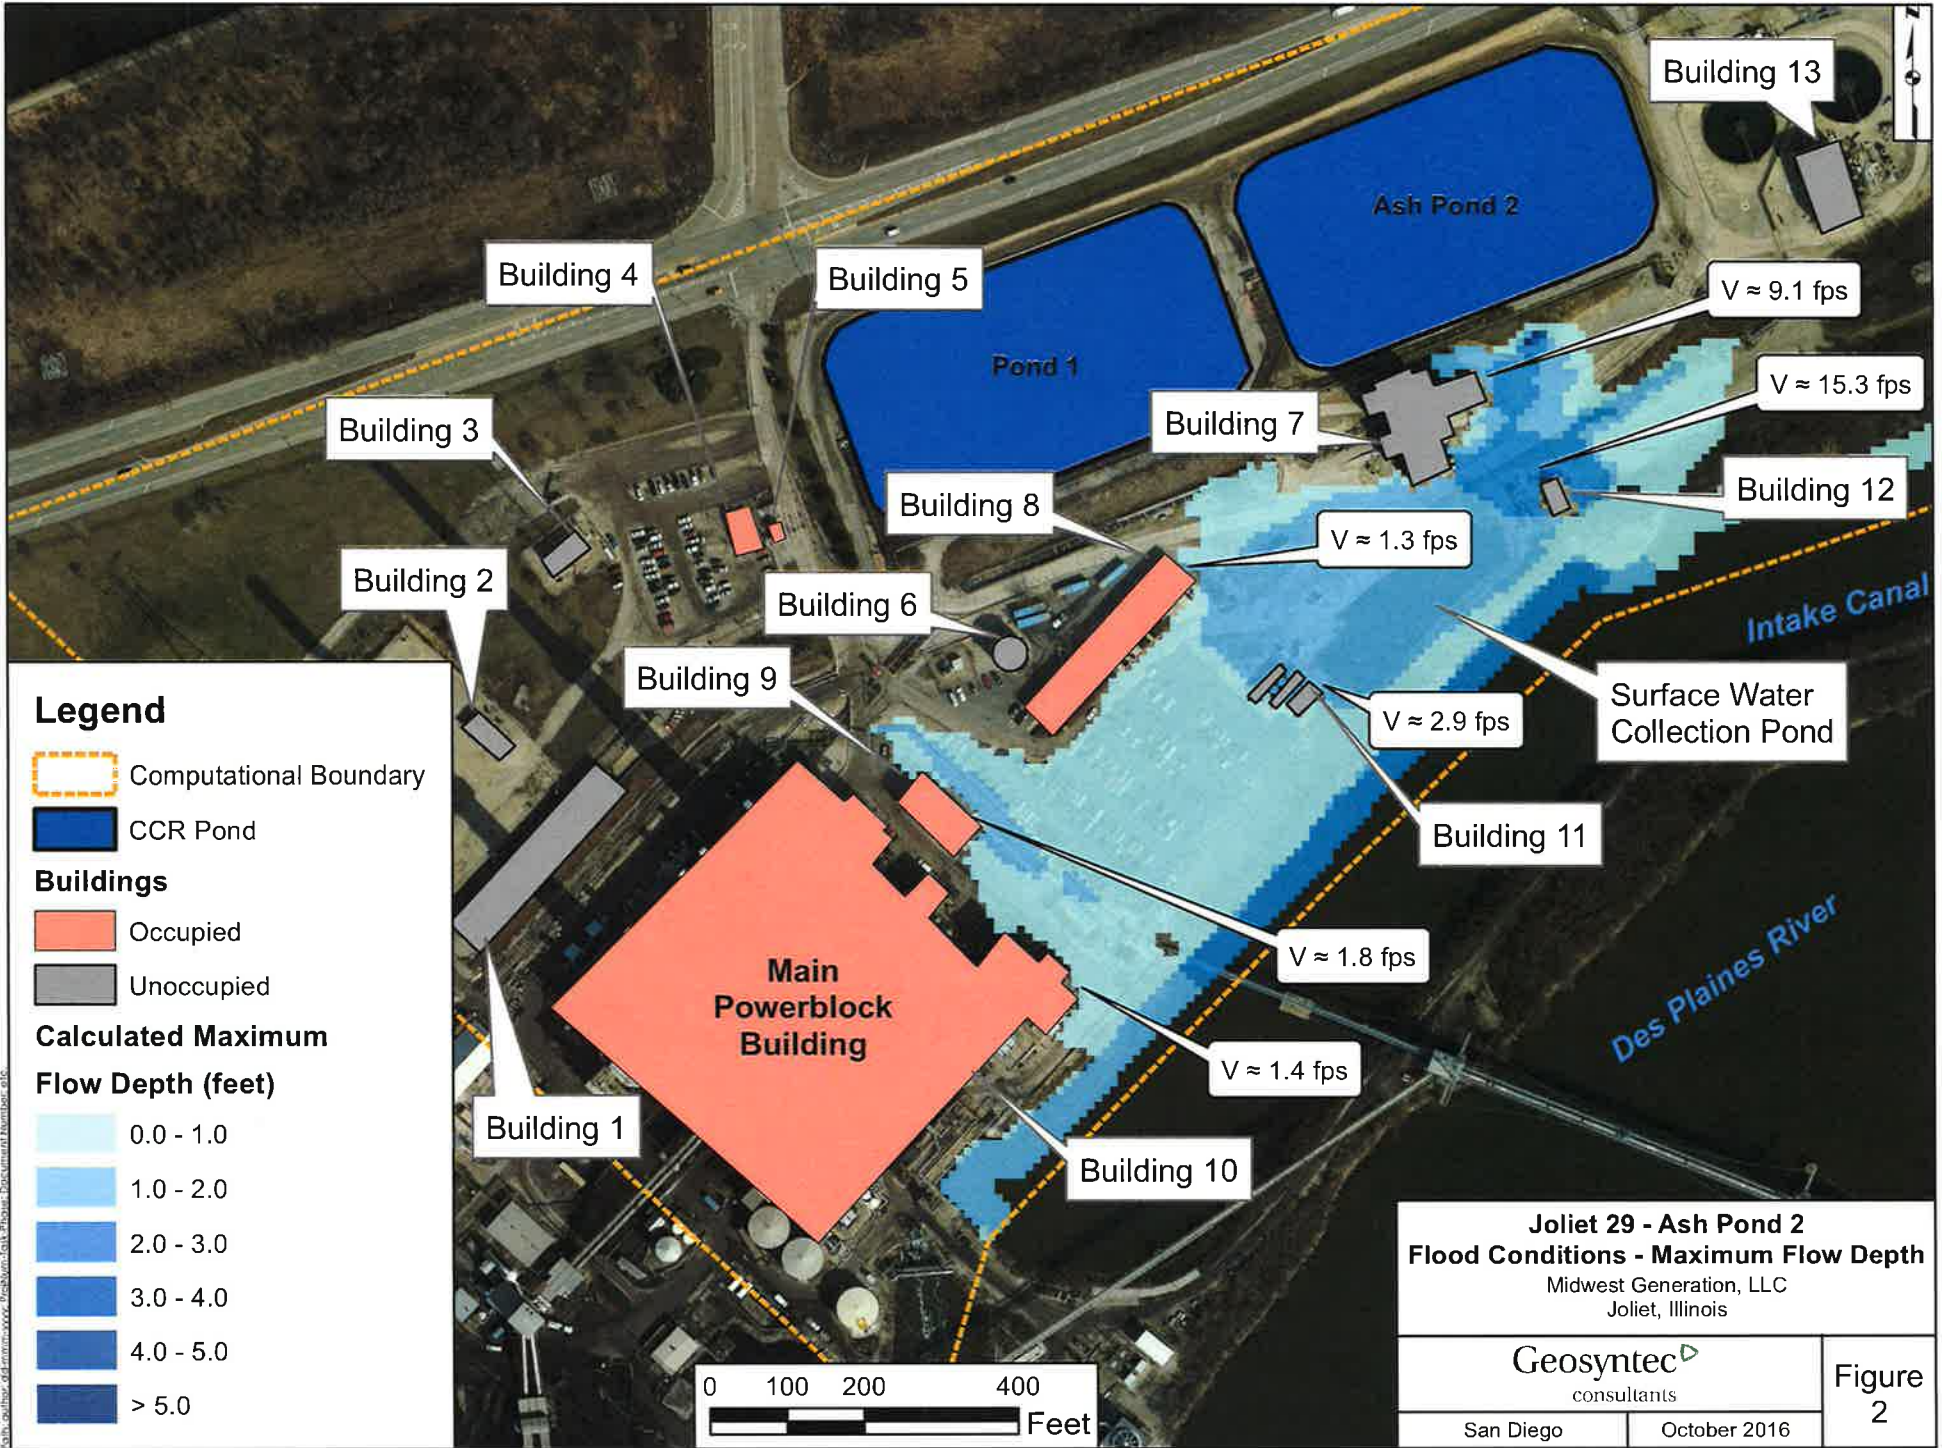
Figure
2

**Joliet 29 - Ash Pond 2
Flood Conditions - Maximum Flow Depth**
Midwest Generation, LLC
Joliet, Illinois

Results of the HPCA indicate that Ash Pond 2 is classified as significant hazard potential CCR surface impoundments. The evaluation reports no loss of life resulting from failure of Ash Pond 2 is probable because no occupied buildings are located within the anticipated inundation areas. However, potential failure during flood conditions could result in off-site economic or environmental impacts. Inundation maps are provided in Appendix A.
