**EMERGENCY ACTION PLAN**

**JOLIET/LINCOLN STONE QUARRY  
MIDWEST GENERATION, LLC  
JOLIET, ILLINOIS  
Permit No. 1994-241-LFM

IEPA Site No. 1978090001**

October 2021

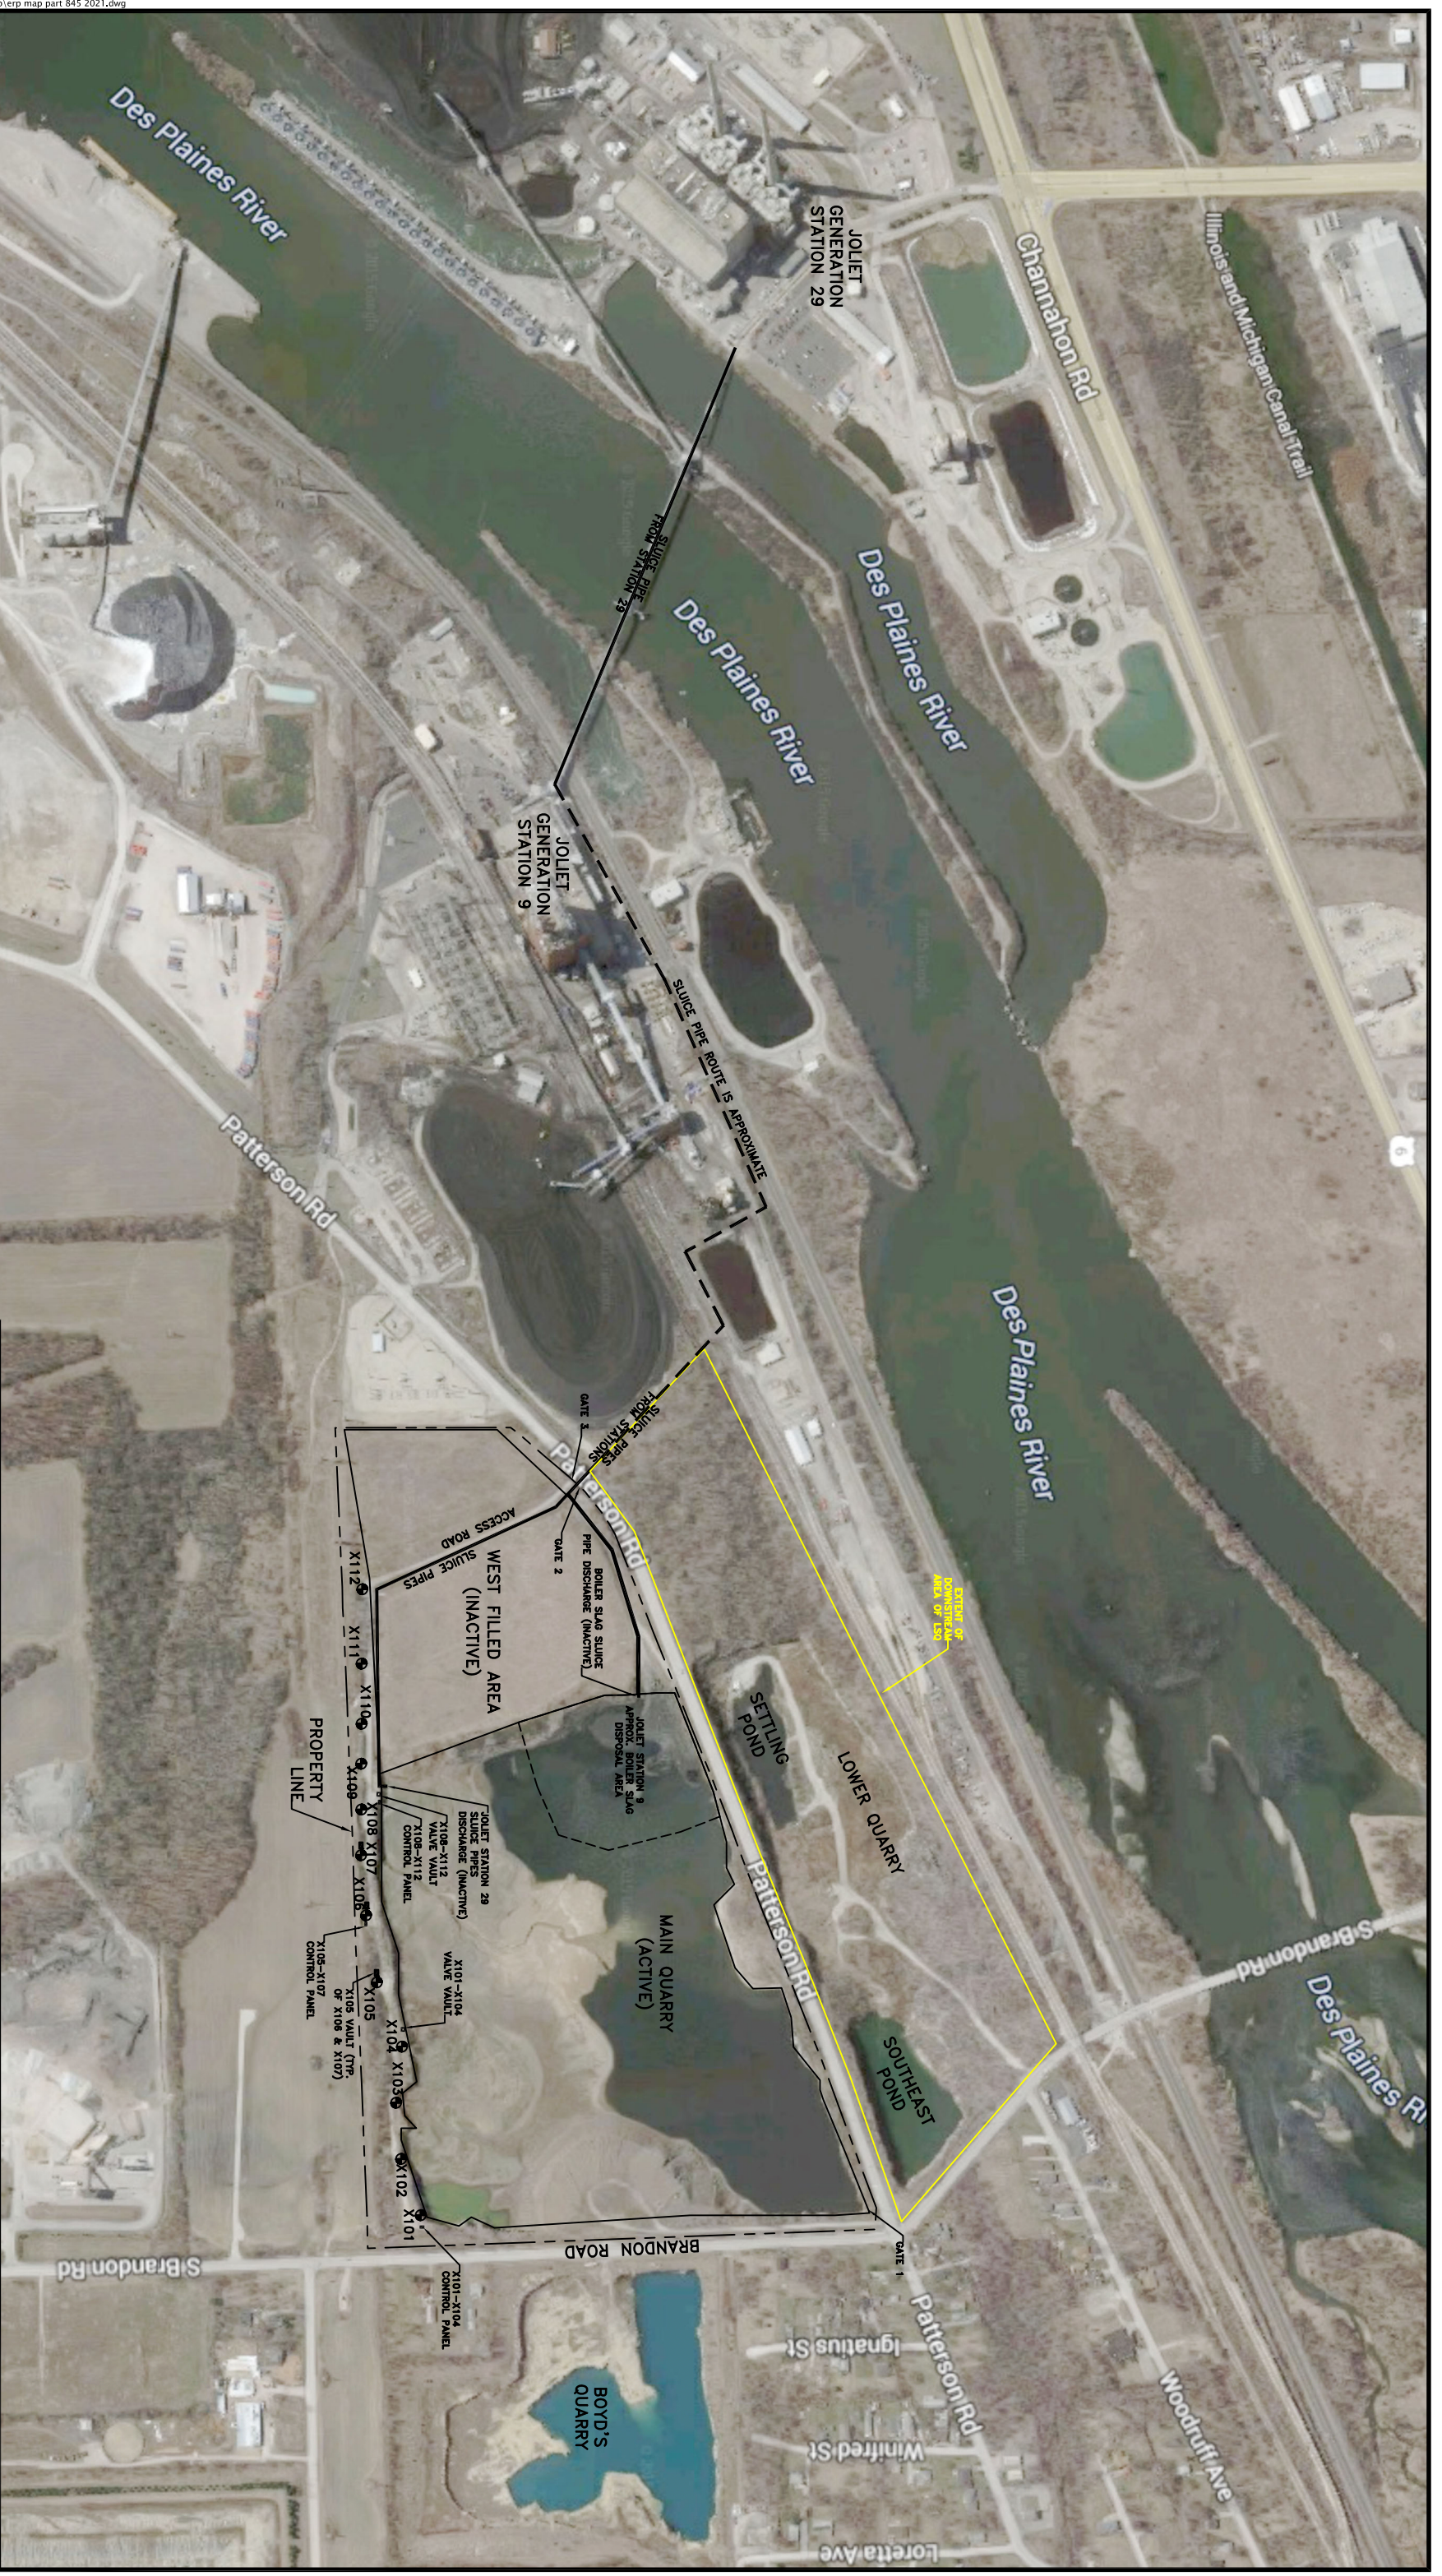
KPRG Project No. 12815 FIGURE 1

Figure 1 – Site Map Including Generating Stations

In accordance with 845.520(b)(), a site map is provided as Figure 1 and a site map close-up is provided as Figure 2. Figure 2 shows the extent of LSQ and the areas downstream of LSQ.
