Midwest Generation, LLC

Powerton Generating Station

2024 Safety Factor Assessment for Ash Surge Basin, Bypass Basin, & Former Ash Basin

Project No.: A12661.190

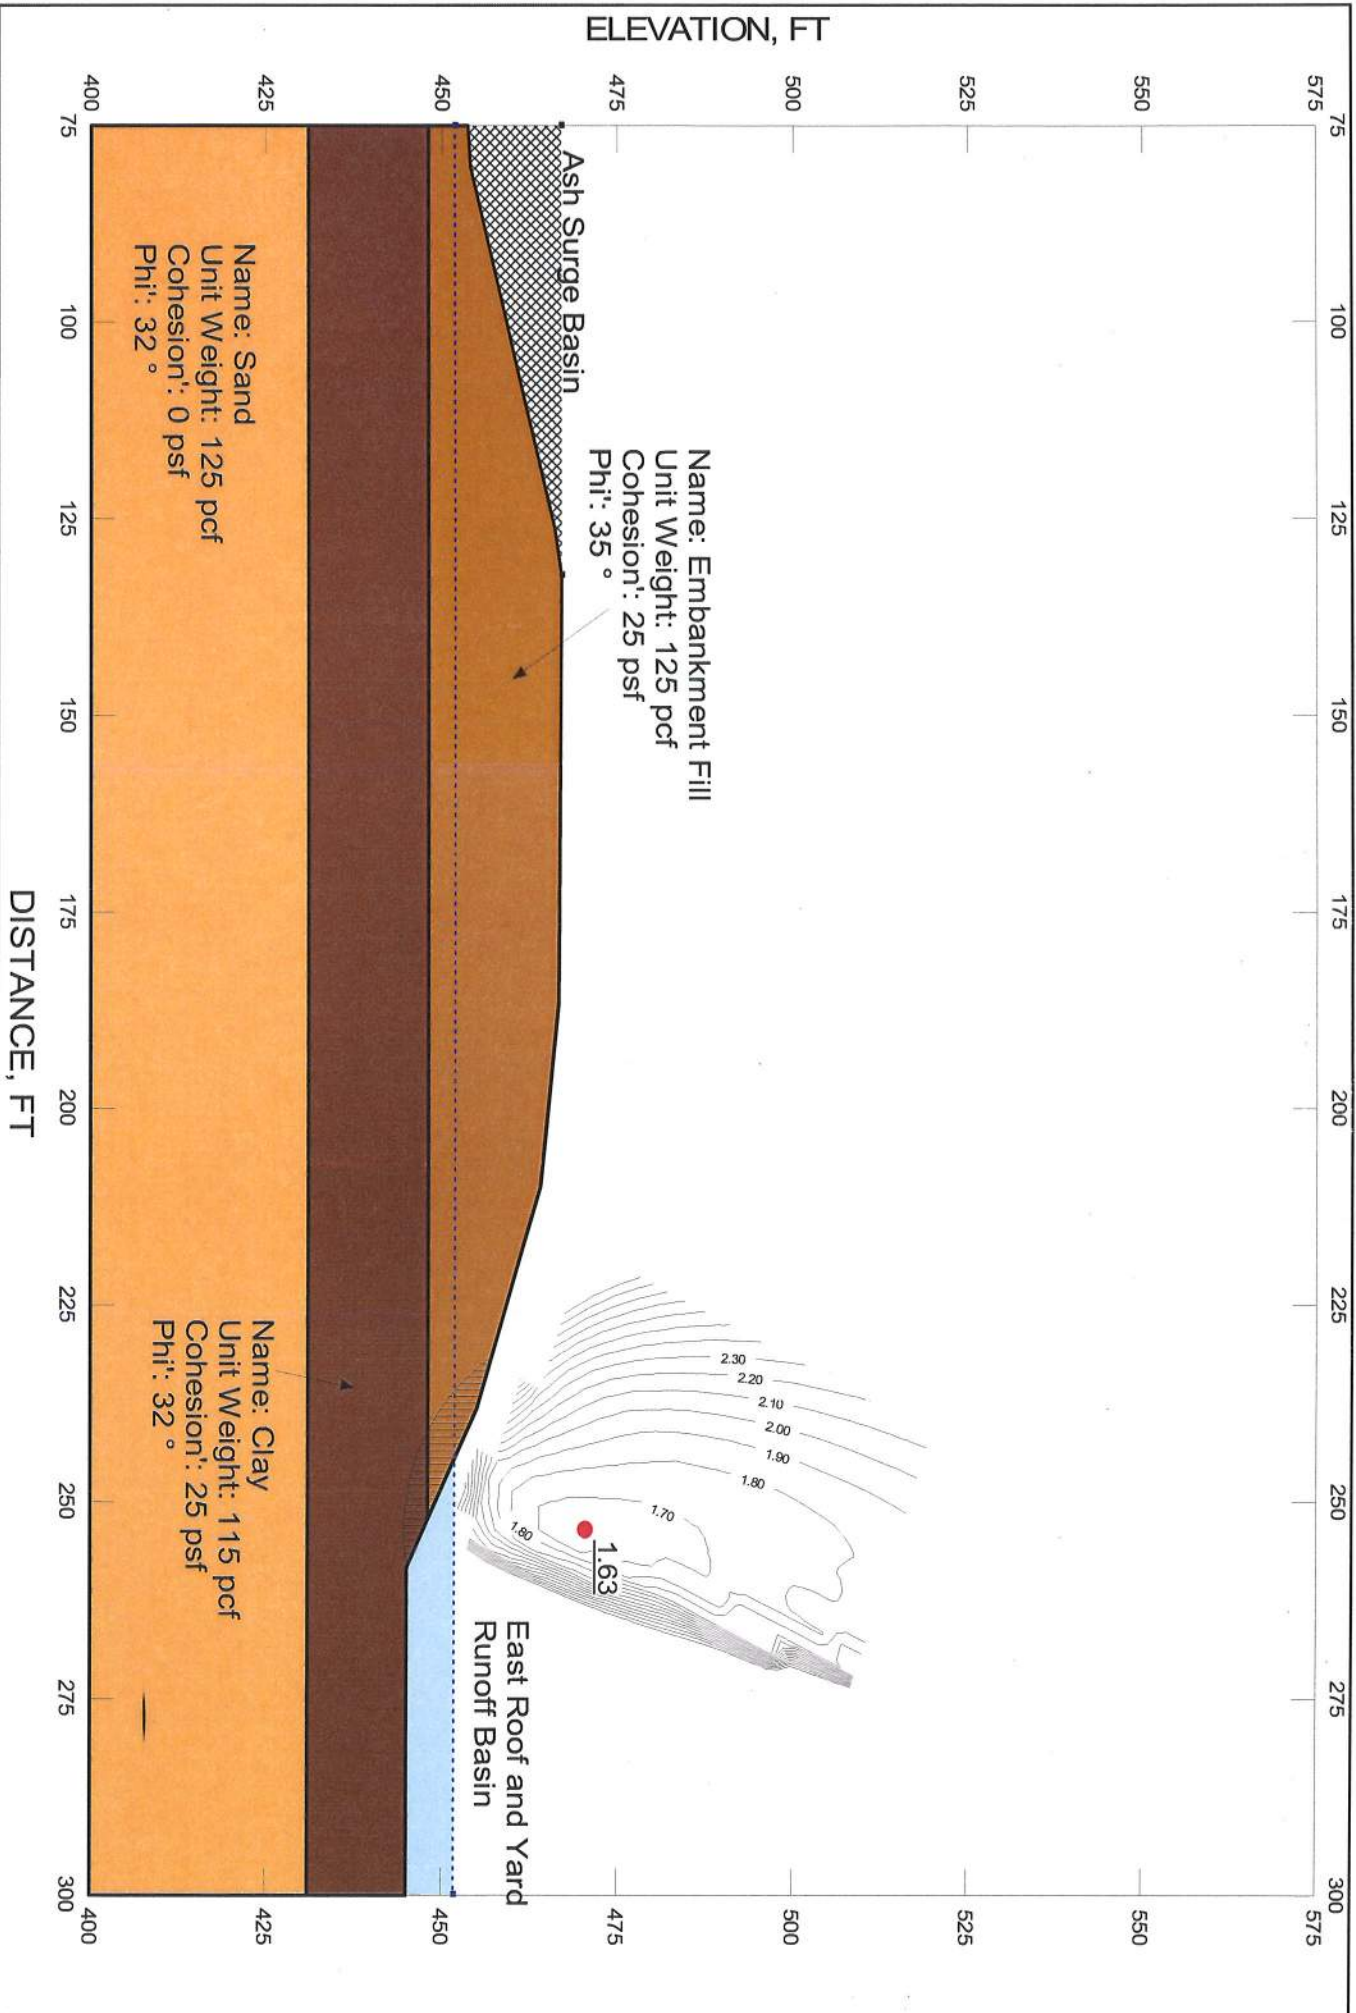
Geosyntec consultants		FIGURE 8	
Analysis	Section 2 - §257.73(e)(1)(ii): Maximum Surcharge Pool Loading	Analysis By	Cory Russell
Project	Powerton Ash Surge and Bypass Basins	Date	October 2016
File Name	Powerton Section 2.gsz

The results of the slope stability analysis for the critical cross sections of the Ash Surge Basin and Bypass Basin embankments are summarized in Table 1 below and presented in Figures 4 through 9 (Geosyntec 2016e).
