Midwest Generation, LLC

Powerton Generating Station

2025 Safety Factor Assessment for Ash Surge Basin, Bypass Basin, & Former Ash Basin

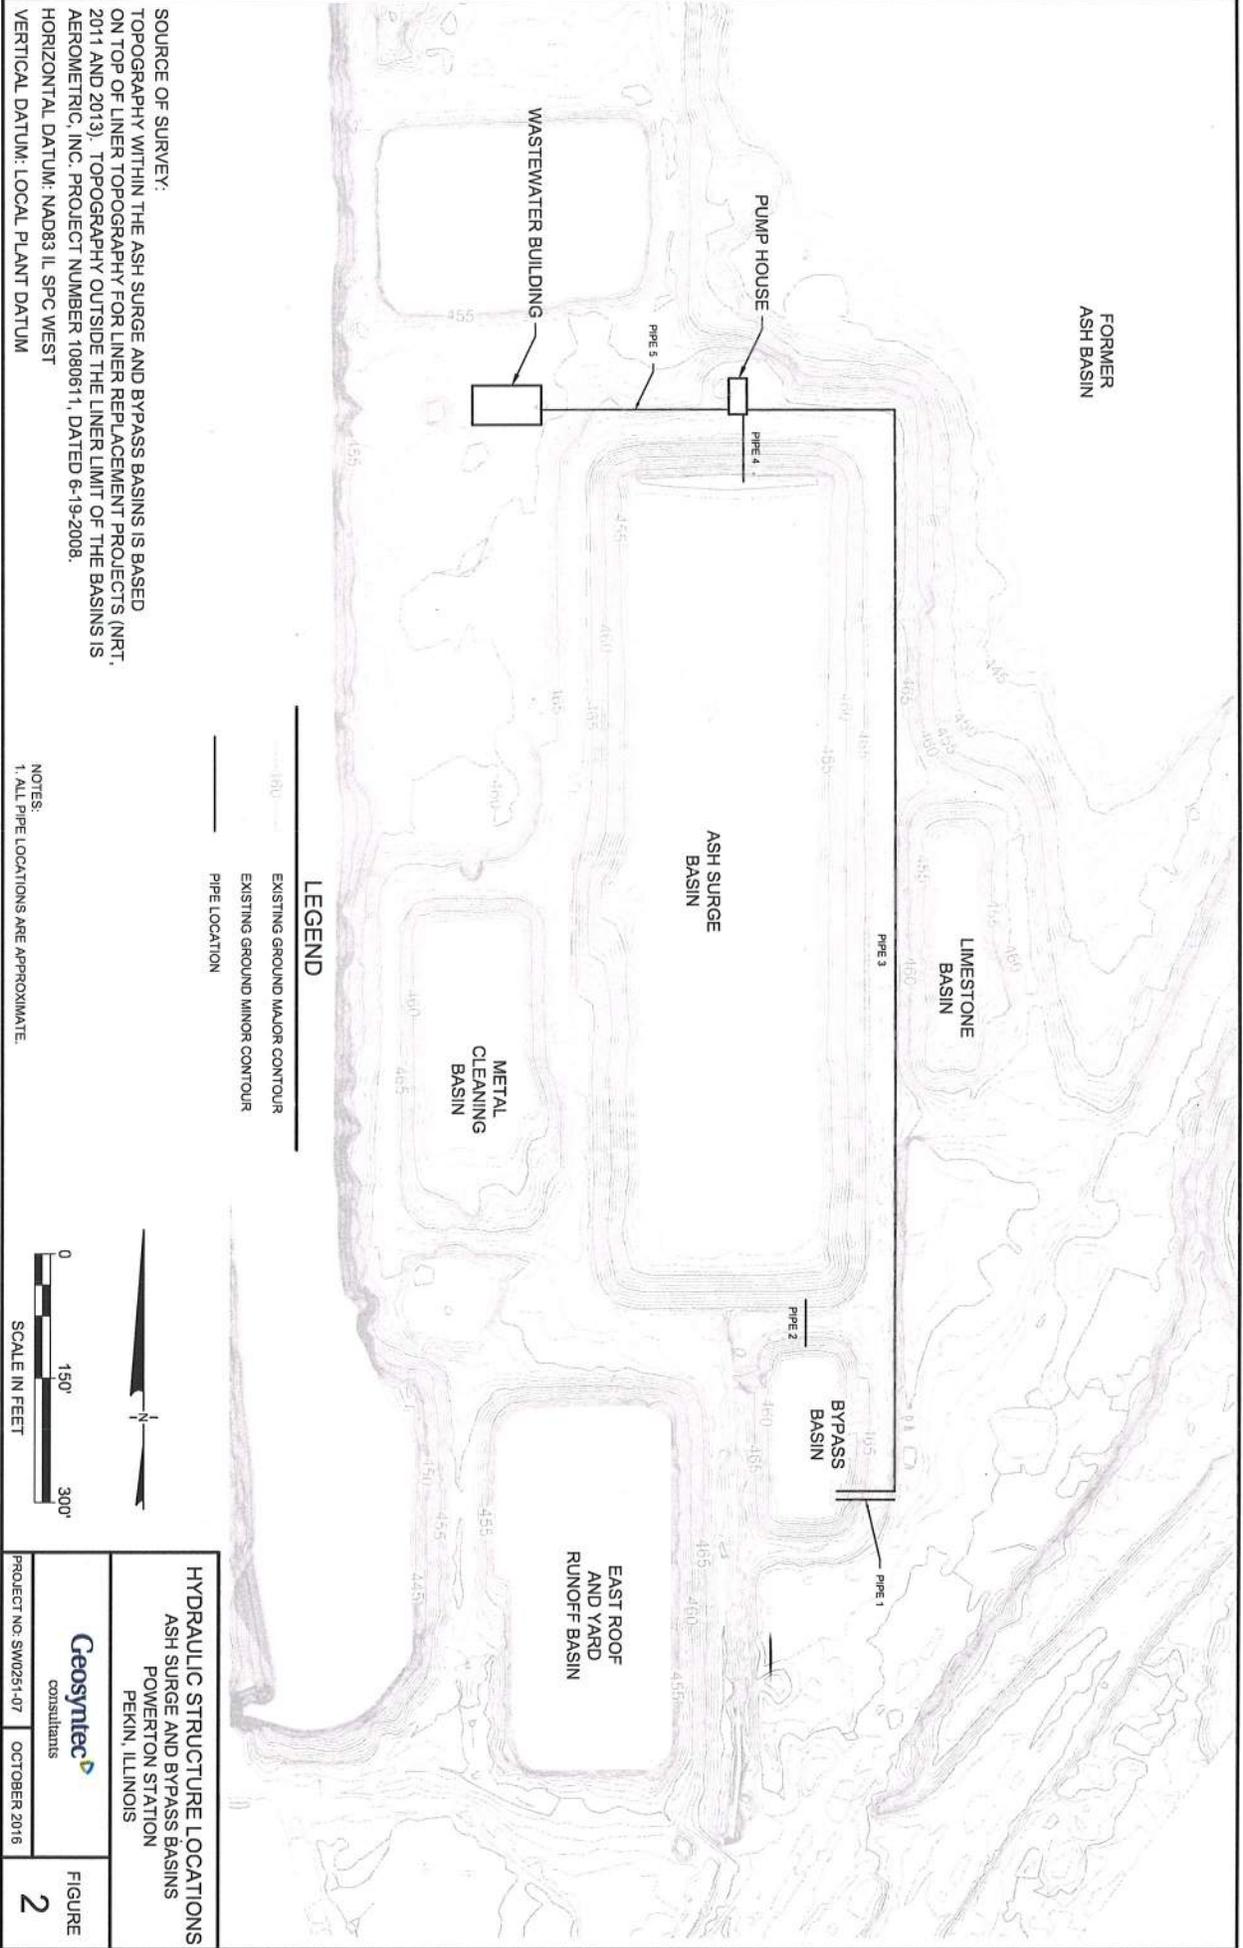
TOPOGRAPHY WITHIN THE ASH SURGE AND BYPASS BASINS IS BASED ON TOP OF LINER TOPOGRAPHY FOR LINER REPLACEMENT PROJECTS (NRT, 2011 AND 2013). TOPOGRAPHY OUTSIDE THE LINER LIMIT OF THE BASINS IS AEROMETRIC, INC. PROJECT NUMBER 1080611, DATED 6-19-2008.
 HORIZONTAL DATUM: NAD83 IL SPC WEST
 VERTICAL DATUM: LOCAL PLANT DATUM

NOTES
 1. ALL PIPE LOCATIONS ARE APPROXIMATE.

Hydraulic structures passing through or beneath the embankments of the Bypass Basin and Ash Surge Basin consist of several pipes and conveyance structures associated with the inlet and outlet structures of the Basins. These structures and pipes were inspected periodically between 10 May 2016 and 24 May 2016 by a company specializing in video camera pipe inspections. The inspected structures and pipes related to the Basins included are presented on Figure 2. The video inspections did not identify significant deterioration, deformation, distortion, bedding deficiencies, sedimentation, or debris that would negatively affect operation of the pipes was observed.

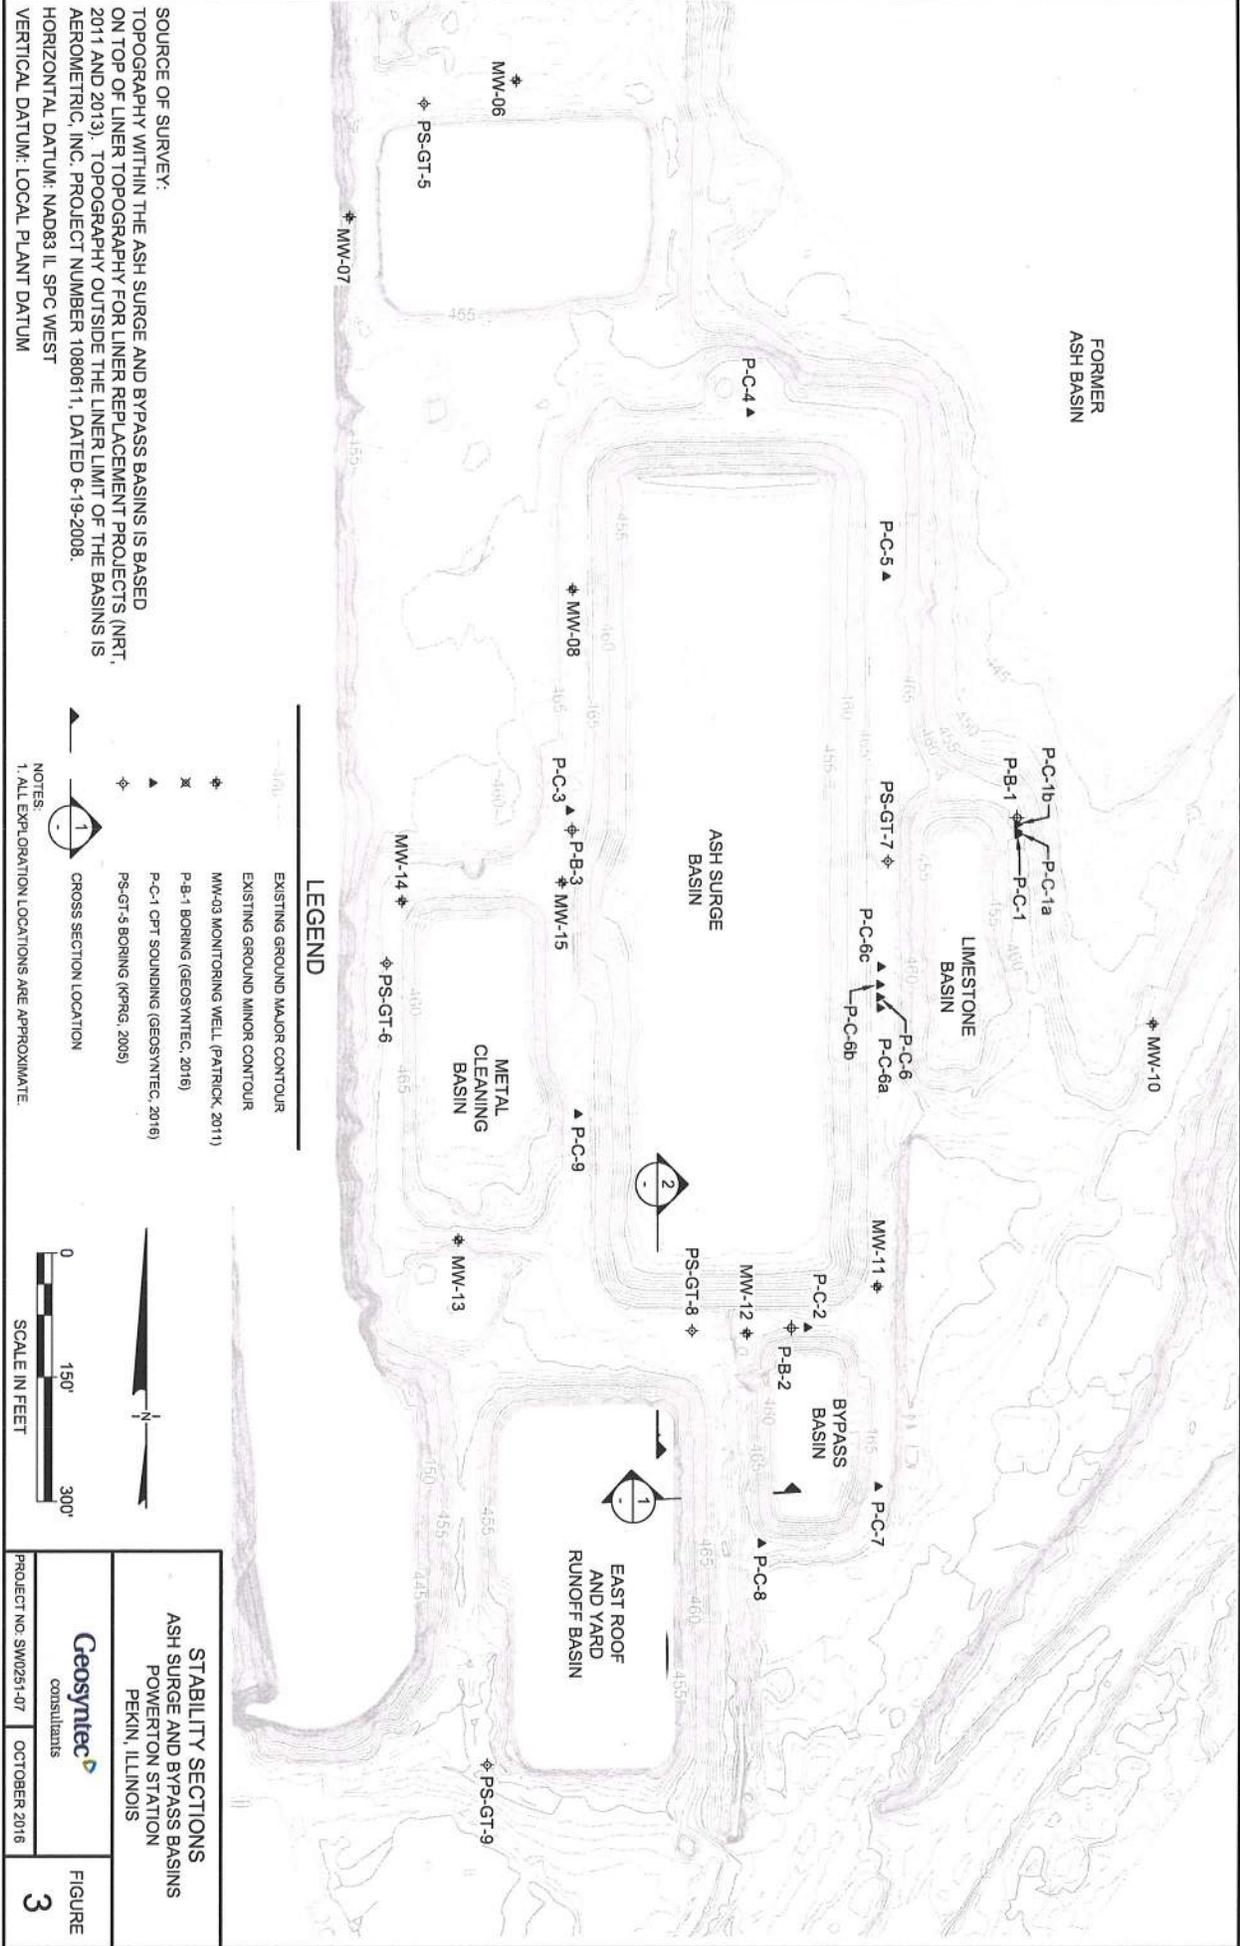
STABILITY SECTIONS ASH SURGE AND BYPASS BASINS POWERTON STATION PEKIN, ILLINOIS	
	FIGURE 3
PROJECT NO. SW0251-07	OCTOBER 2016

SOURCE OF SURVEY:
 TOPOGRAPHY WITHIN THE ASH SURGE AND BYPASS BASINS IS BASED ON TOP OF LINER TOPOGRAPHY FOR LINER REPLACEMENT PROJECTS (NRT, 2011 AND 2013). TOPOGRAPHY OUTSIDE THE LINER LIMIT OF THE BASINS IS AEROMETRIC, INC. PROJECT NUMBER 1080611, DATED 6-19-2008.
 HORIZONTAL DATUM: NAD83 IL SFC WEST
 VERTICAL DATUM: LOCAL PLANT DATUM

Ponds or water bodies near downstream slopes of the Ash Surge Basin and Bypass Basin are identified on Figure 3 and include:

This section describes the initial safety factor assessment for the Ash Surge Basin and Bypass Basin and the methodology used to perform the assessment in accordance with §257.73(e)(1). This assessment includes slope stability analyses of the critical embankment cross-section for each basin, shown in Figure 3.

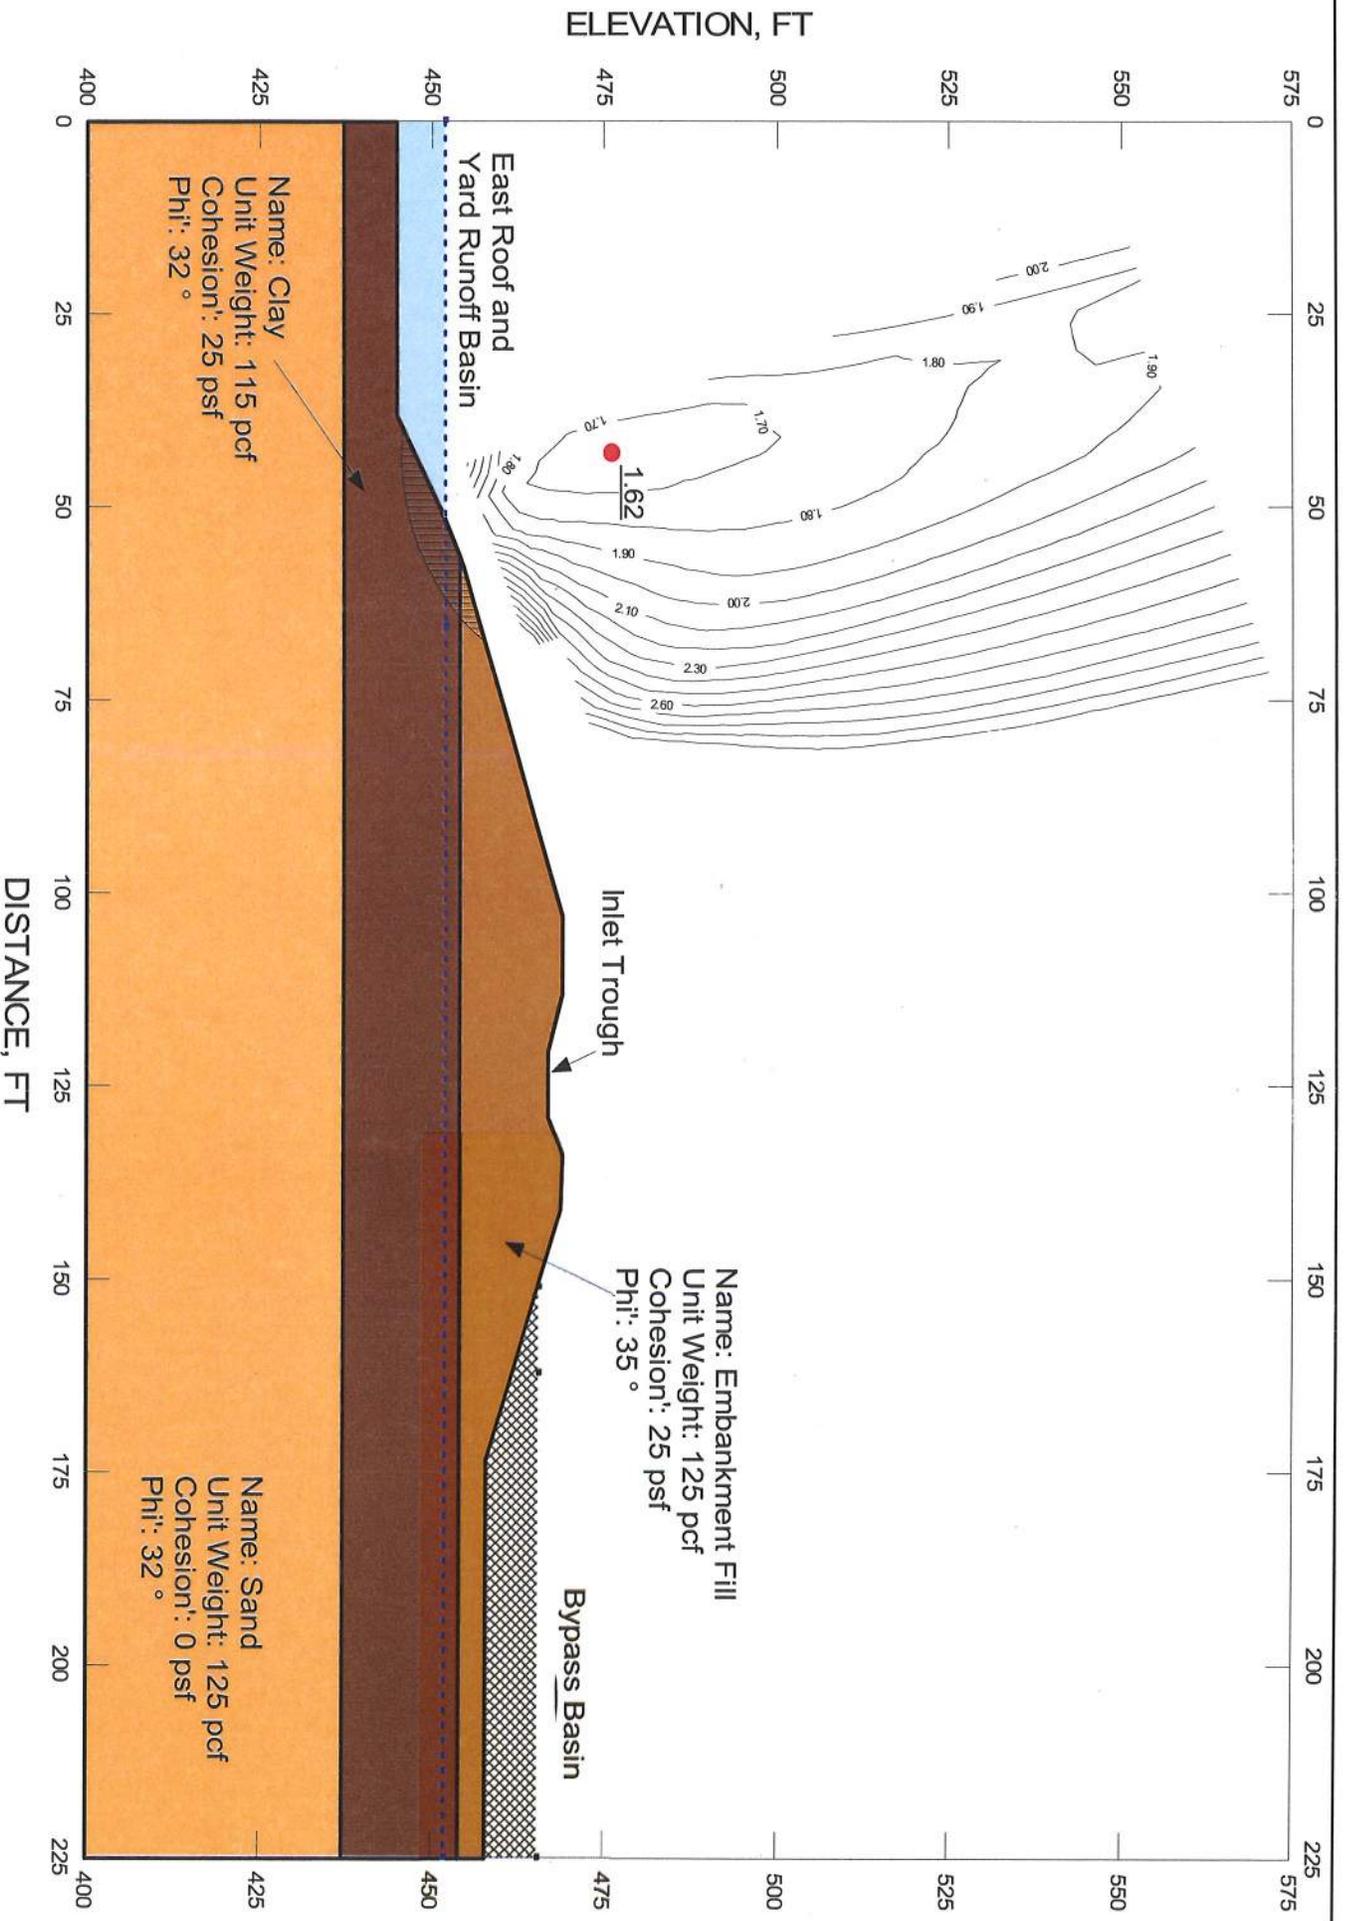
Analysis	Section 1 - \$257.73(e)(1)(i): Long Term, Maximum Storage Pool Loading
Project	Powerton Ash Surge and Bypass Basins
File Name	Powerton Section 1.gsz
Analysis By	Cory Russell
Date	October 2016

The results of the slope stability analysis for the critical cross sections of the Ash Surge Basin and Bypass Basin embankments are summarized in Table 1 below and presented in Figures 4 through 9 (Geosyntec 2016e).
