**ANNUAL INSPECTION REPORT  
ASH SURGE BASIN AND BYPASS BASIN  
POWERTON STATION  
18 JANUARY 2016**

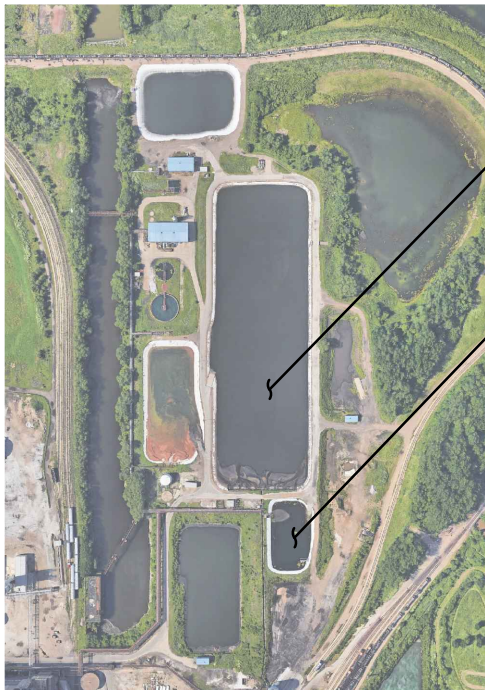
SITE PLAN

ASH SURGE BASIN

Pursuant to 40 CFR 257.83(b), Geosyntec Consultants (Geosyntec) performed an annual inspection of the Ash Surge Basin and Bypass Basin at the Powerton Station in Pekin, Illinois (see Figure 1). The inspection included a review of available information regarding the status and condition of the CCR units, a visual inspection of the CCR units, including hydraulic and appurtenant structures, and preparation of this inspection report. The visual inspection was performed by Ms. Jane Soule, P.E., on 13 November 2015. A summary of the inspection findings is presented below and in Tables 1 and 2 following the text.
