**EMERGENCY ACTION PLAN  
EAST AND WEST ASH PONDS  
WAUKEGAN STATION  
NOVEMBER 2022**

This Emergency Action Plan (EAP) has been prepared pursuant to Title 40 of the Code of Federal Regulations (40 CFR) Part 257, Subpart D, §257.73(a)(3) for the East and West Ash Ponds at the Midwest Generation, LLC (MWG) Waukegan Station (Station) in Waukegan, Illinois. This November 2022 update of the initial EAP has been revised to comply with 35 Illinois Administrative Code (35 IAC) Part 845, Subpart E, §845.520(b)(3) by revising the code references, and includes an updated contact list provided as Table 5. The EAP is presented as follows:

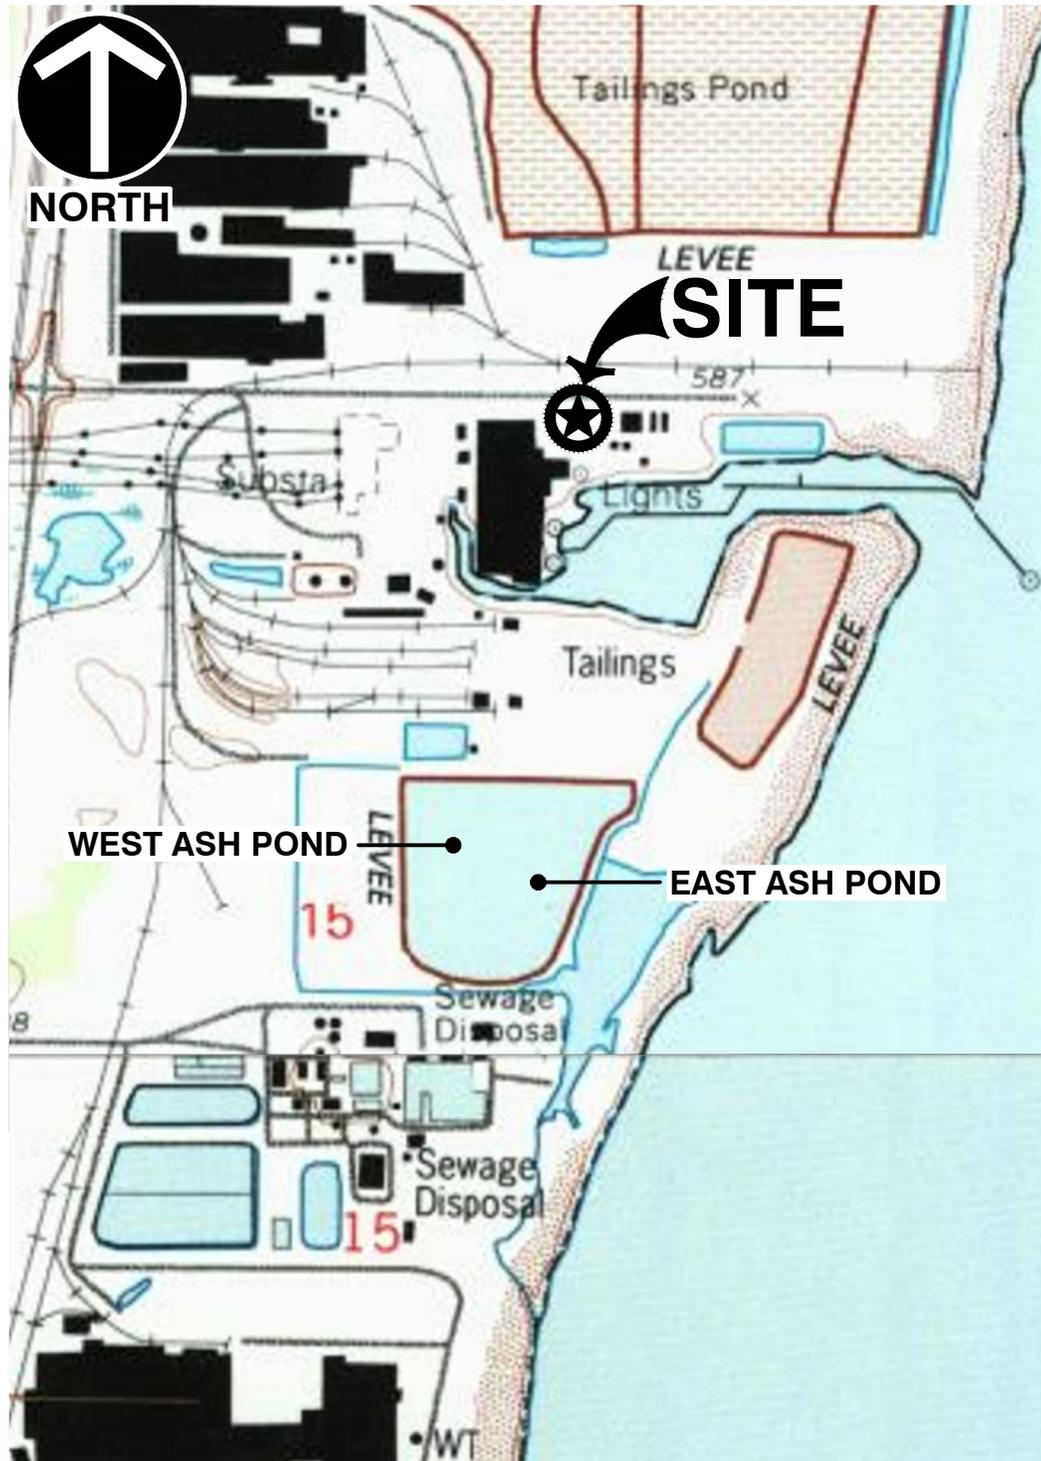
P:\2017\170-204\CADD\Draw\170204-CV01-Waukegan Station\170204-CV01-Site Vicinity Map.dwg[LAYOUT] LS:(4/5/2017 - mkrpff) - LP: 4/5/2017 1:28 PM

1. U.S.G.S. 7.5' TOPOGRAPHIC MAP, ZION QUADRANGLE, ILLINOIS-WISCONSIN DATED: 1993.

The following section provides a physical description of the East and West Ash Ponds. A site vicinity map is provided as Figure 1, attached. Drawings depicting the locations of, and the downstream areas affected by, a potential failure of East and West Ash Ponds were prepared by Geosyntec in October 16, 2016 and are provided in Attachment A.

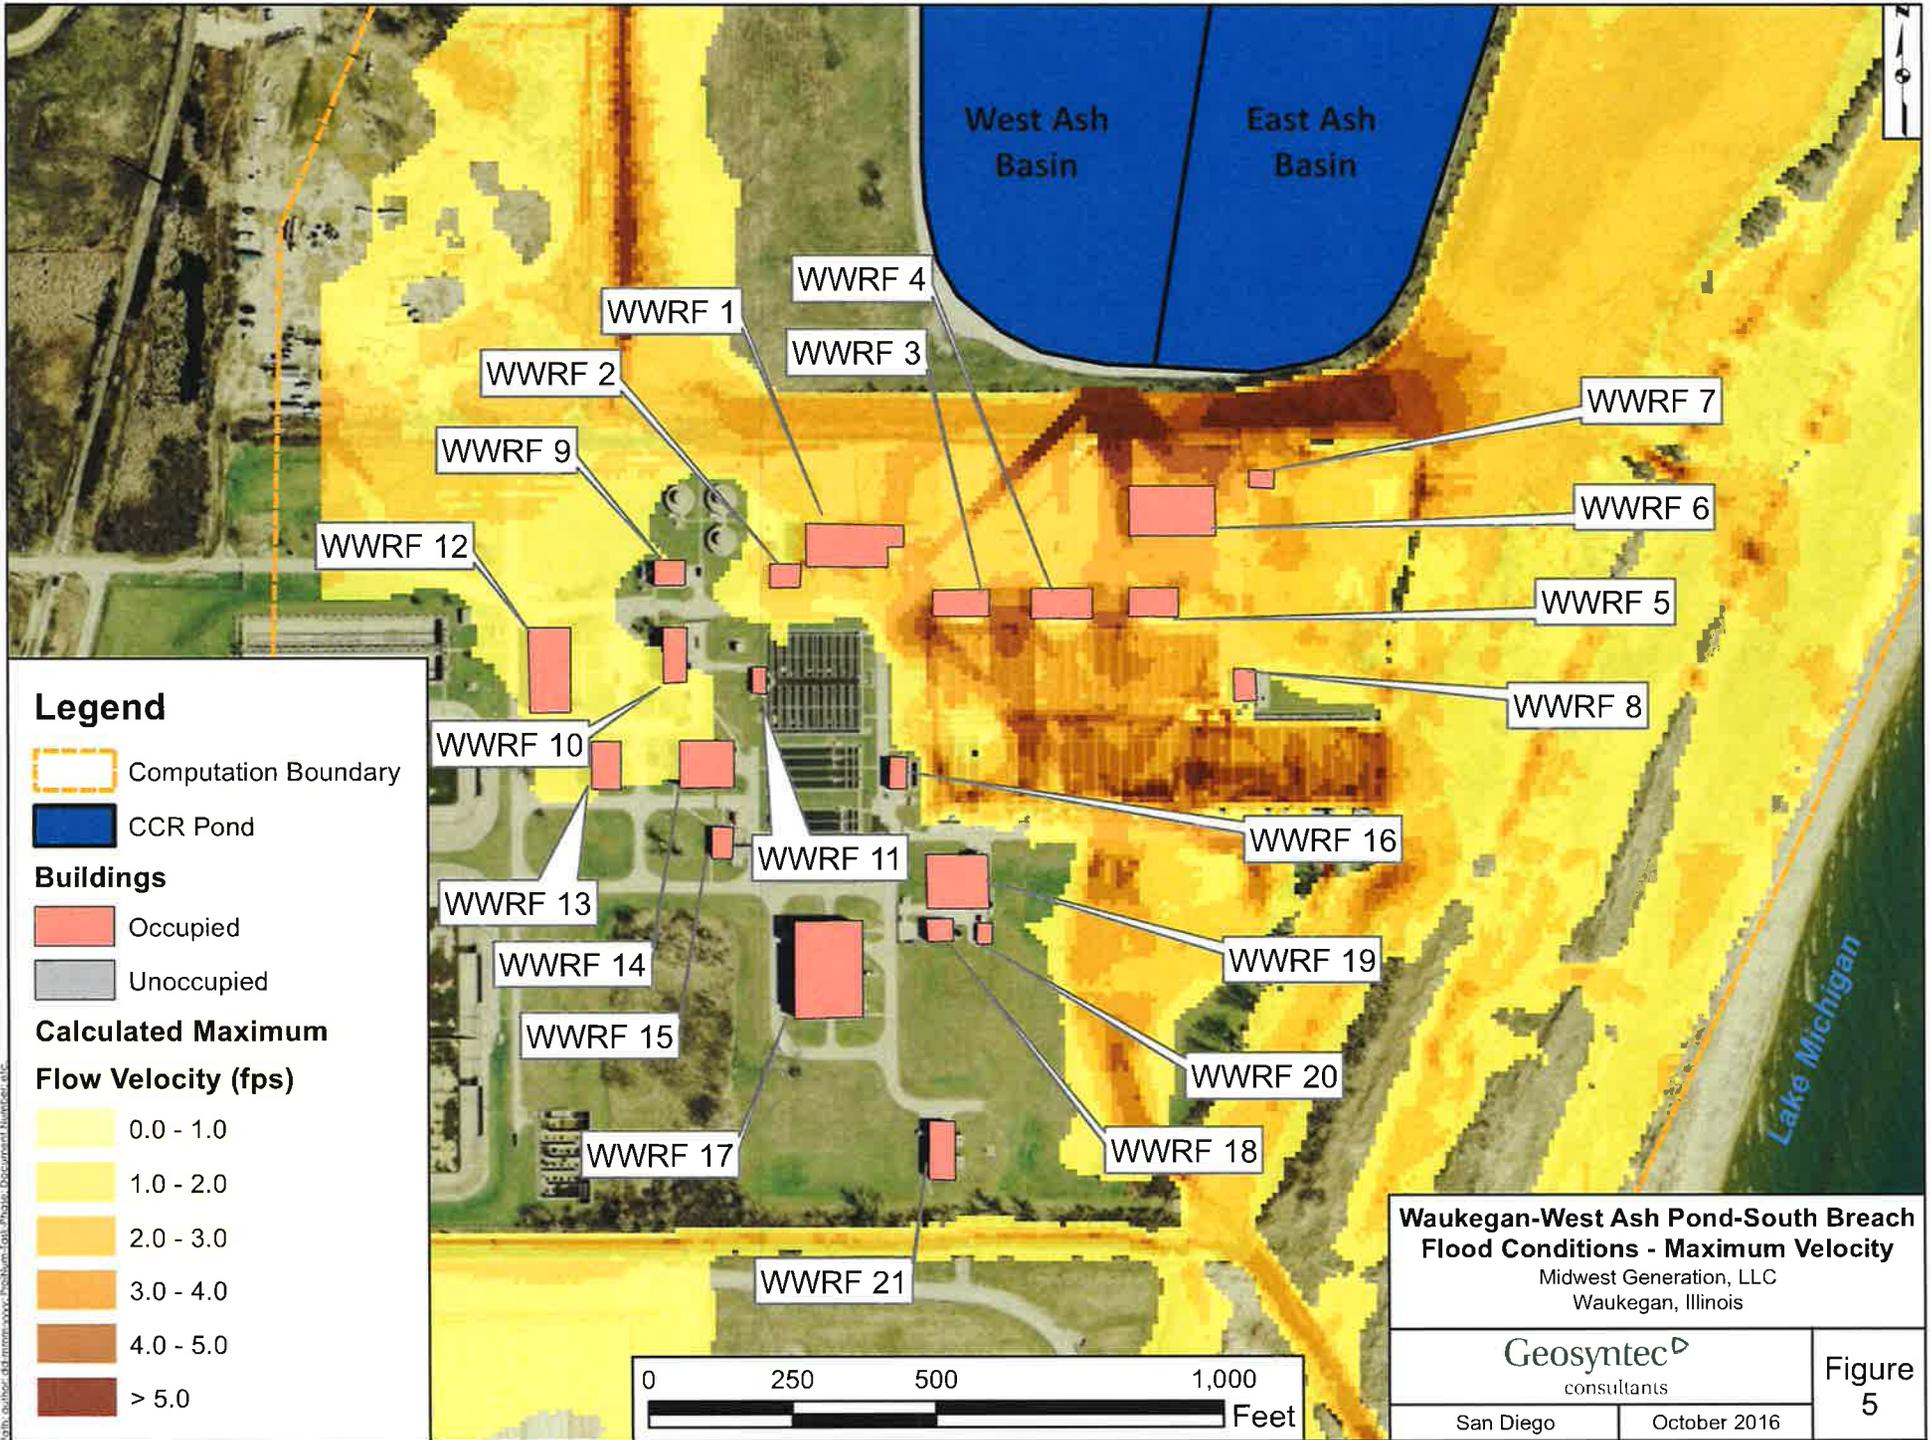
Figure  
 5

**Waukegan-West Ash Pond-South Breach Flood Conditions - Maximum Velocity**  
 Midwest Generation, LLC  
 Waukegan, Illinois

The potential impacts from failure of the East and West Ash Ponds were evaluated and reported by Geosyntec in the Hazard Potential Classification Assessment (HPCA), dated October 2016. A copy of the HPCA is contained on the CCR Rule Compliance Data and Information website (<http://www.nrg.com/legal/coal-combustion-residuals/>).

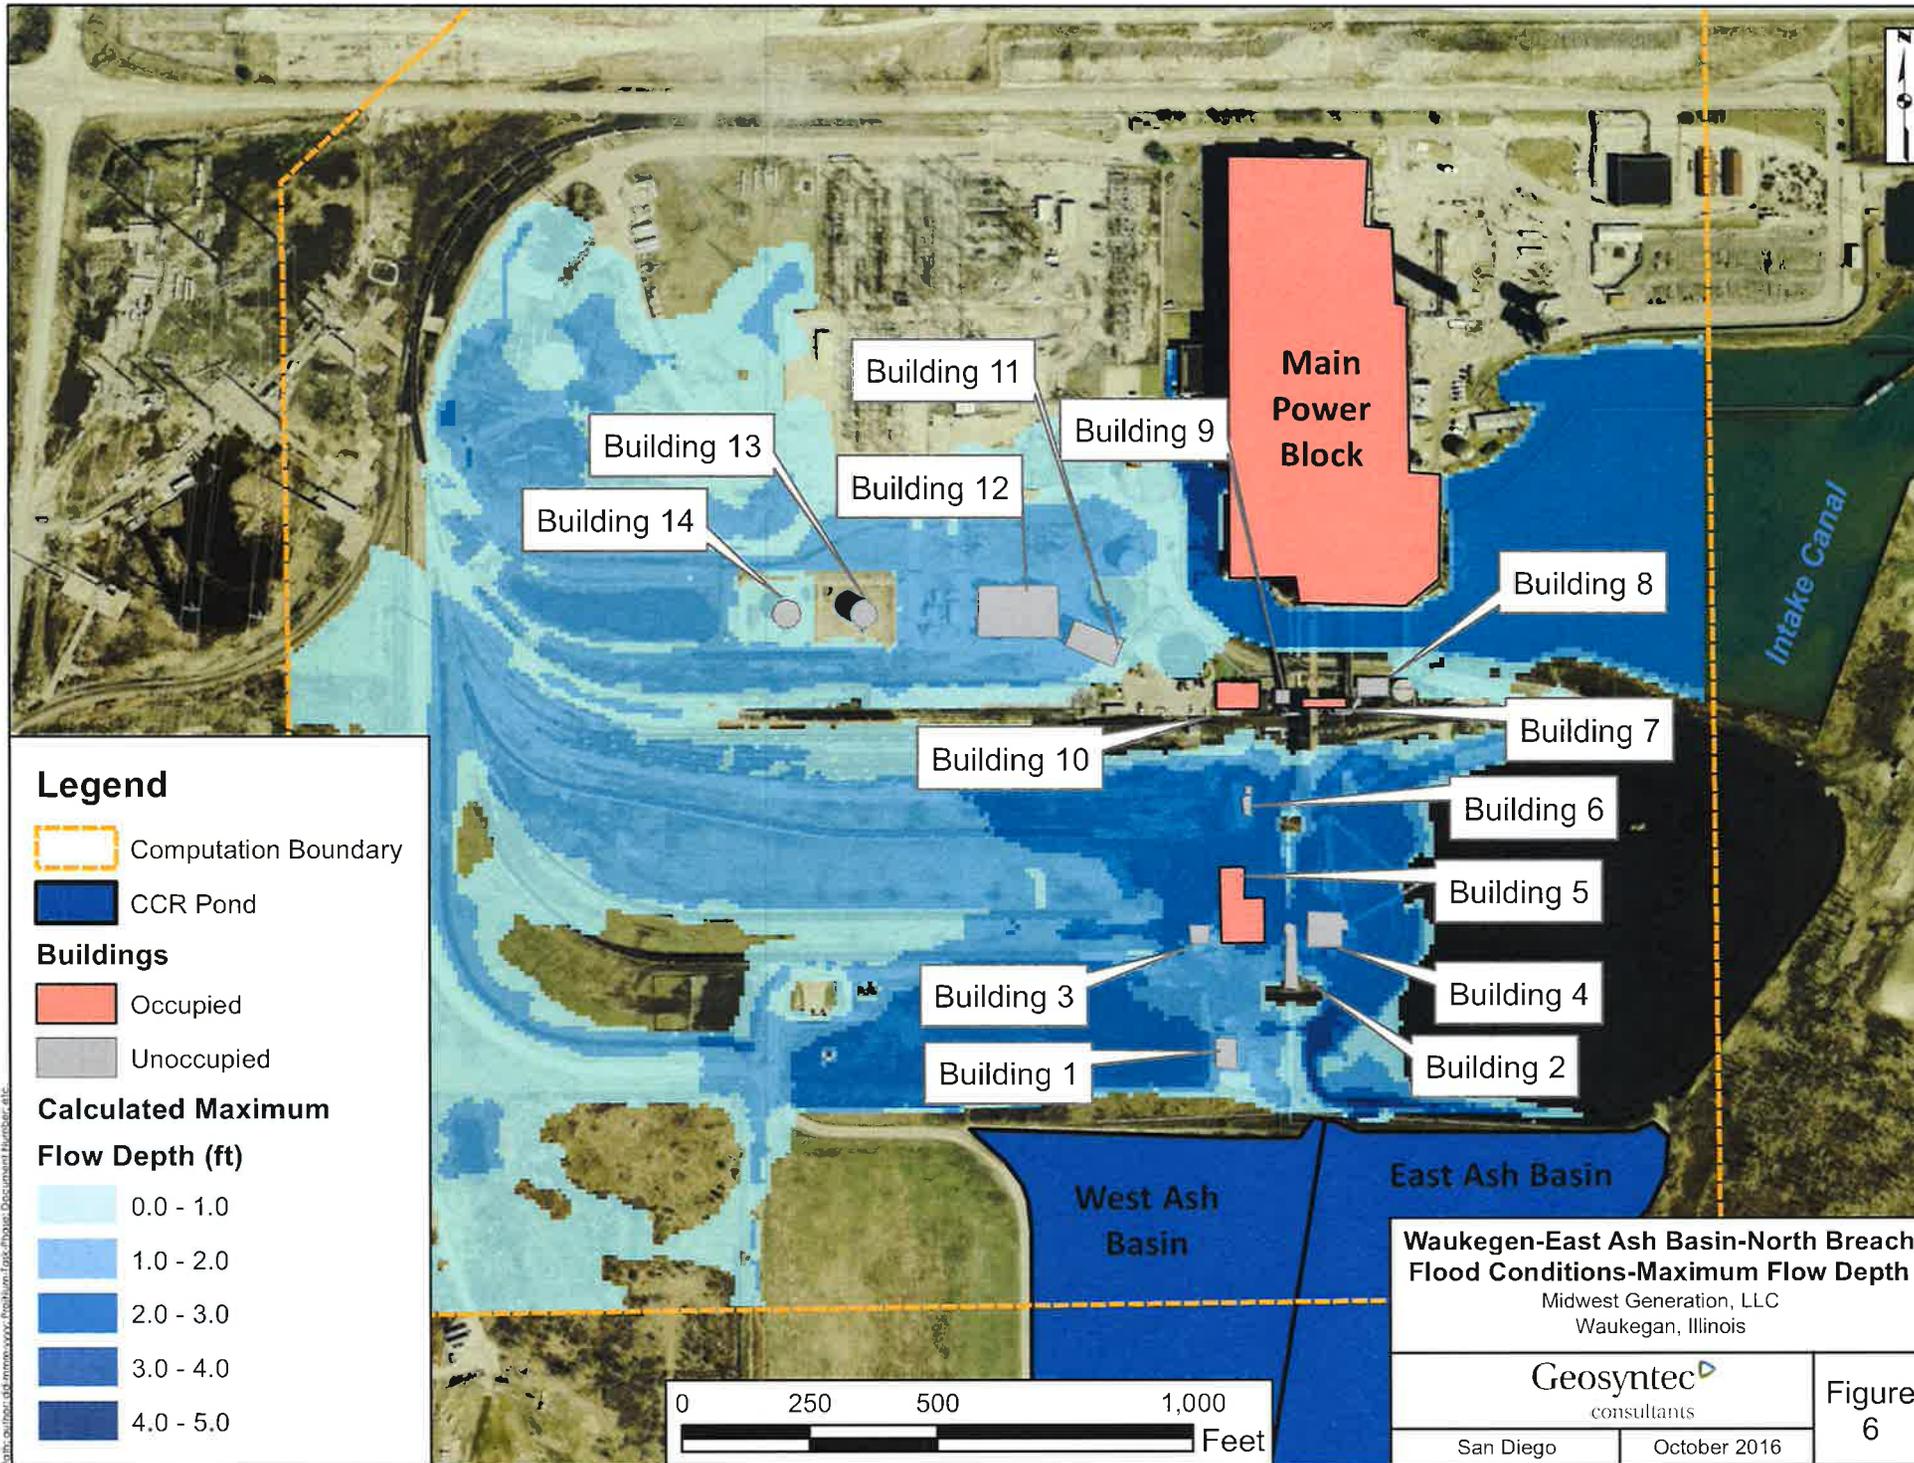
Figure  
 6

**Waukegen-East Ash Basin-North Breach Flood Conditions-Maximum Flow Depth**  
 Midwest Generation, LLC  
 Waukegan, Illinois

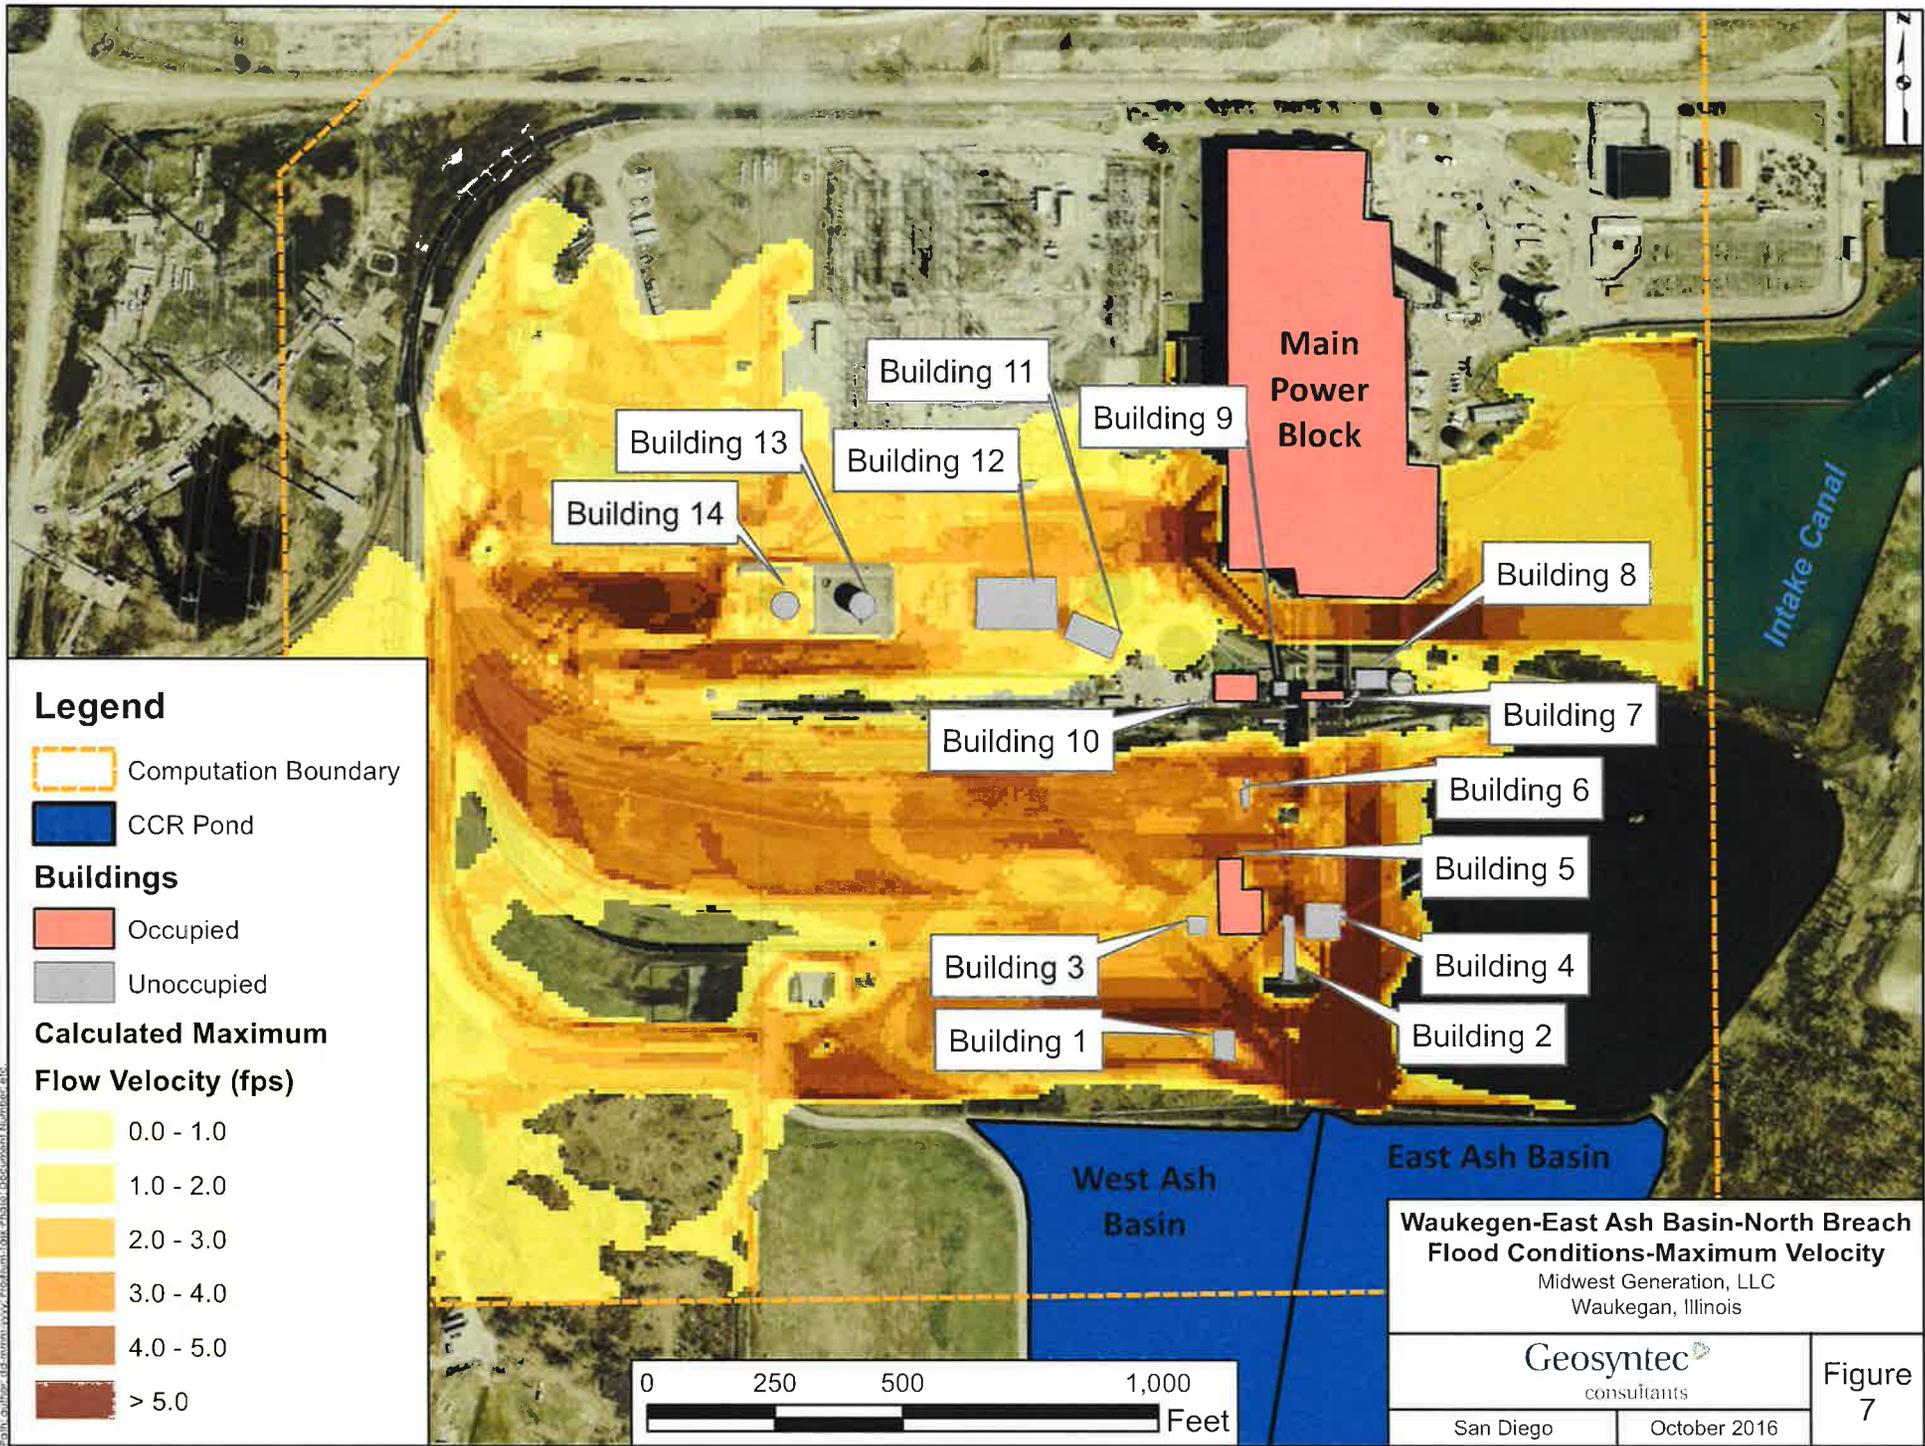
Figure  
7

**Waukegen-East Ash Basin-North Breach  
Flood Conditions-Maximum Velocity**  
Midwest Generation, LLC  
Waukegan, Illinois
