Waukegan Generating Station

# 2024 Safety Factor Assessment for East Ash Pond & West Ash Pond

Revision 0 October 13, 2024 Issue Purpose: Use Project No.: A12661.187

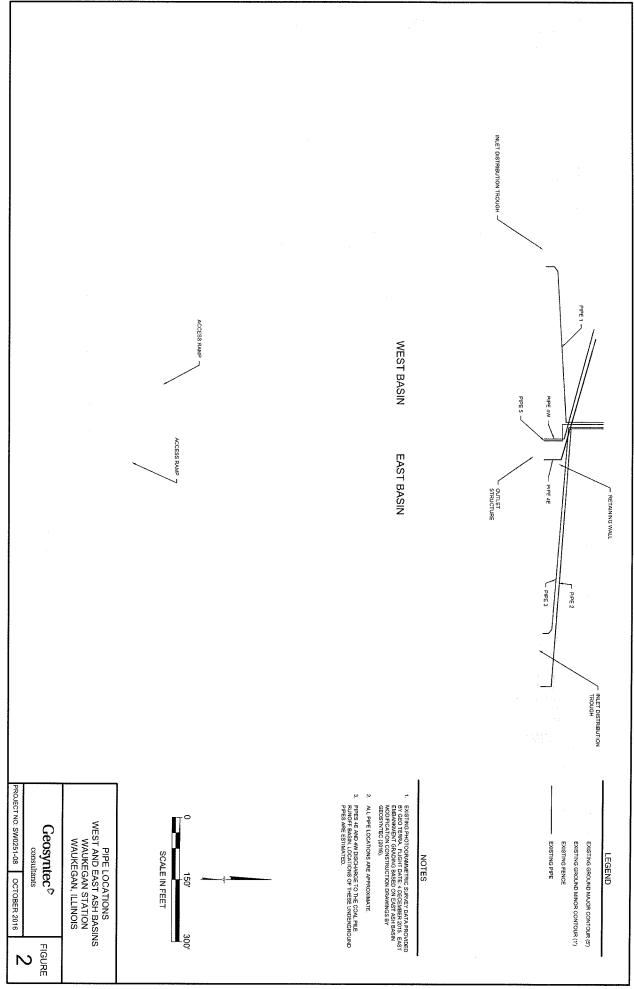
only of the length of the pipe or structure that passes through or beneath the Basins' embankments. The inspected structures and pipes related to the East and West Ash Basins are presented on Figure 2.

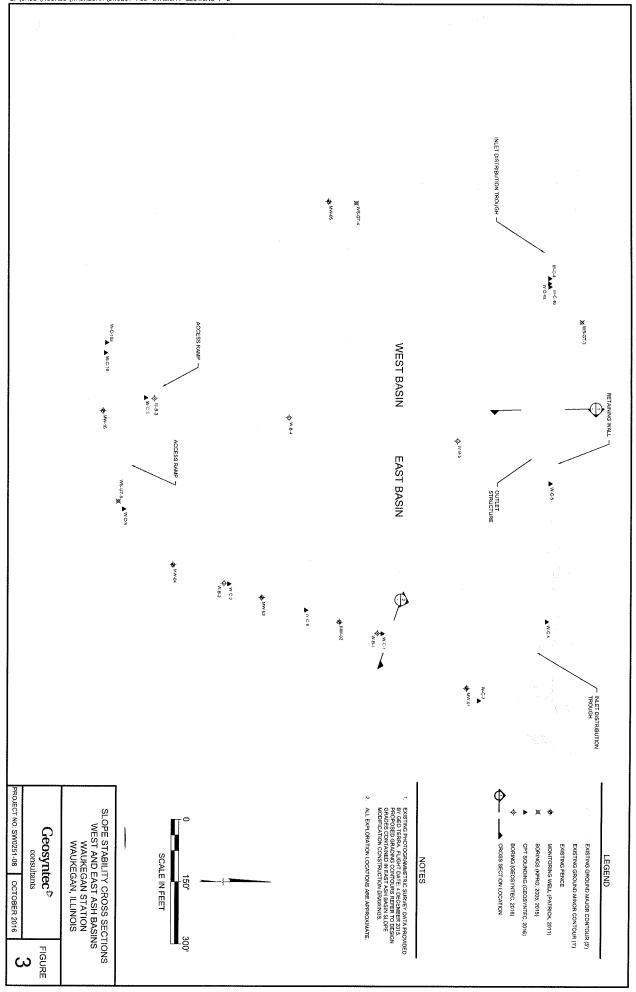
This section describes the initial safety factor assessment for the East and West Ash Basins and the methodology used to perform the assessment in accordance with \$257.73(e)(1). This assessment includes slope stability analyses of the critical embankment cross-sections for each basin, shown in Figure 3, and evaluation of stability of the retaining wall north of the Basins.

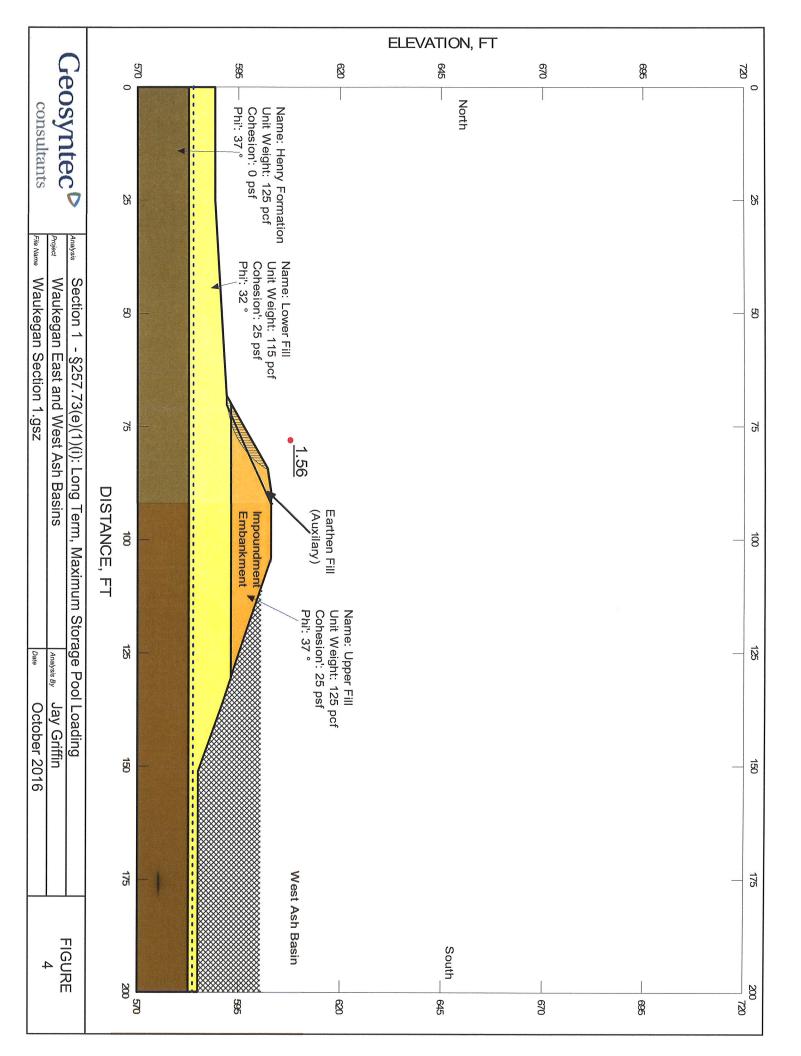
The results of the slope stability analysis for the critical cross sections of the East and West Ash Basin embankments are summarized in Table 1 below and presented in Figures 4 through 9 (Geosyntec 2016e).

The conditions for \$257.73(e)(1)(i) are identical to \$257.73(e)(1)(i) with the exception of the pool elevation, which is set at the lowest points of the embankment crest (Geosyntec, 2016e).
