**STRUCTURAL STABILITY AND FACTOR OF SAFETY ASSESSMENT  
ASH PONDS 1N, 1S, 2S, AND 3S, WILL COUNTY STATION  
SEPTEMBER 2021**

MIDWEST GENERATION LLC  
 WILL COUNTY STATION  
 PONDS 1N, 1S, 2S, AND 3S SLOPE STABILITY  
 ROMEOVILLE, WILL COUNTY, ILLINOIS

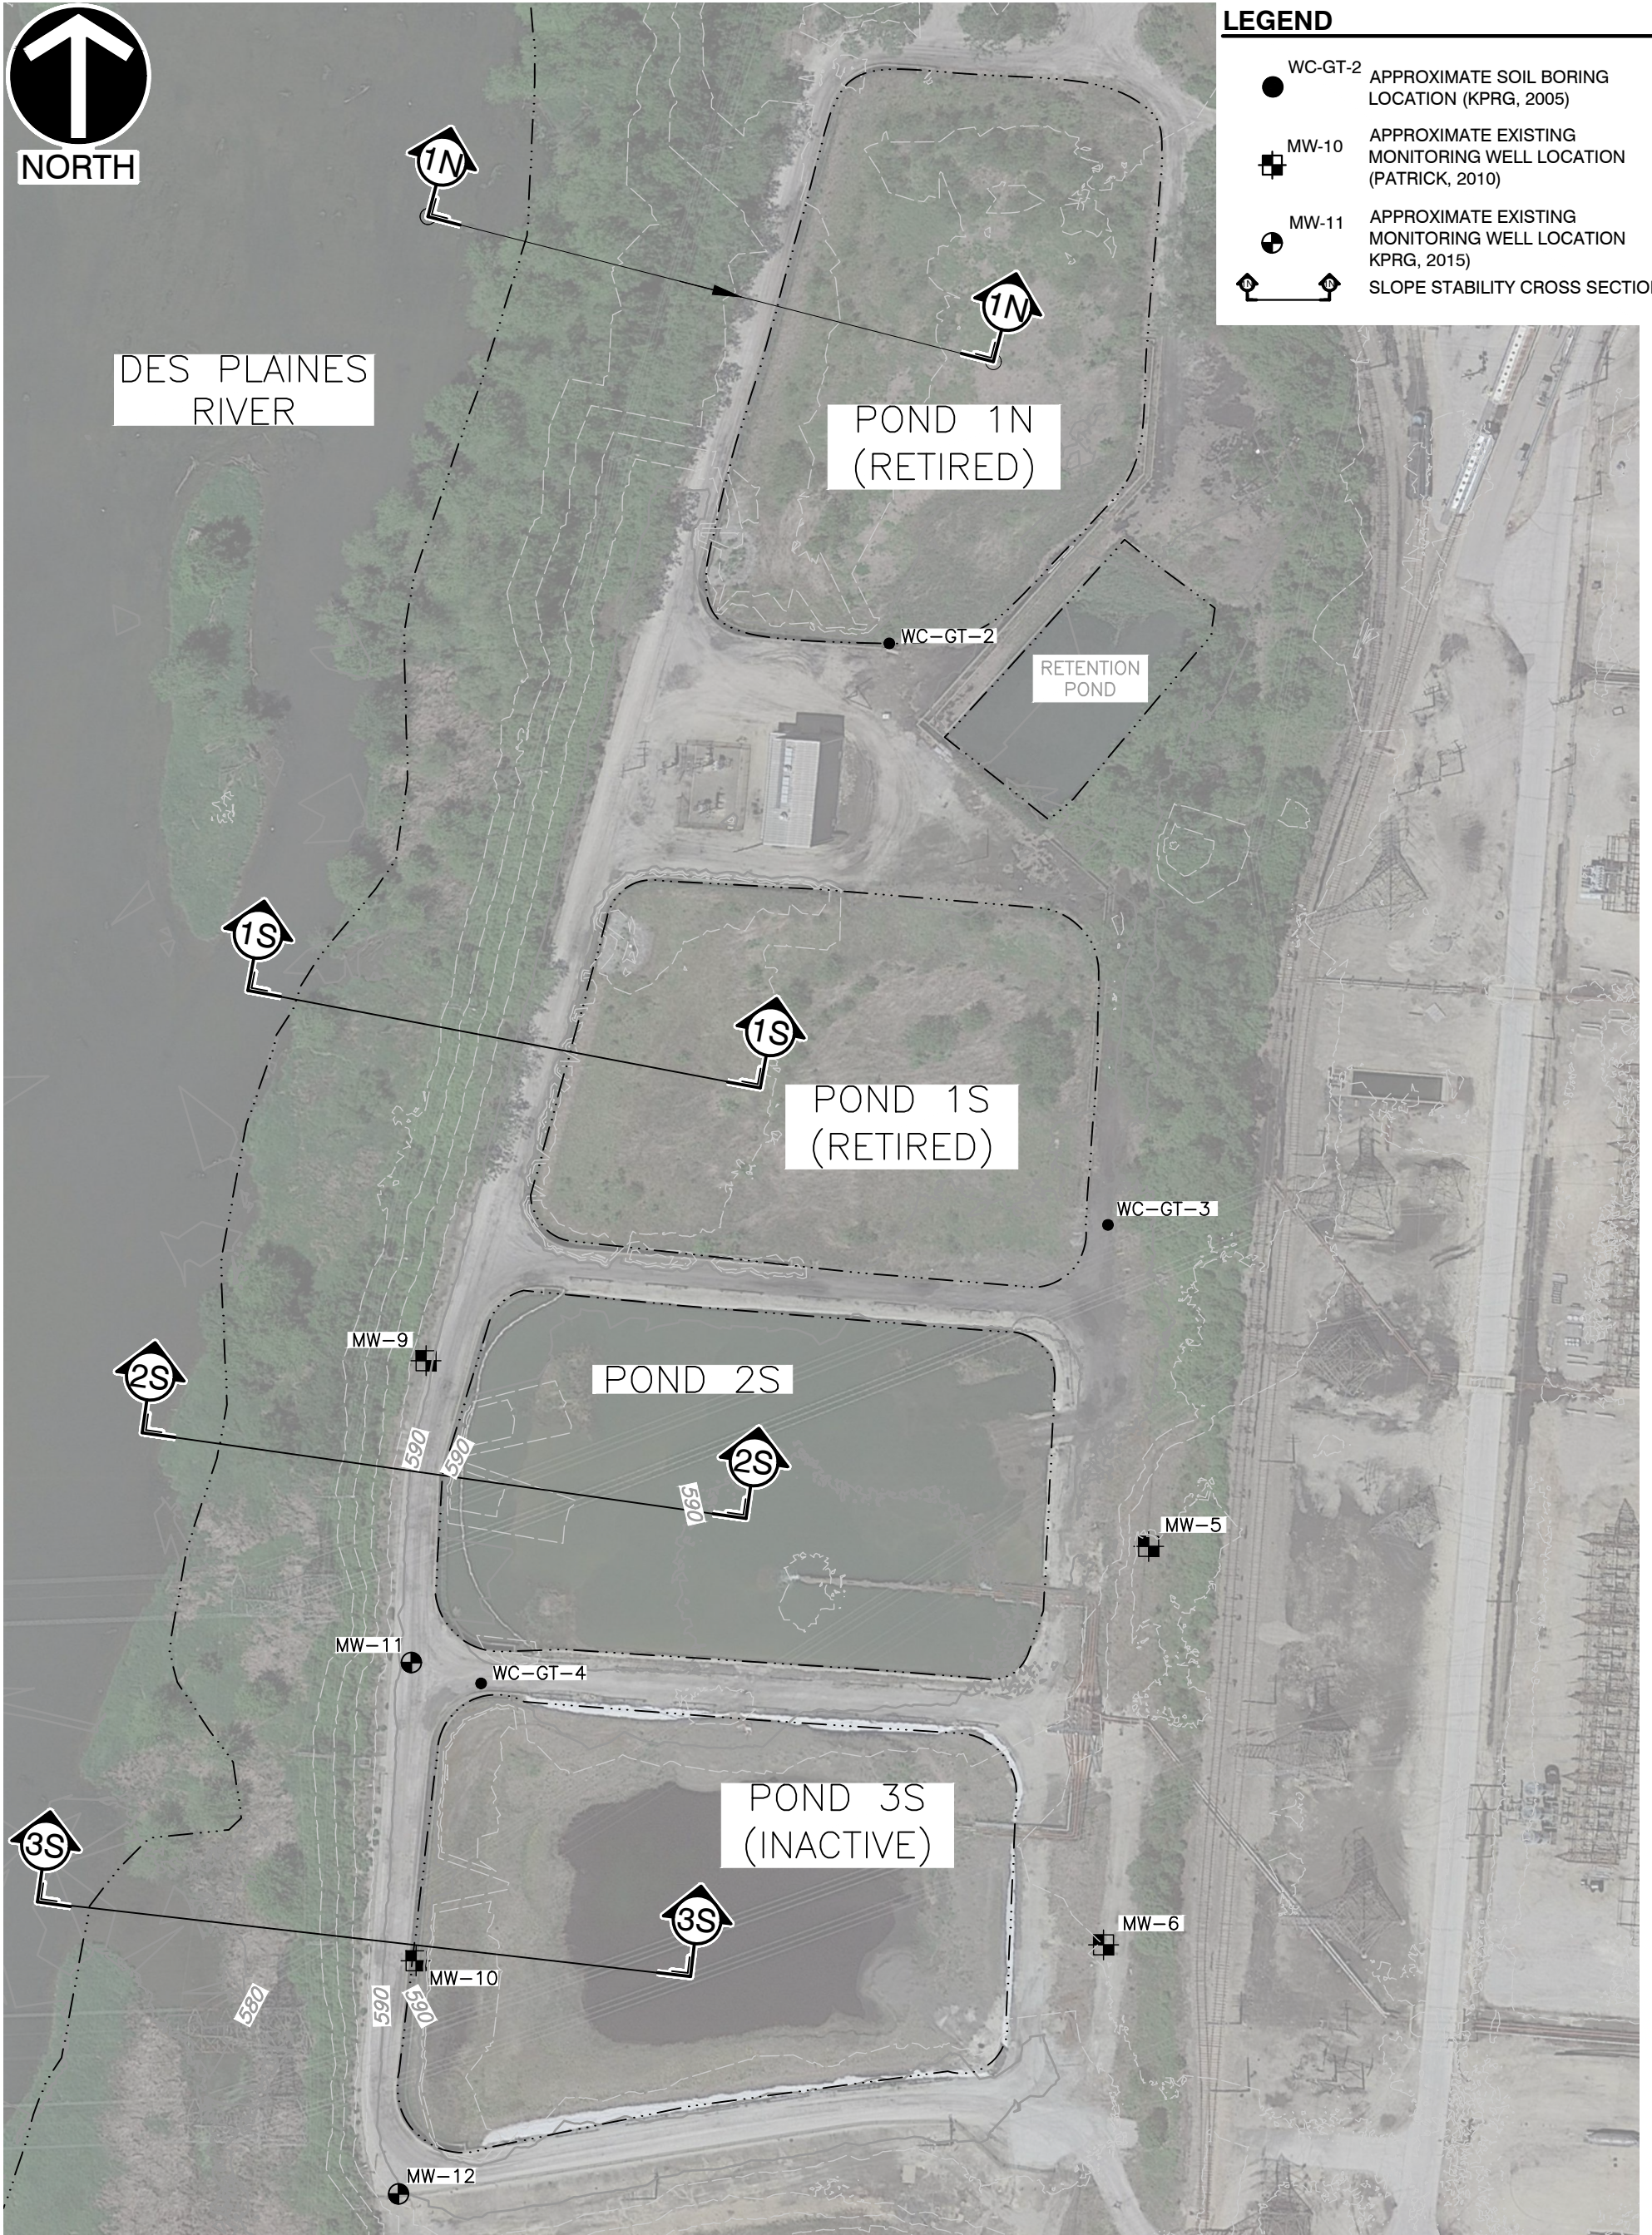
**SITE PLAN WITH CROSS-SECTIONS**

- WC-GT-2 APPROXIMATE SOIL BORING LOCATION (KPRG, 2005)
- ⊠ MW-10 APPROXIMATE EXISTING MONITORING WELL LOCATION (PATRICK, 2010)
- ⊕ MW-11 APPROXIMATE EXISTING MONITORING WELL LOCATION (KPRG, 2015)
- ↔ SLOPE STABILITY CROSS SECTION

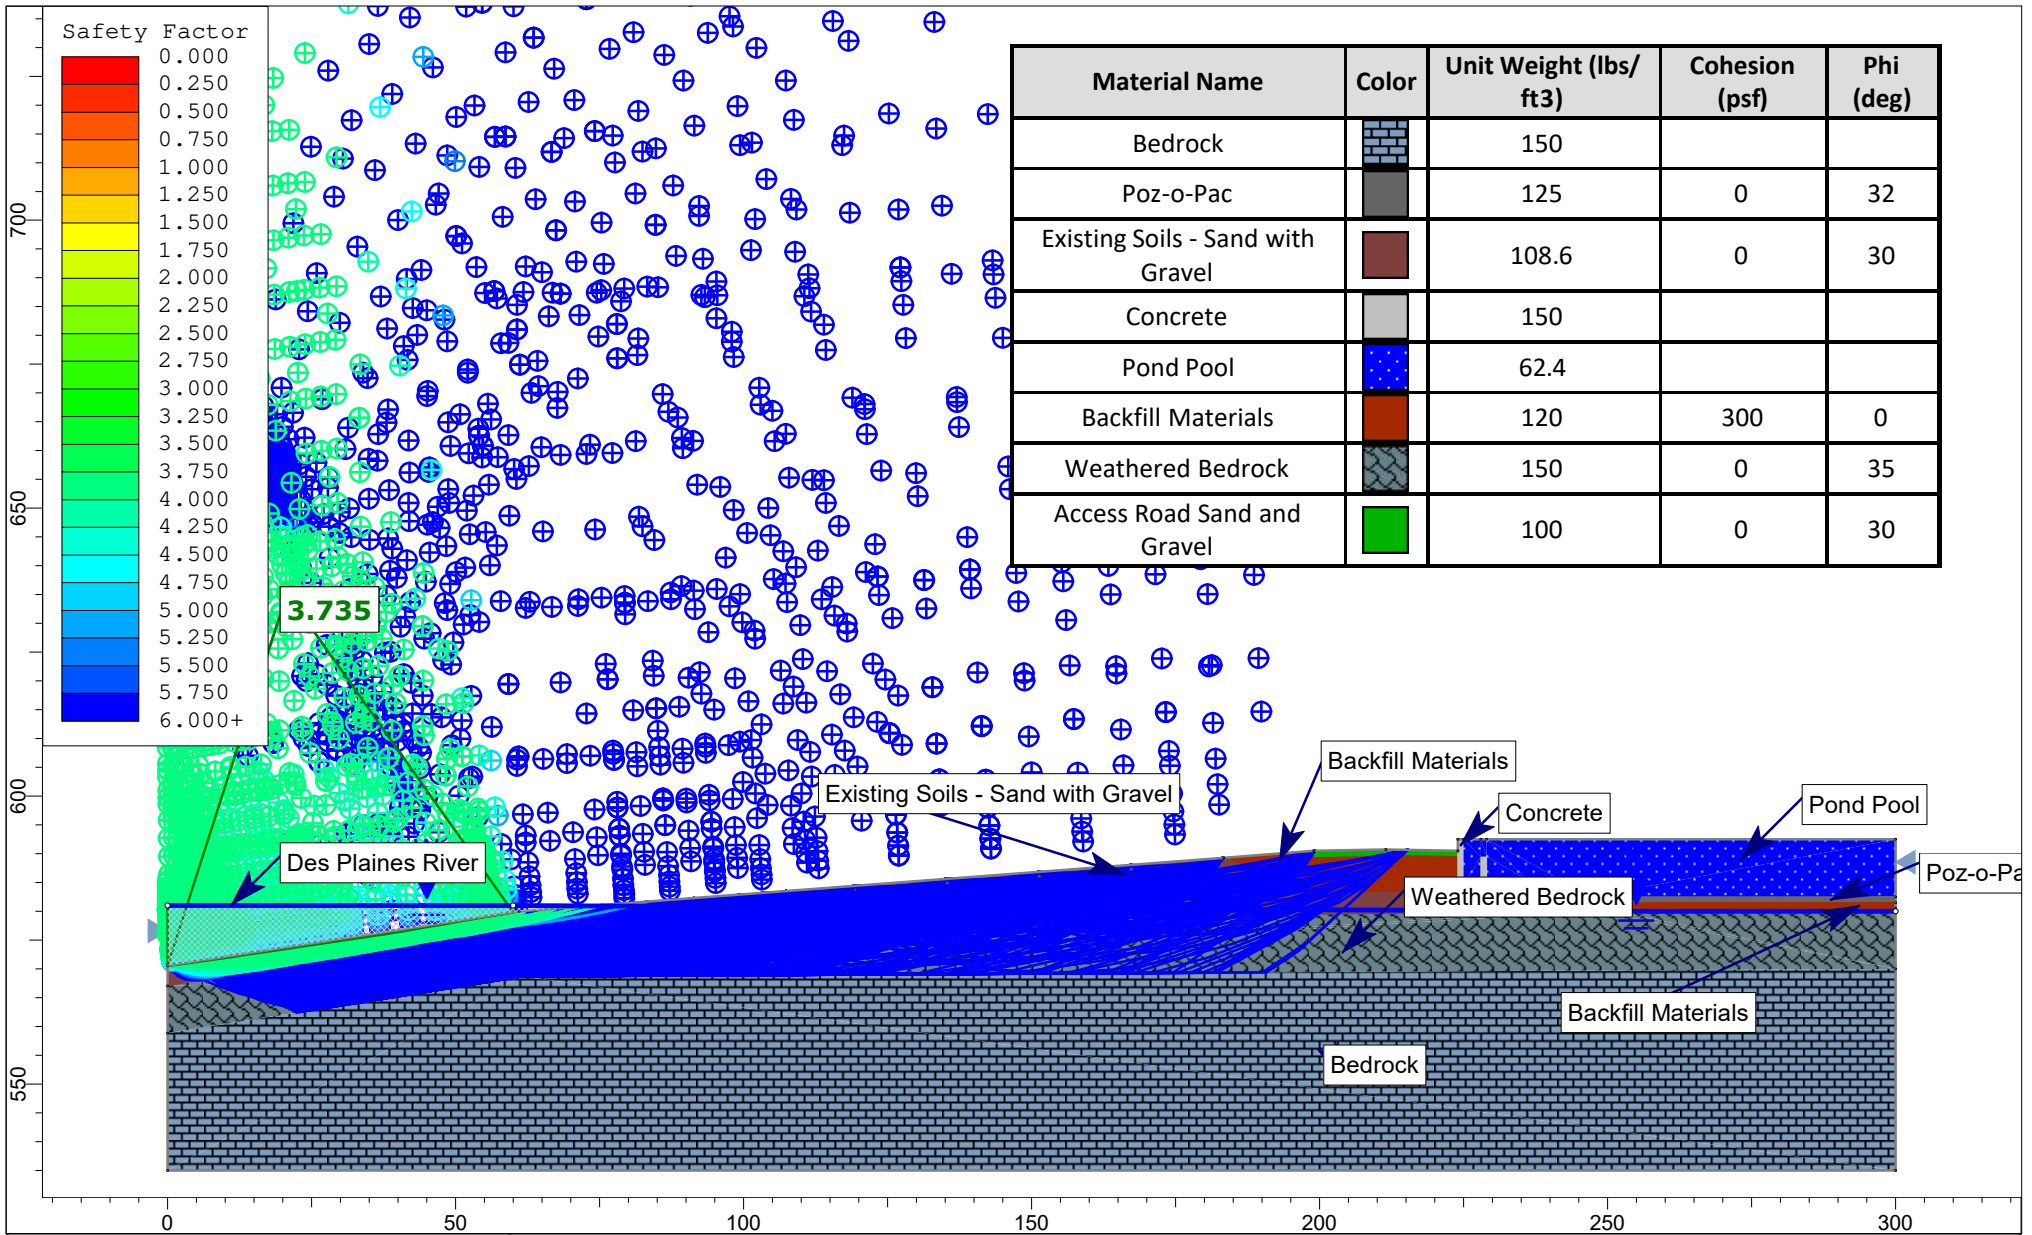
<b>Civil &amp; Environmental Consultants, Inc.</b>	ProjectF				<b>Figure 2: Pond 1N Slope Stability Analysis</b>	
	Analysis: Spencer		Scale: 1:400		Scenario: Pond 1N, Long-Term, Maximum Surcharge Pool	
	Drawn By: CAC		Checked By: MDB		Approved By: MDJ	
	Date: 08/25/2021		Date: 9/23/2021		Date: 9/23/2021	
					Company: Civil & Environmental Consultants, Inc.	
				File Name: 312192-WC-Pond 1N.slmd

The static, long-term condition with the maximum surcharge loading on the embankment was evaluated. The static, long-term analysis included a pool elevation at 592.5 feet mean sea level and a groundwater elevation at 580.5 feet mean sea level.

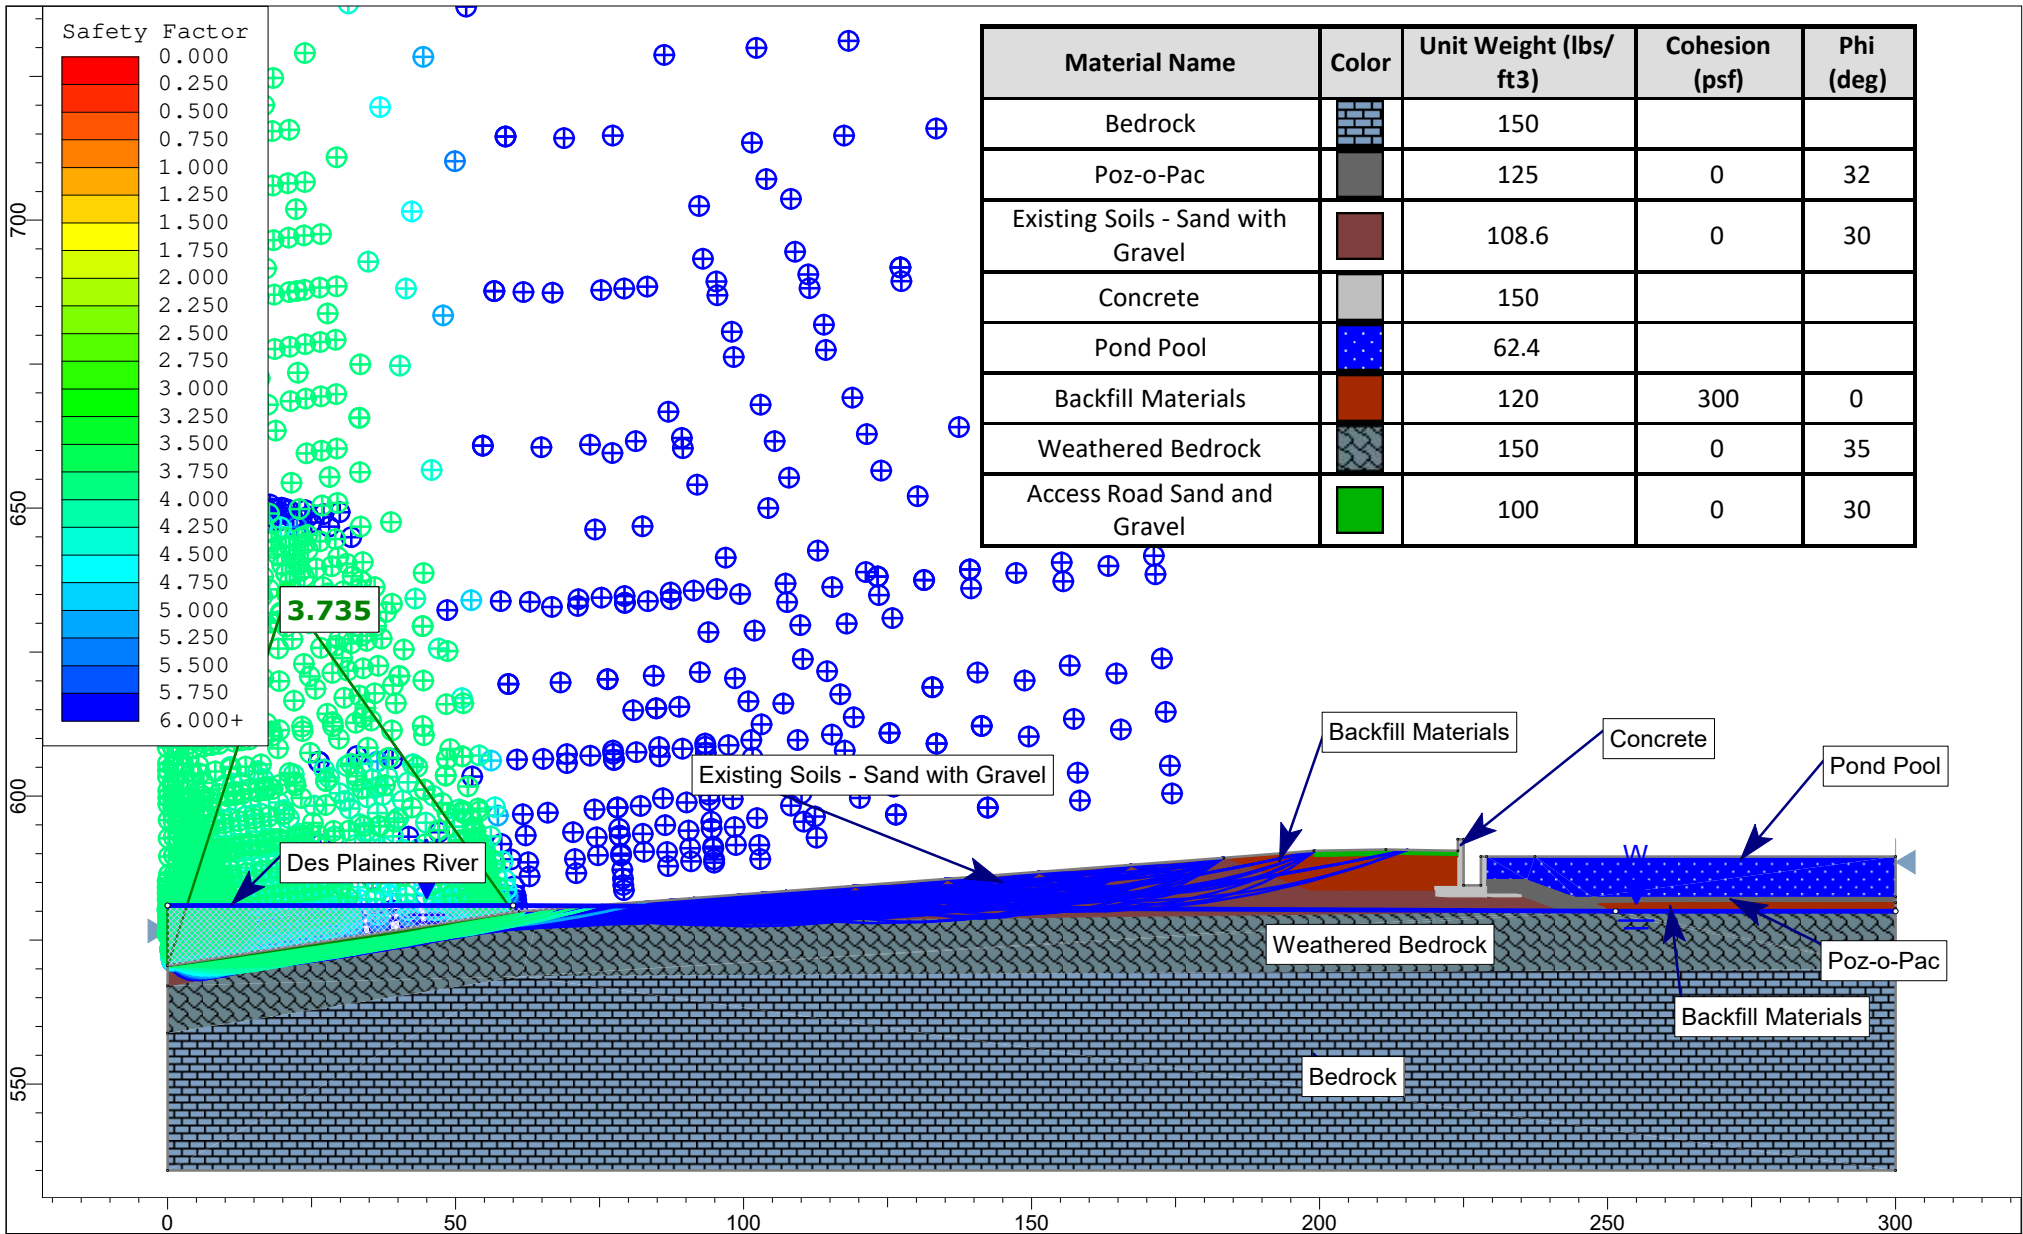
**Figure 3: Pond 1N Slope Stability Analysis**

Project		<b>Figure 3: Pond 1N Slope Stability Analysis</b>			
Analysis	Spencer	Scale:	1:400	Scenario	Pond 1N, Long-Term, Maximum Storage Pool
Drawn By	CAC	Checked By:	MDB	Approved By:	MDJ
Date	08/25/2021	Date:	9/23/2021	Date:	9/23/2021
				Company	Civil & Environmental Consultants, Inc.
				File Name	312192-WC-Pond 1N.slmtd

The static, long-term, maximum storage pool condition with the maximum surcharge loading on the embankment was evaluated. The static, long-term analysis included a pool elevation set at the lowest points of the embankment crest, 589.5 feet mean sea level, and a groundwater elevation at 580.5 feet mean sea level.

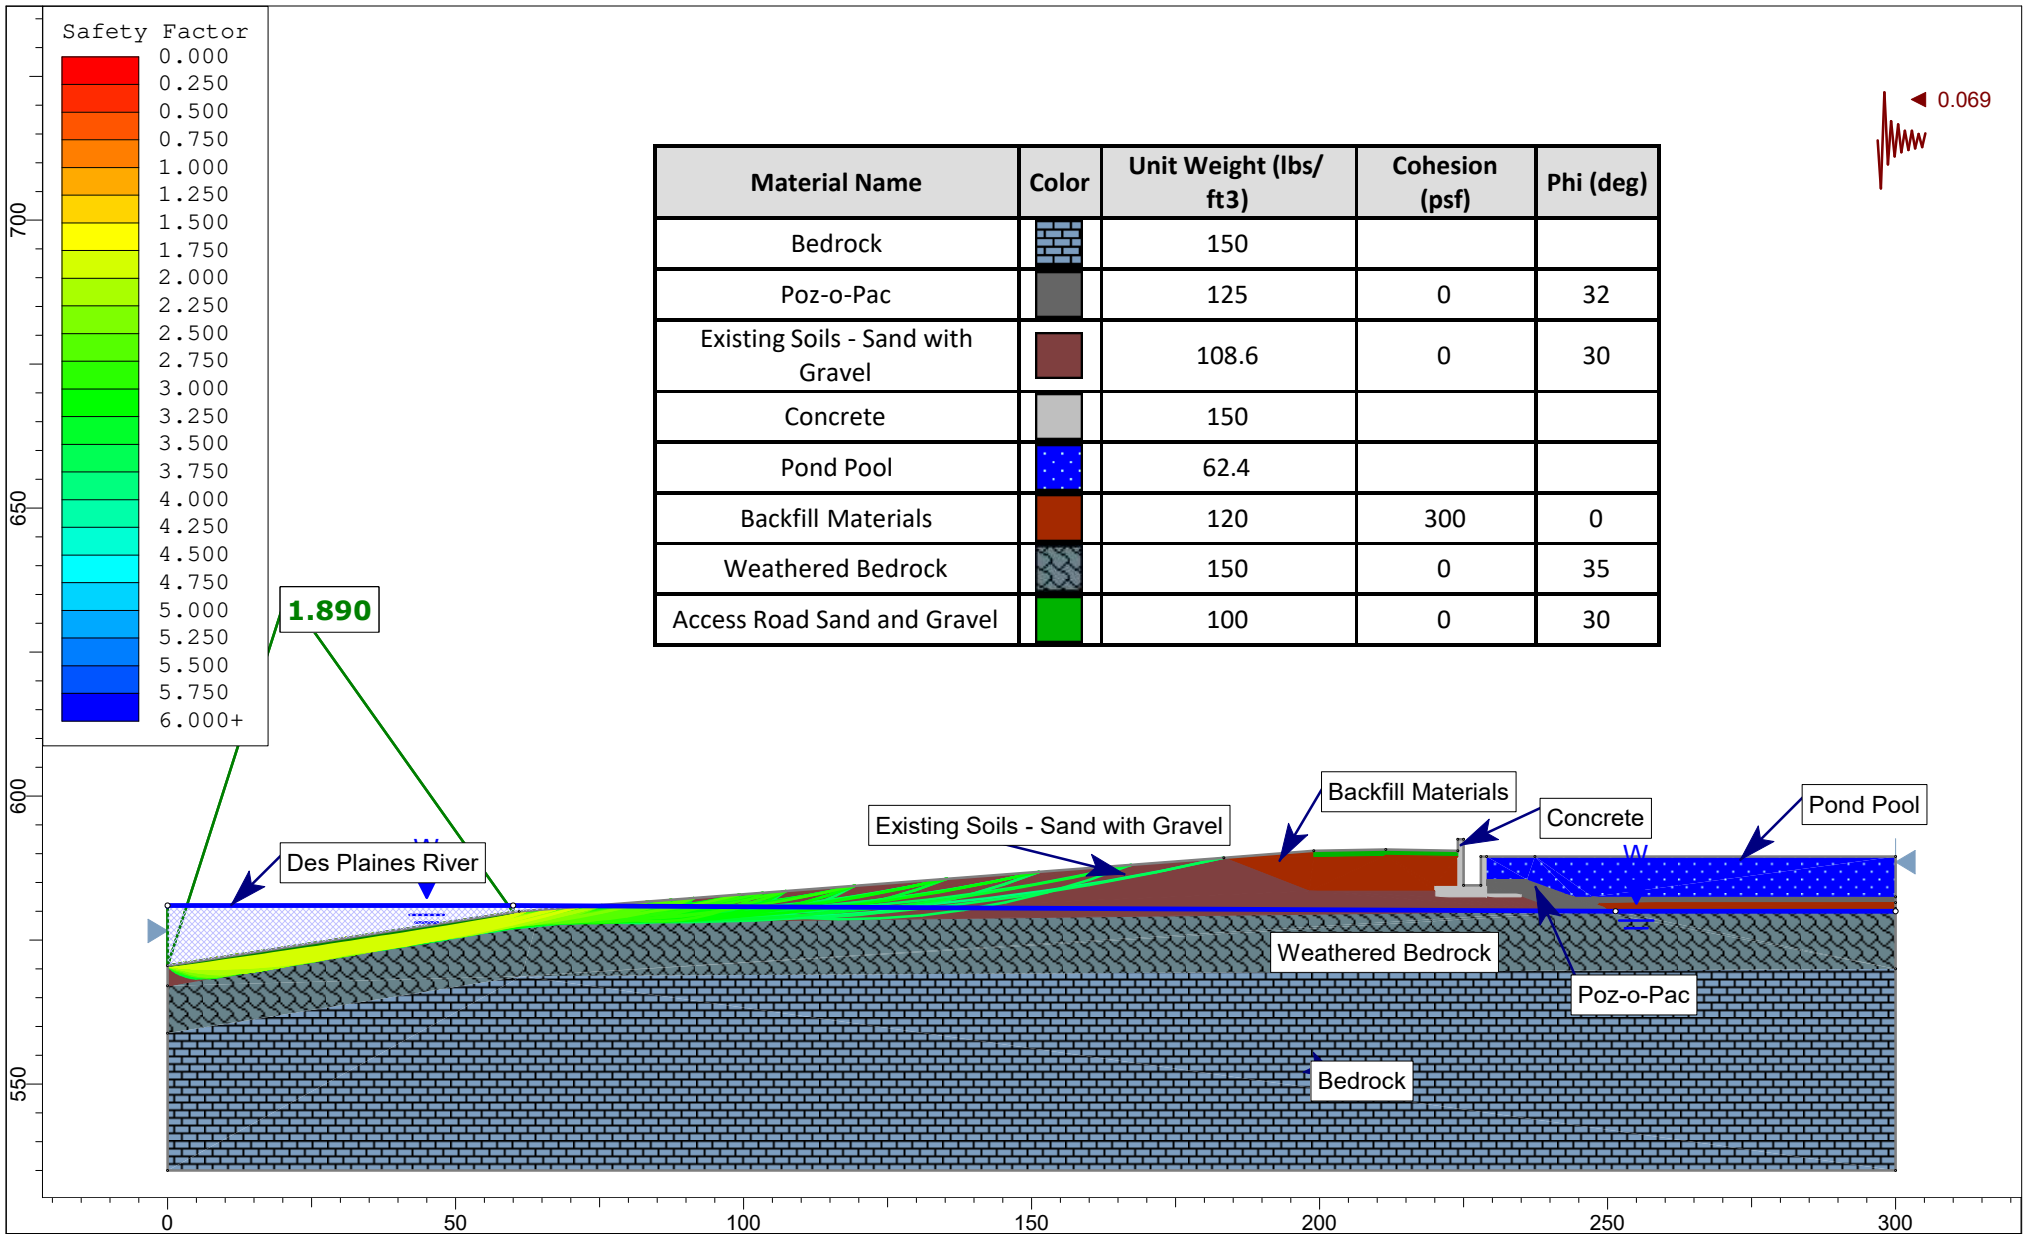
**Figure 4: Pond 1N Slope Stability Analysis**

Material Name	Color	Unit Weight (lbs/ft3)	Cohesion (psf)	Phi (deg)
Bedrock		150		
Poz-o-Pac		125	0	32
Existing Soils - Sand with Gravel		108.6	0	30
Concrete		150		
Pond Pool		62.4		
Backfill Materials		120	300	0
Weathered Bedrock		150	0	35
Access Road Sand and Gravel		100	0	30

Project		Scale:		Scenario	
Spencer		1:400		Pond 1N, Long-Term, Maximum Storage Pool - Seismic	
Drawn By	Checked By:	Approved By:	Company		
CAC	MDB	MDJ	Civil & Environmental Consultants, Inc.		
Date	Date:	Date:	File Name		
08/25/2021	9/23/2021	9/23/2021	312192-WC-Pond 1N.slmd

Seismic analysis was performed by incorporating pseudo static seismic loading scenarios in the long-term global stability analysis calculations. A pseudo-static seismic horizontal load was applied to the long-term maximum storage pool loading condition model.

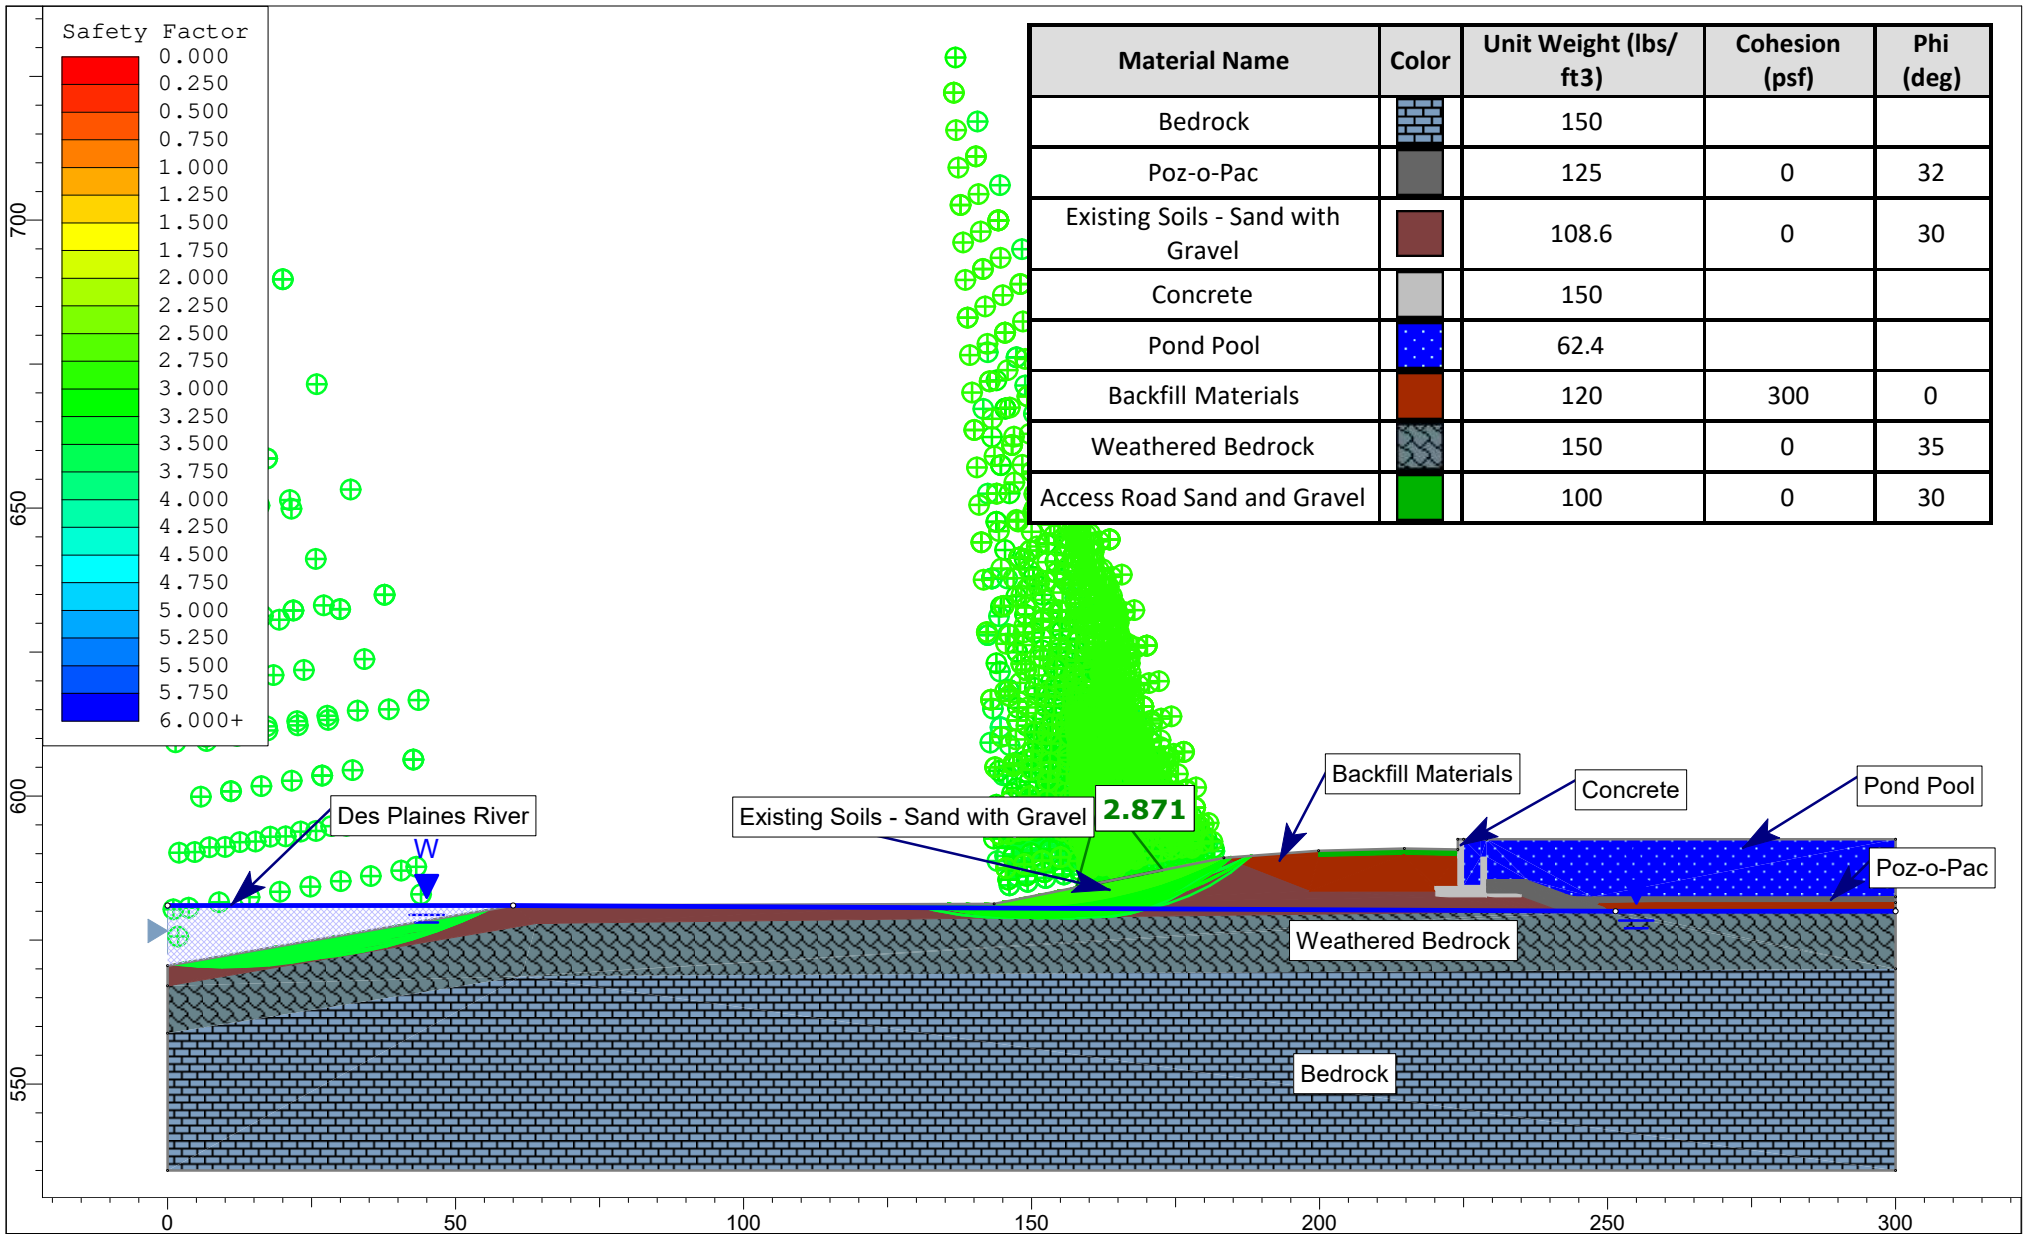
<b>Civil &amp; Environmental Consultants, Inc.</b>	Project				<b>Figure 5: Pond 1S Slope Stability Analysis</b>				
	Analysis		Spencer	Scale:		1:400	Scenario		Pond 1S, Long-Term, Maximum Surcharge Pool
	Drawn By		CAC	Checked By:		MDB	Approved By:		MDJ
	Date		08/25/2021	Date:		9/23/2021	Date:		9/23/2021
Company		Civil & Environmental Consultants, Inc.							
File Name		312192-WC-Pond 1N.slmd

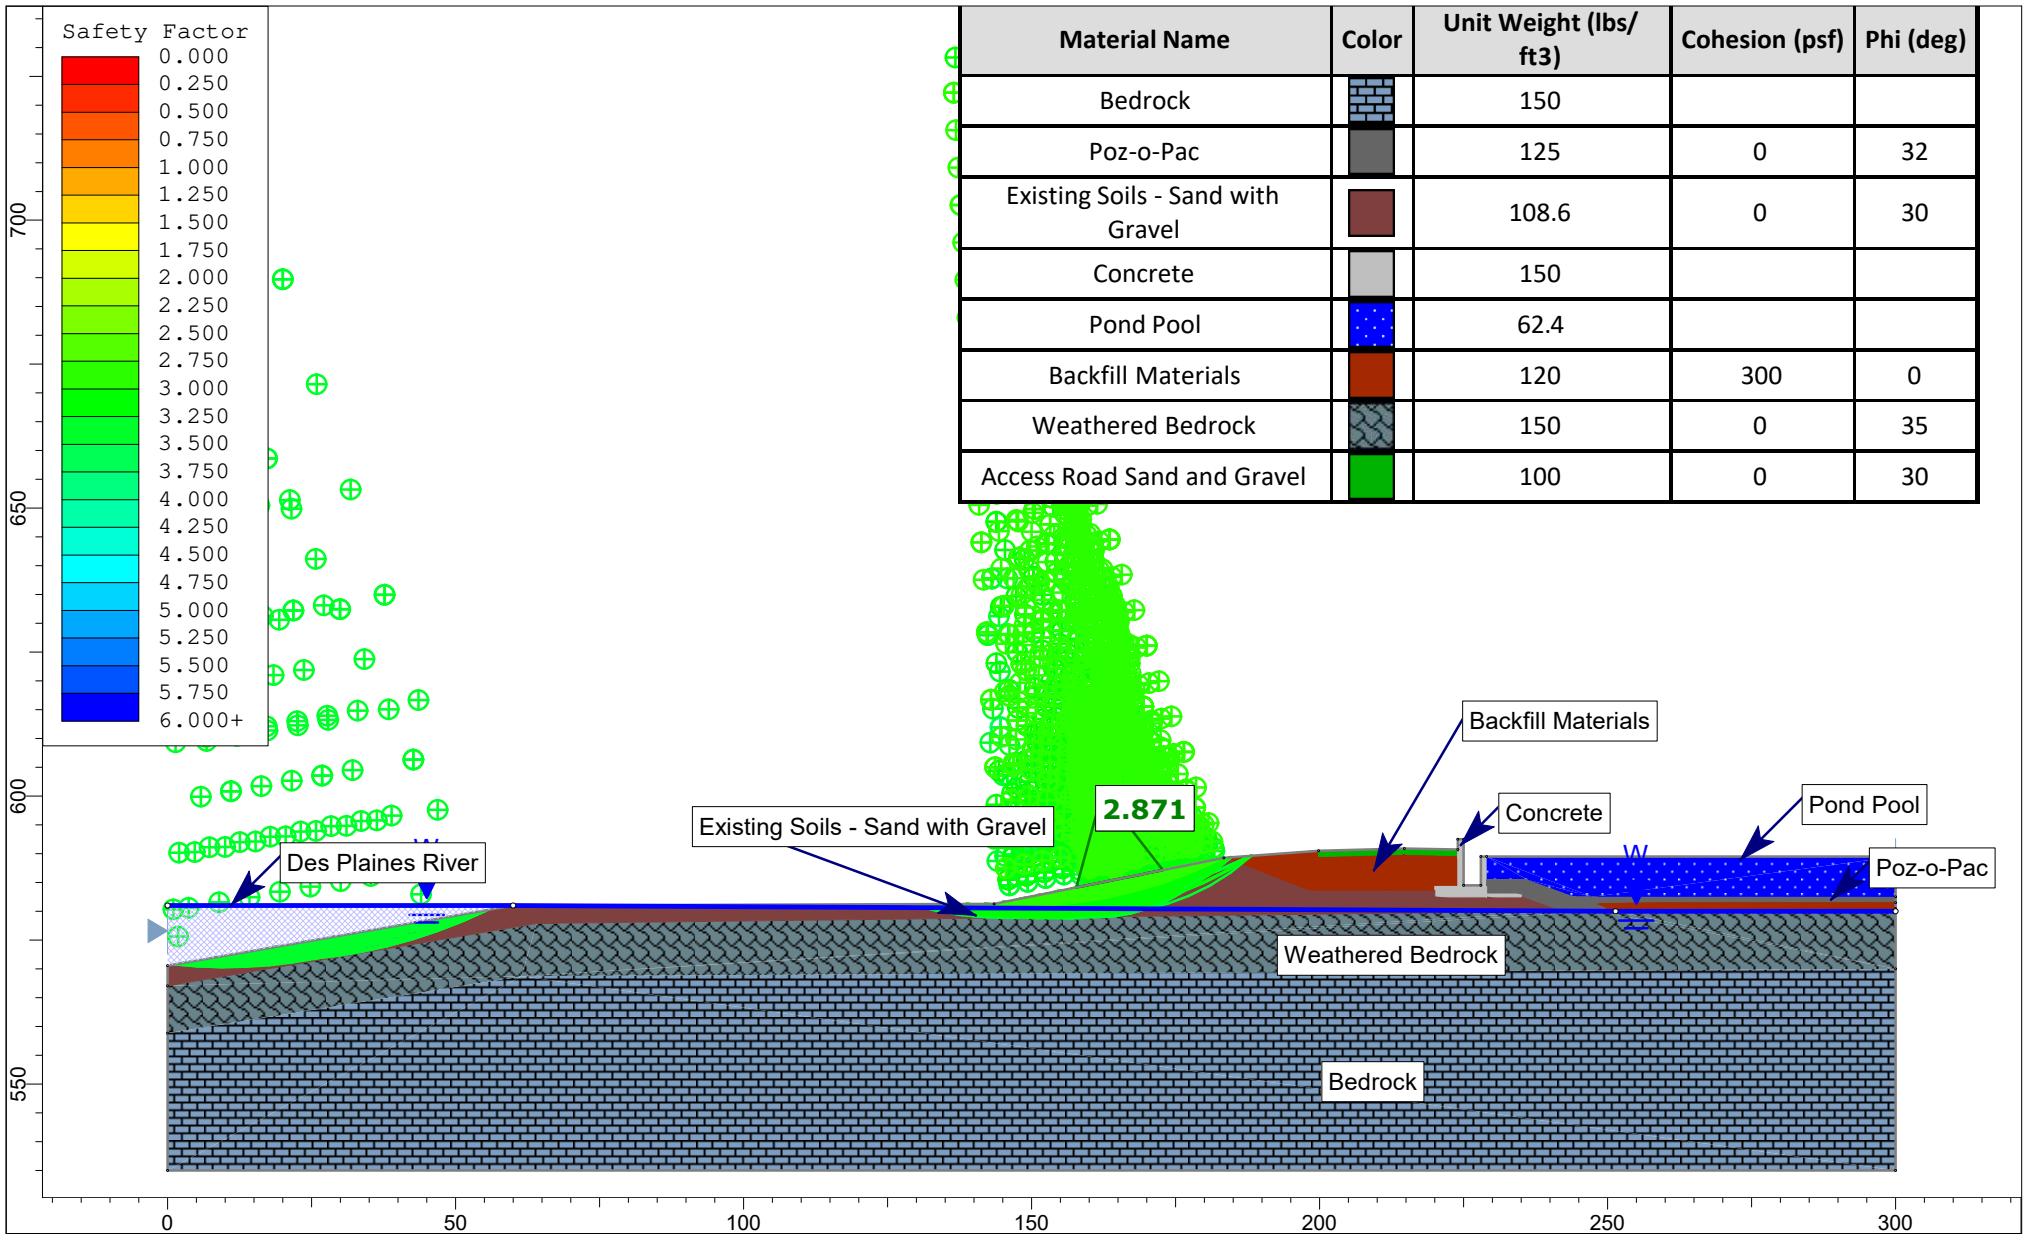
**Figure 6: Pond 1S Slope Stability Analysis**

Project		Scale:		Scenario	
Spencer		1:400		Pond 1S, Long-Term, Maximum Storage Pool	
Drawn By	Checked By:	Approved By:	Company		
CAC	MDB	MDJ	Civil & Environmental Consultants, Inc.		
Date	Date:	Date:	File Name		
08/25/2021	9/23/2021	9/23/2021	312192-WC-Pond 1N.slmd

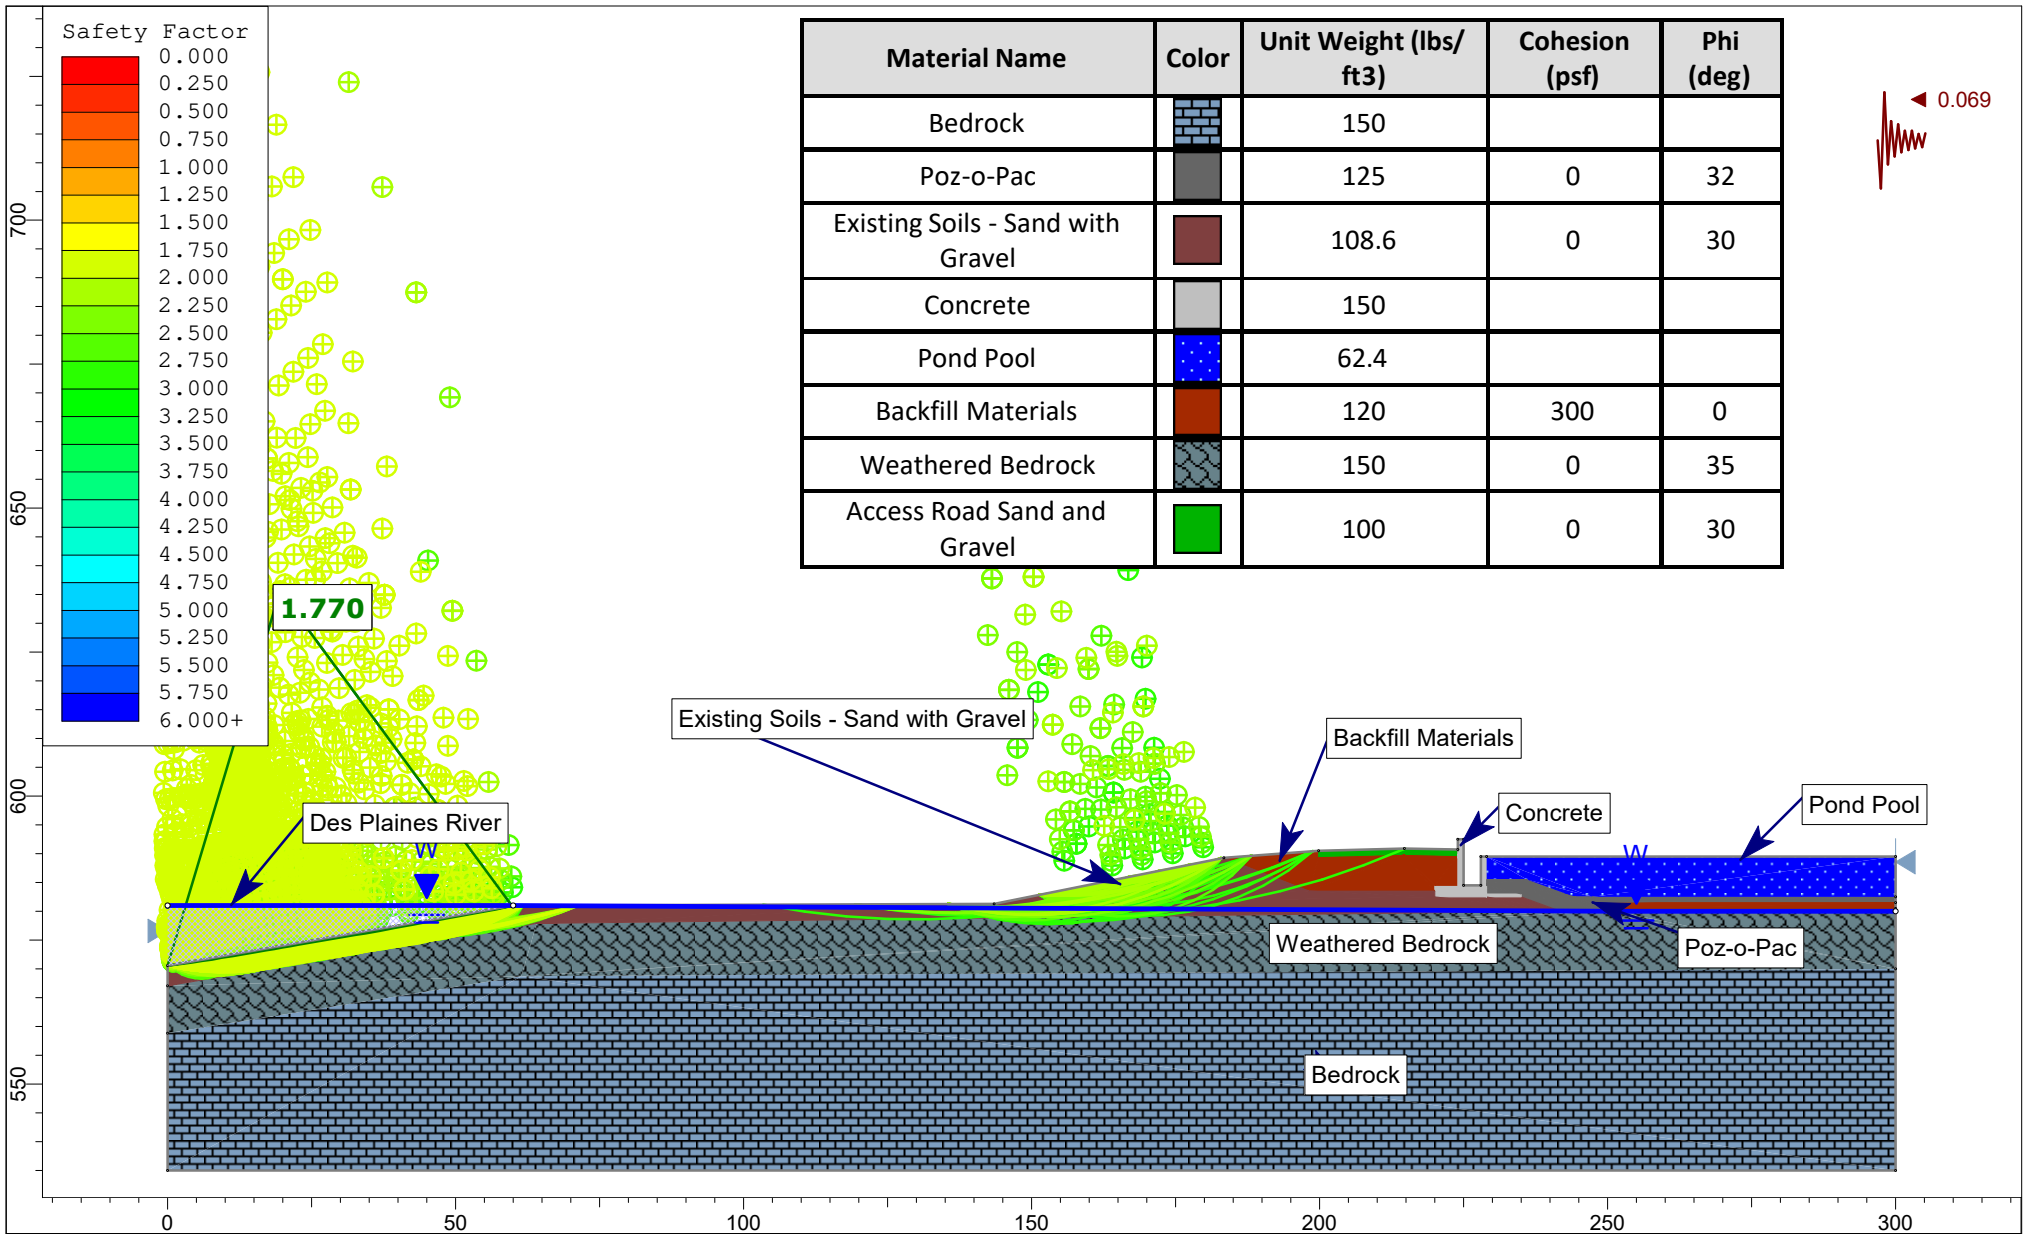
**Figure 7: Pond 1S Slope Stability Analysis**

Material Name	Color	Unit Weight (lbs/ft3)	Cohesion (psf)	Phi (deg)
Bedrock		150		
Poz-o-Pac		125	0	32
Existing Soils - Sand with Gravel		108.6	0	30
Concrete		150		
Pond Pool		62.4		
Backfill Materials		120	300	0
Weathered Bedrock		150	0	35
Access Road Sand and Gravel		100	0	30

Project		<b>Figure 7: Pond 1S Slope Stability Analysis</b>			
Analysis	Spencer	Scale:	1:400	Scenario	Pond 1S, Long-Term, Maximum Storage Pool - Seismic
Drawn By	CAC	Checked By:	MDB	Approved By:	MDJ
Date	08/25/2021	Date:	9/23/2021	Date:	9/23/2021
				Company	Civil & Environmental Consultants, Inc.
				File Name	312192-WC-Pond 1N.slmd

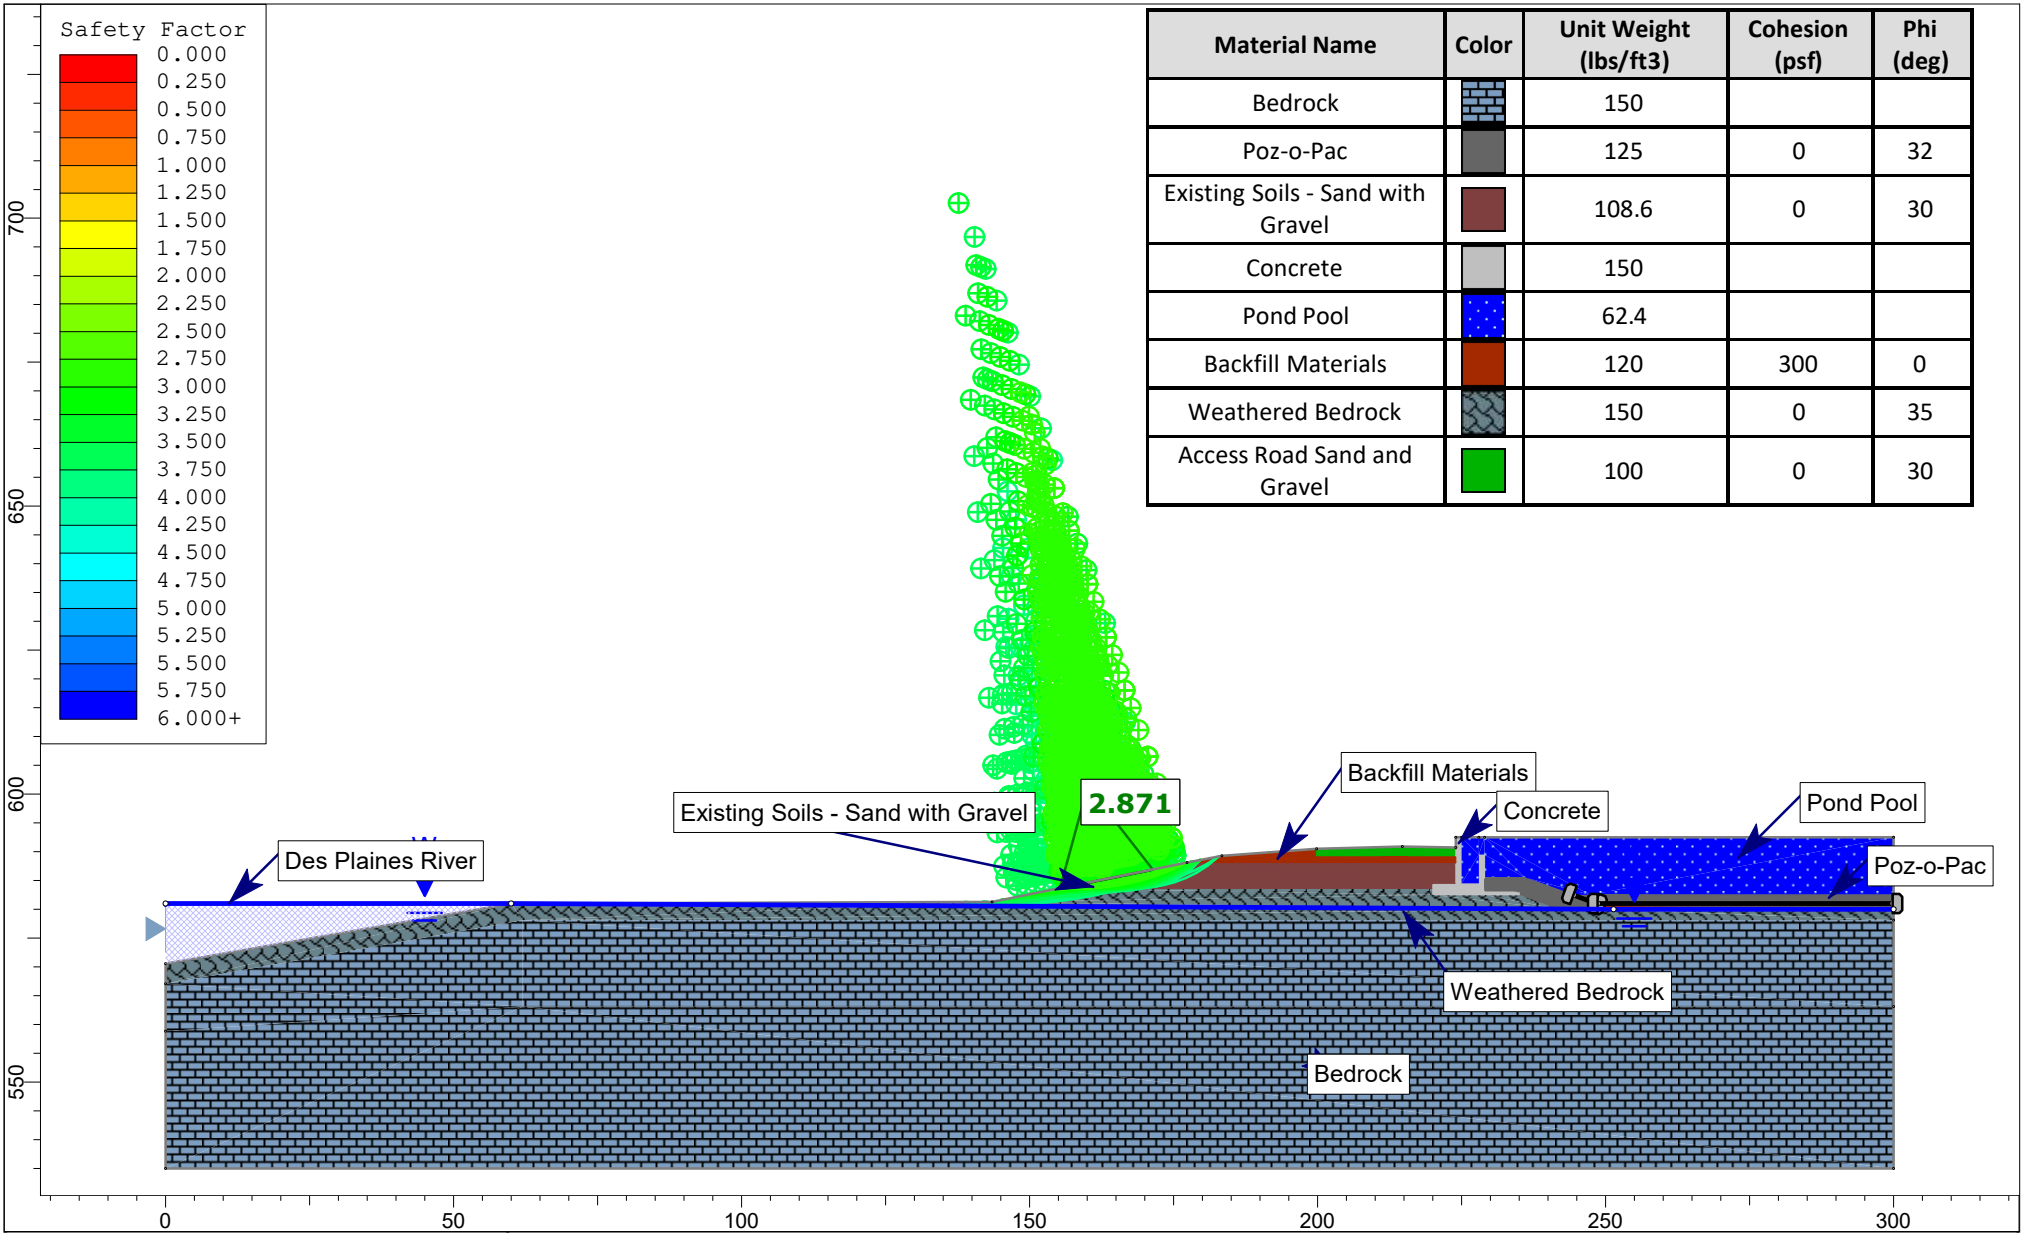
**Figure 8: Pond 2S Slope Stability Analysis**

Project				<b>Figure 8: Pond 2S Slope Stability Analysis</b>			
Analysis		Spencer		Scale:		1:400	
Scenario				Pond 2S, Long-Term, Maximum Surcharge Pool			
Drawn By		Checked By:		Approved By:		Company	
CAC		MDB		MDJ		Civil & Environmental Consultants, Inc.	
Date		Date:		Date:		File Name	
08/25/2021		9/23/2021		9/23/2021		312192-WC-Pond 1N.slmd
