**STRUCTURAL STABILITY AND FACTOR OF SAFETY ASSESSMENT  
ASH PONDS 1N, 1S, 2S, AND 3S, WILL COUNTY STATION  
SEPTEMBER 2021**

MIDWEST GENERATION LLC  
 WILL COUNTY STATION  
 PONDS 1N, 1S, 2S, AND 3S SLOPE STABILITY  
 ROMEOVILLE, WILL COUNTY, ILLINOIS

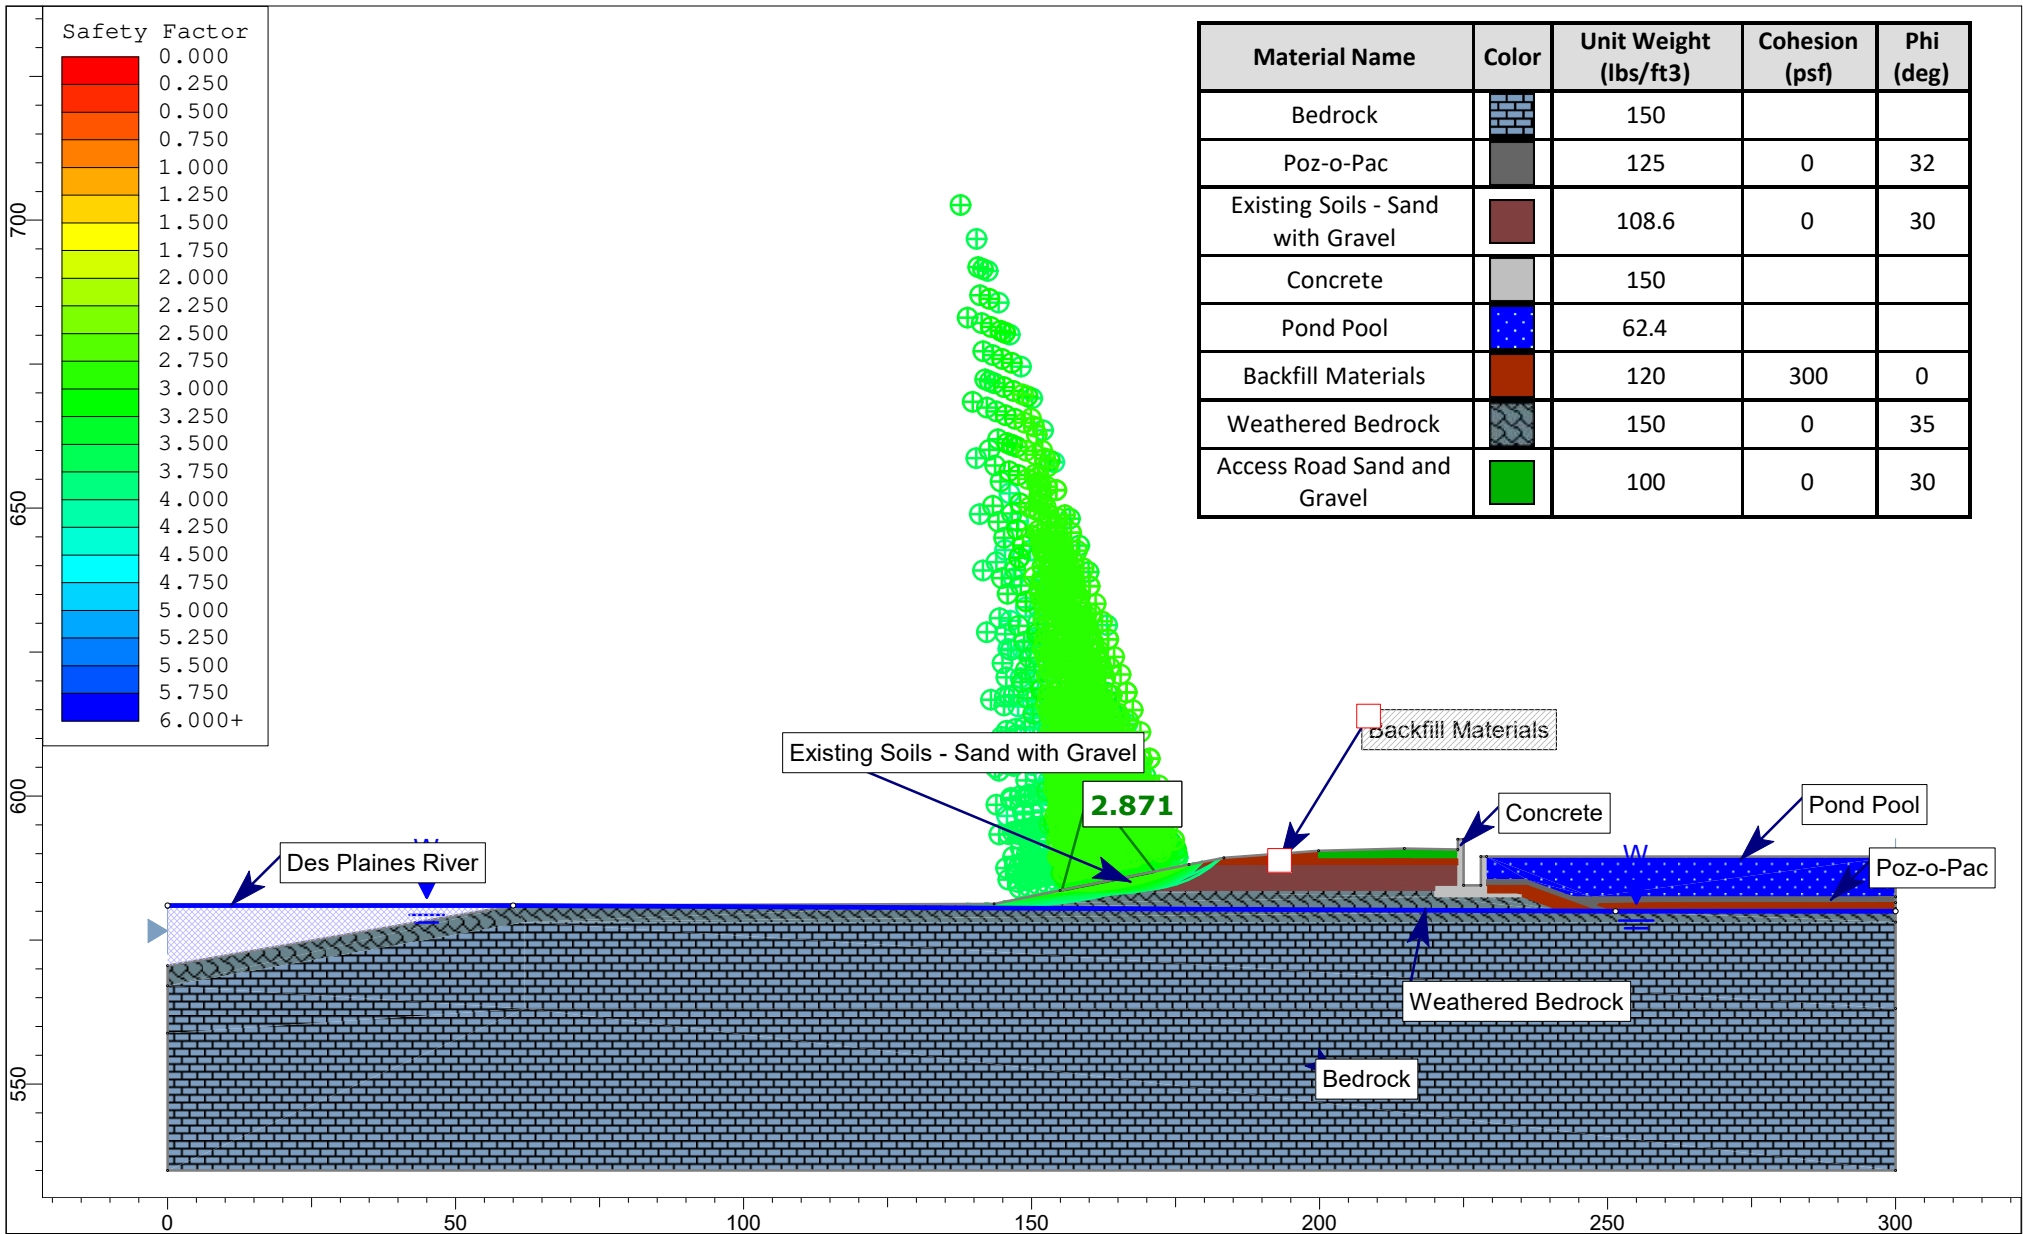
<b>Civil &amp; Environmental Consultants, Inc.</b>	<b>Figure 9: Pond 2S Slope Stability Analysis</b>			
	Project: Spencer		Scale: 1:400	Scenario: Pond 2S, Long-Term, Maximum Storage Pool
	Drawn By: CAC	Checked By: MDB	Approved By: MDJ	Company: Civil & Environmental Consultants, Inc.
	Date: 08/25/2021	Date: 9/23/2021	Date: 9/23/2021	File Name: 312192-WC-Pond 1N.slmd

The static, long-term, maximum storage pool condition with the maximum surcharge loading on the embankment was evaluated. The static, long-term analysis included a pool elevation set at the lowest points of the embankment crest, 589.5 feet mean sea level, and a groundwater elevation at 580.5 feet mean sea level.

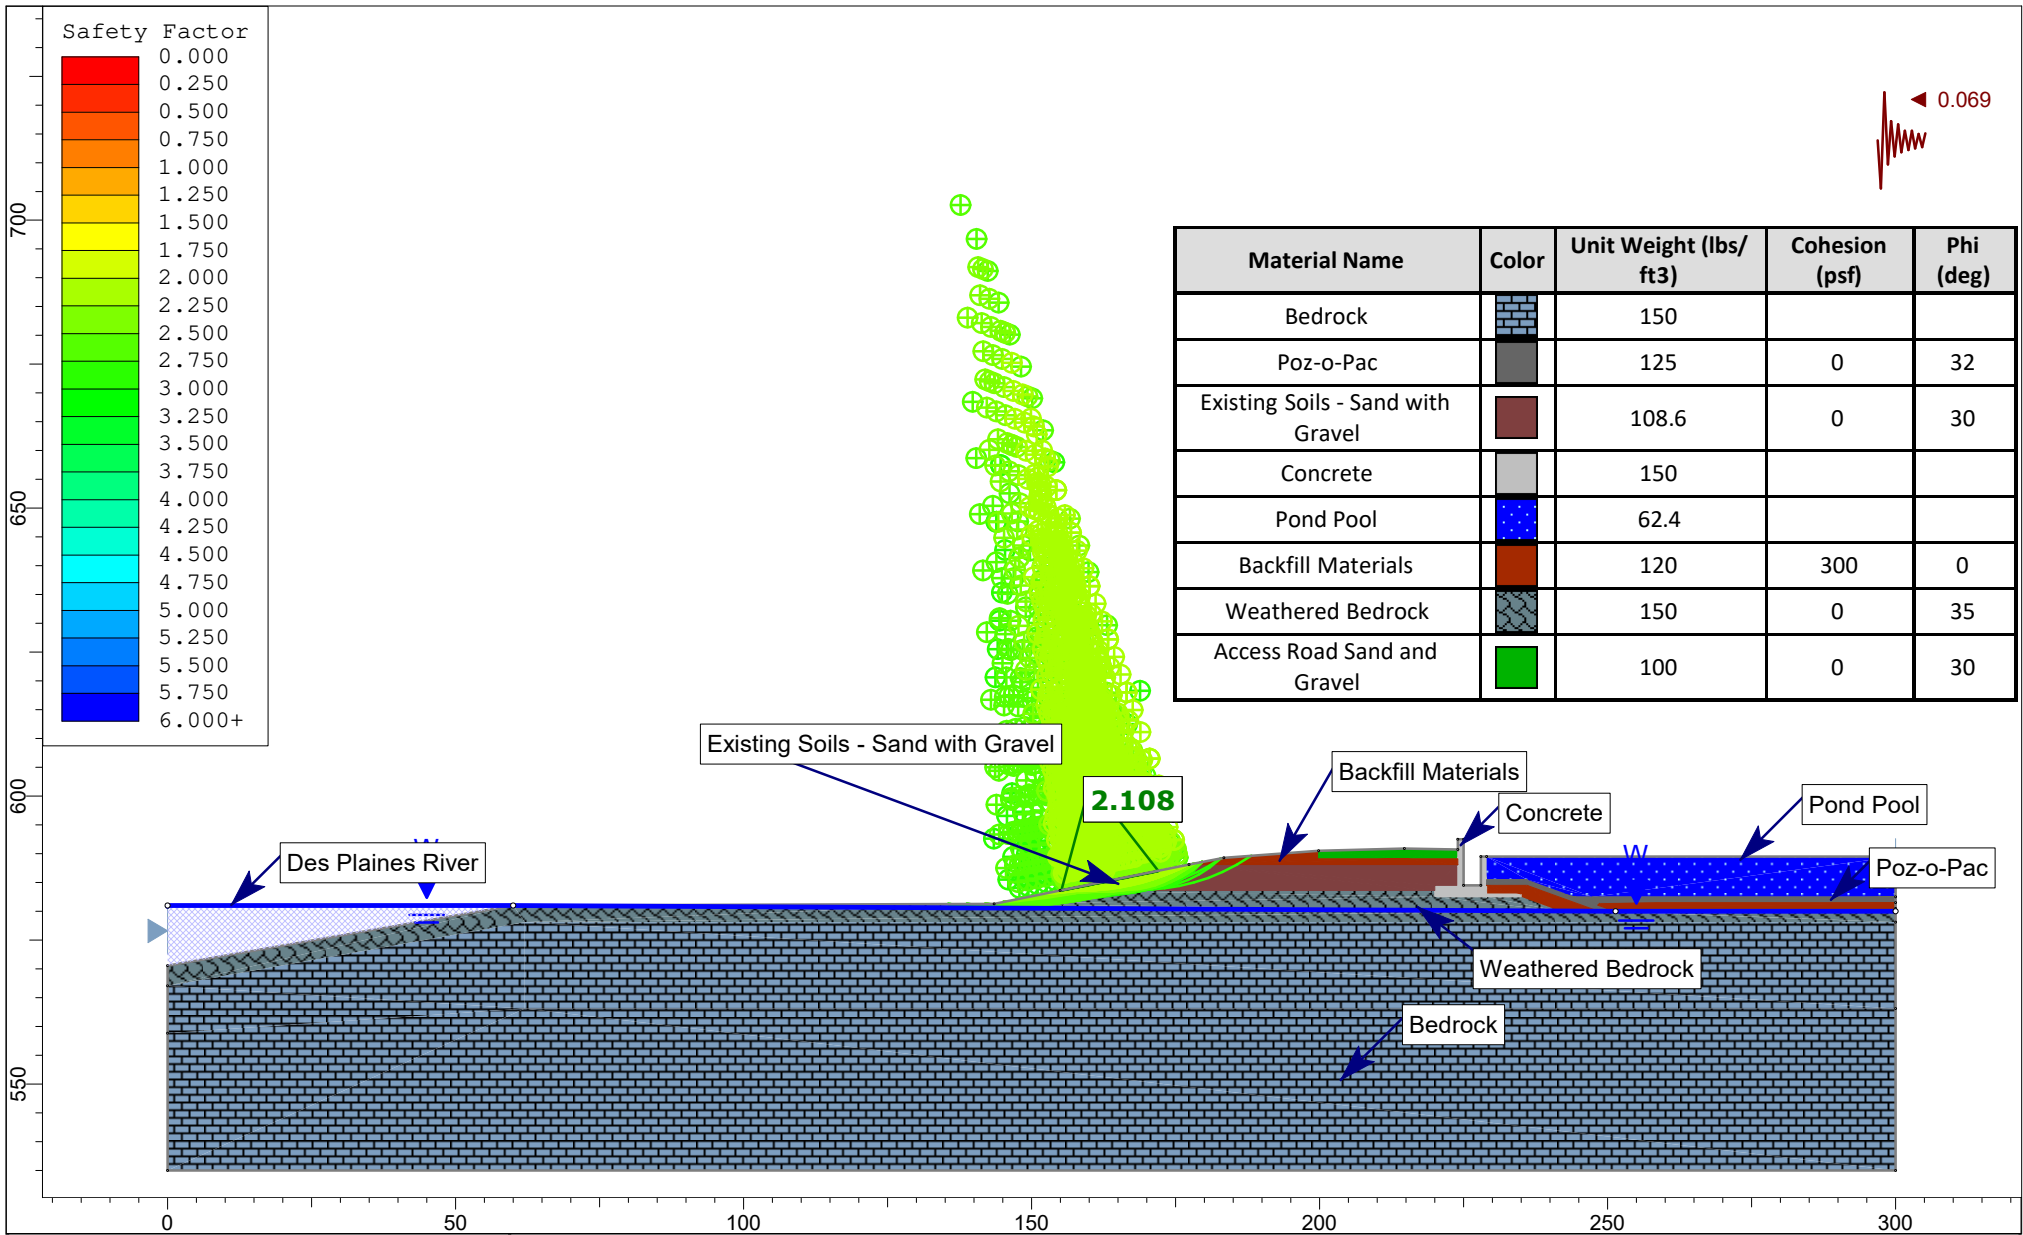
**Figure 10: Pond 2S Slope Stability Analysis**

Project		<b>Figure 10: Pond 2S Slope Stability Analysis</b>			
Analysis	Spencer	Scale:	1:400	Scenario	Pond 2S, Long-Term, Maximum Storage Pool - Seismic
Drawn By	CAC	Checked By:	MDB	Approved By:	MDJ
Date	08/25/2021	Date:	9/23/2021	Date:	9/23/2021
				Company	Civil & Environmental Consultants, Inc.
				File Name	312192-WC-Pond 1N.slmd

Seismic analysis was performed by incorporating pseudo static seismic loading scenarios in the long-term global stability analysis calculations. A pseudo-static seismic horizontal load was applied to the long-term maximum storage pool loading condition model.

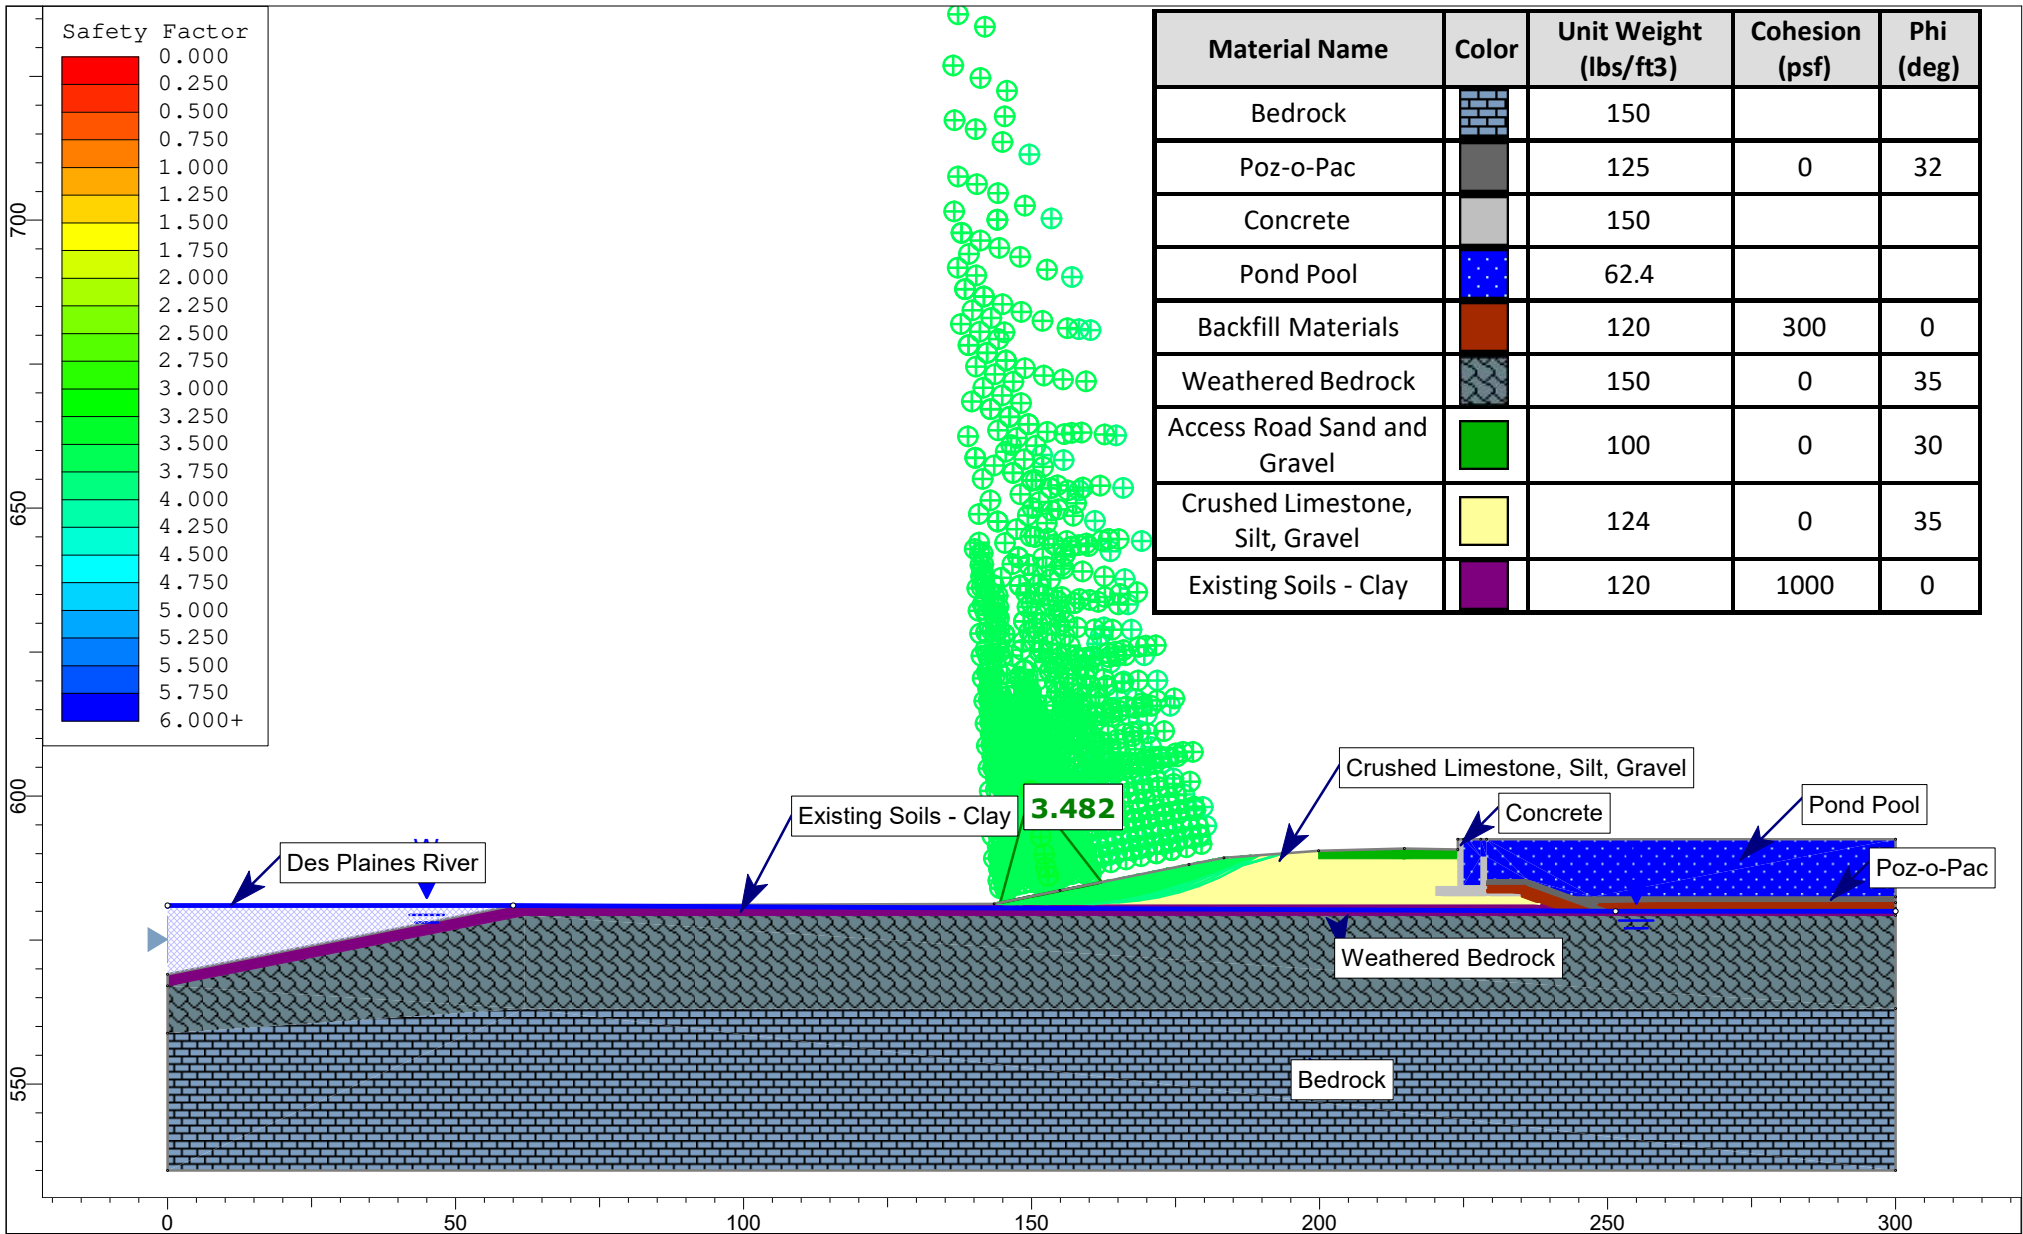
<b>Civil &amp; Environmental Consultants, Inc.</b>	<b>Figure 11: Pond 3S Slope Stability Analysis</b>			
	Project: Spencer		Scale: 1:400	Scenario: Pond 3S, Long-Term, Maximum Surcharge Pool
	Drawn By: CAC	Checked By: MDB	Approved By: MDJ	Company: Civil & Environmental Consultants, Inc.
	Date: 08/25/2021	Date: 9/23/2021	Date: 9/23/2021	File Name: 312192-WC-Pond 1N.slmd

The static, long-term condition with the maximum surcharge loading on the embankment was evaluated. The static, long-term analysis included a pool elevation at 592.5 feet mean sea level and a groundwater elevation at 580.5 feet mean sea level.

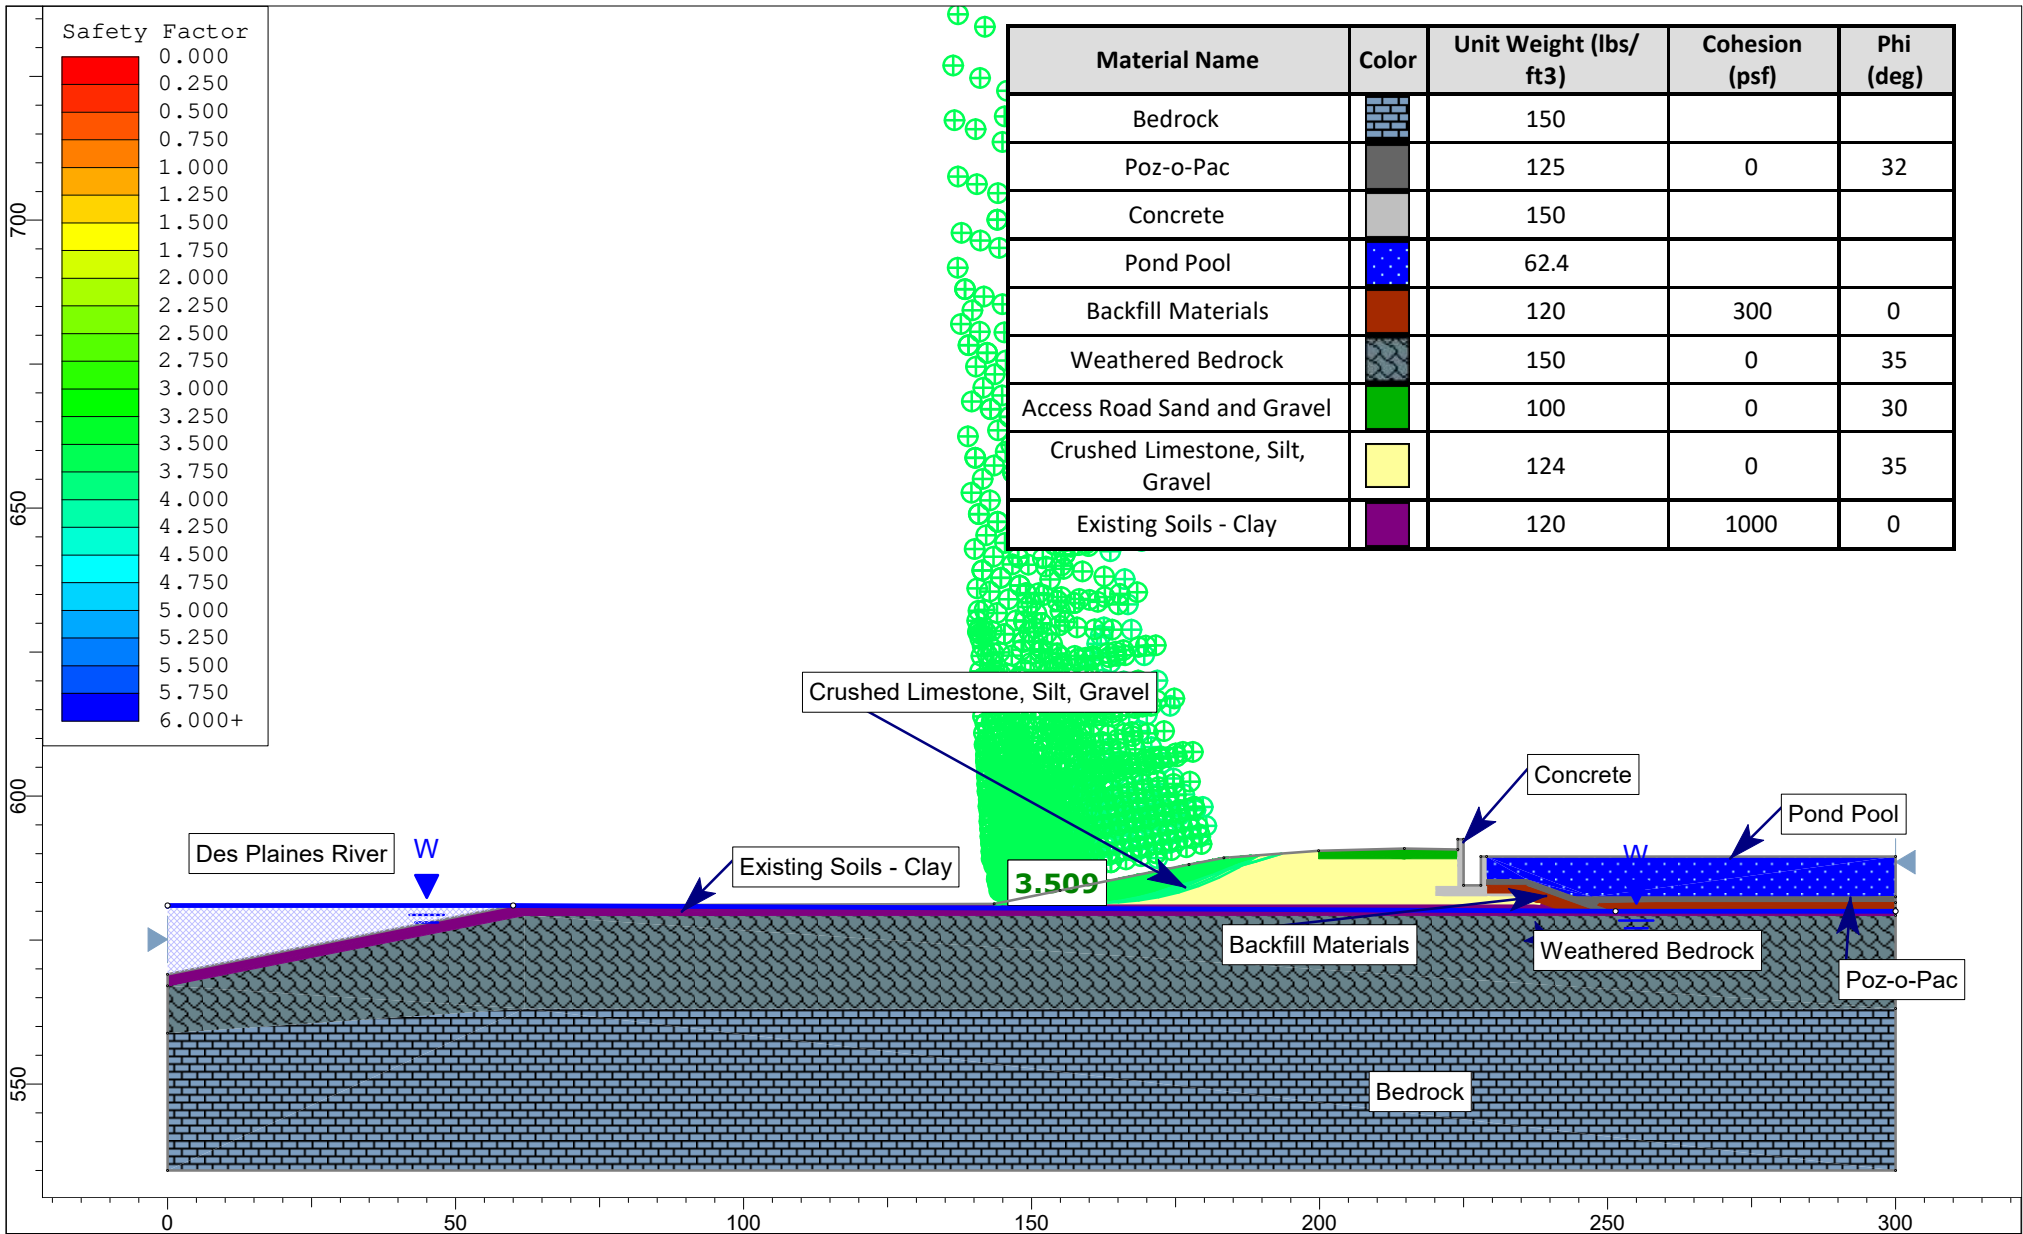
**Figure 12: Pond 3S Slope Stability Analysis**

Project				<b>Figure 12: Pond 3S Slope Stability Analysis</b>				
Analysis		Spencer	Scale:		1:400	Scenario		Pond 3S, Long-Term, Maximum Storage Pool
Drawn By		CAC	Checked By:		MDB	Approved By:		MDJ
Date		08/25/2021	Date:		9/23/2021	Date:		9/23/2021
Company						Civil & Environmental Consultants, Inc.		
File Name						312192-WC-Pond 1N.sldm

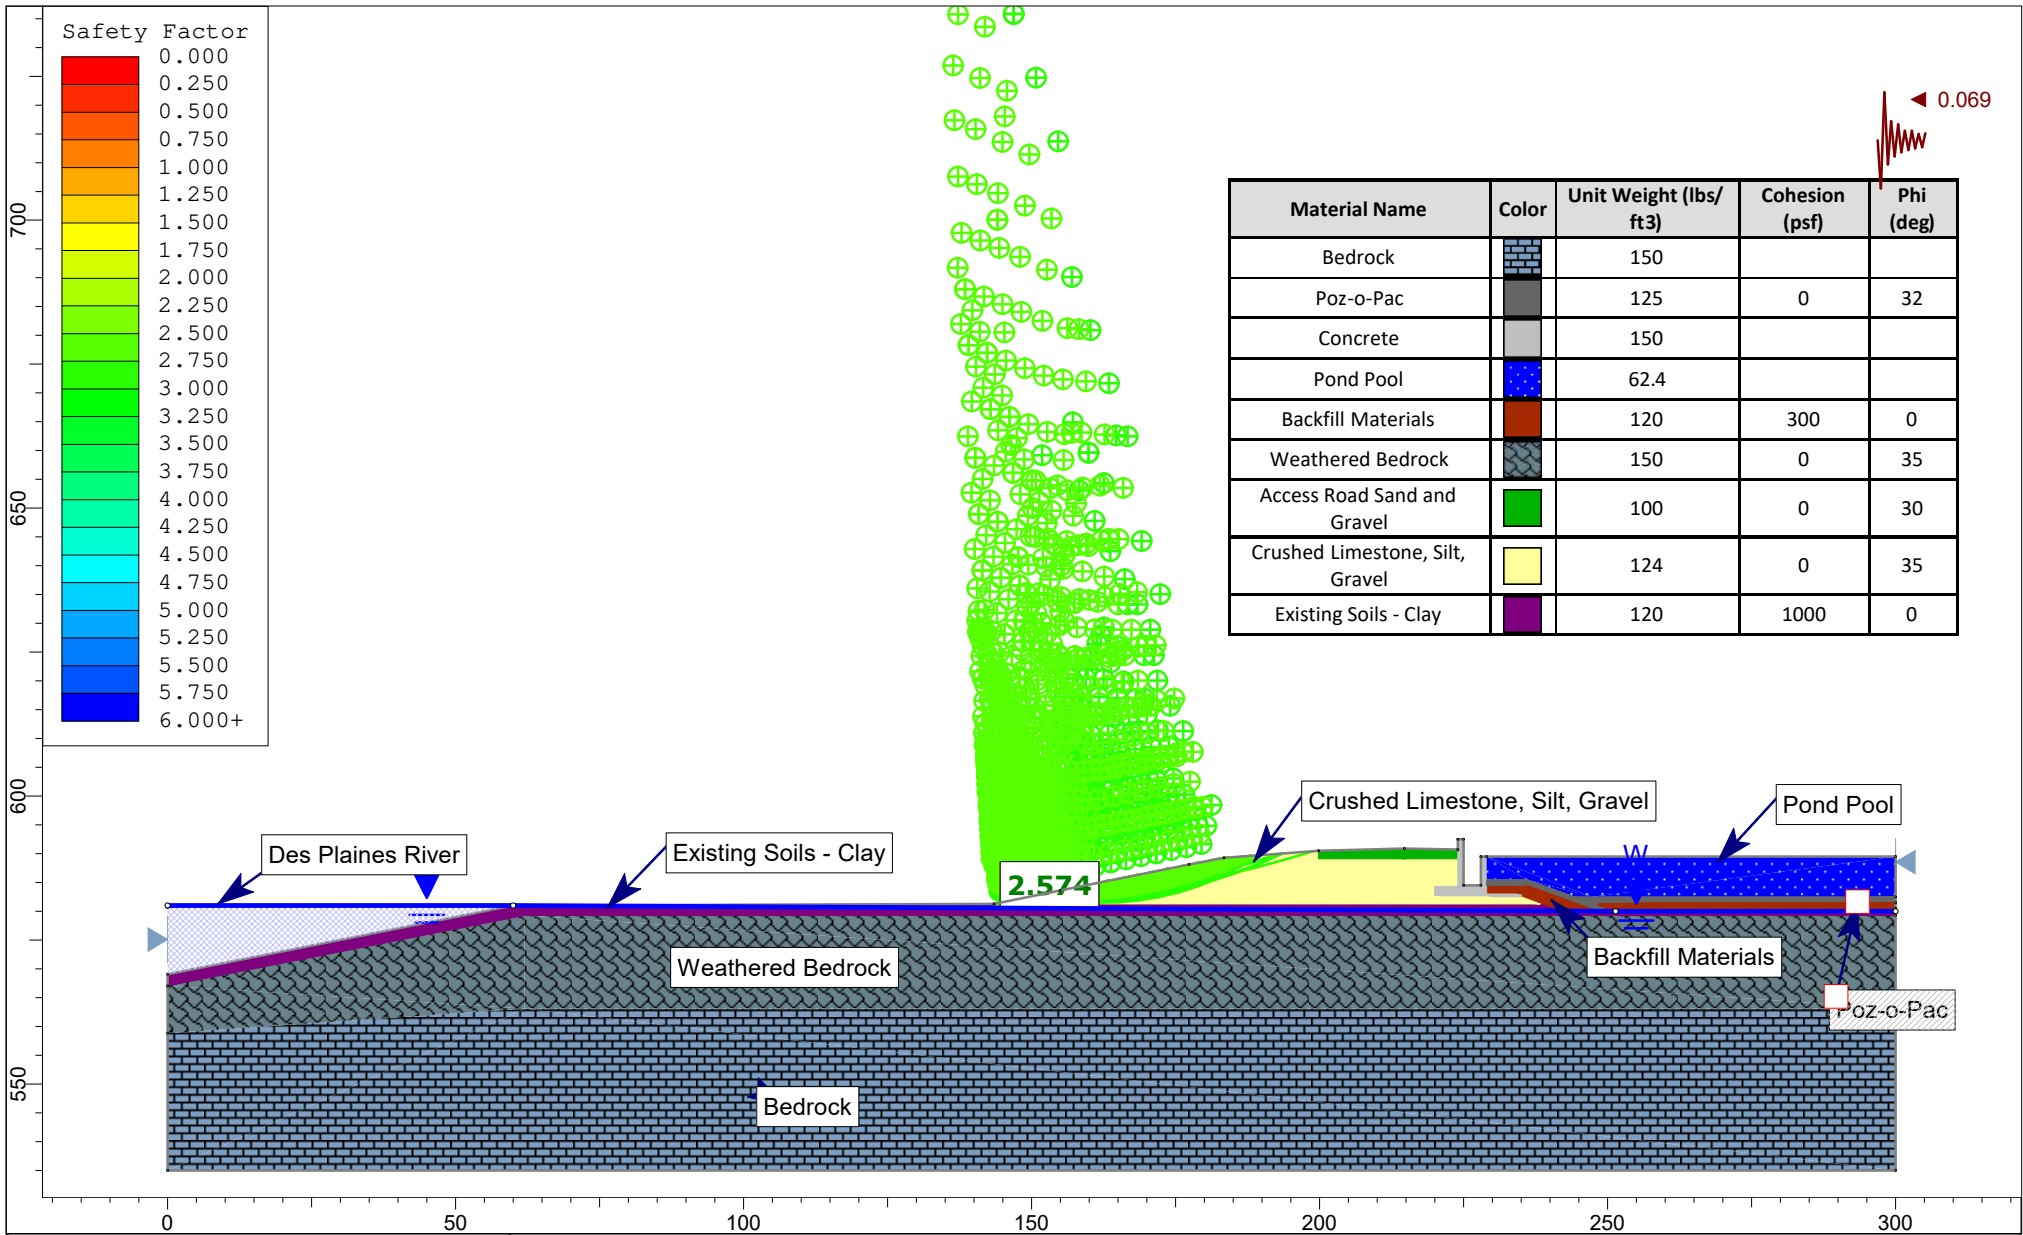
**Figure 13: Pond 3S Slope Stability Analysis**

Project				<b>Figure 13: Pond 3S Slope Stability Analysis</b>				
Analysis		Spencer	Scale:		1:400	Scenario		Pond 3S, Long-Term, Maximum Storage Pool - Seismic
Drawn By		CAC	Checked By:		MDB	Approved By:		MDJ
Date		08/25/2021	Date:		9/23/2021	Date:		9/23/2021
				Company		Civil & Environmental Consultants, Inc.		
				File Name		312192-WC-Pond 1N.slmld
