2023 Annual Groundwater Monitoring and Corrective Action Report

Limestone Electric Generating Station, Jewett, Texas

CCR RN 115
Landfill Unit (Unit 004)

January 31, 2024

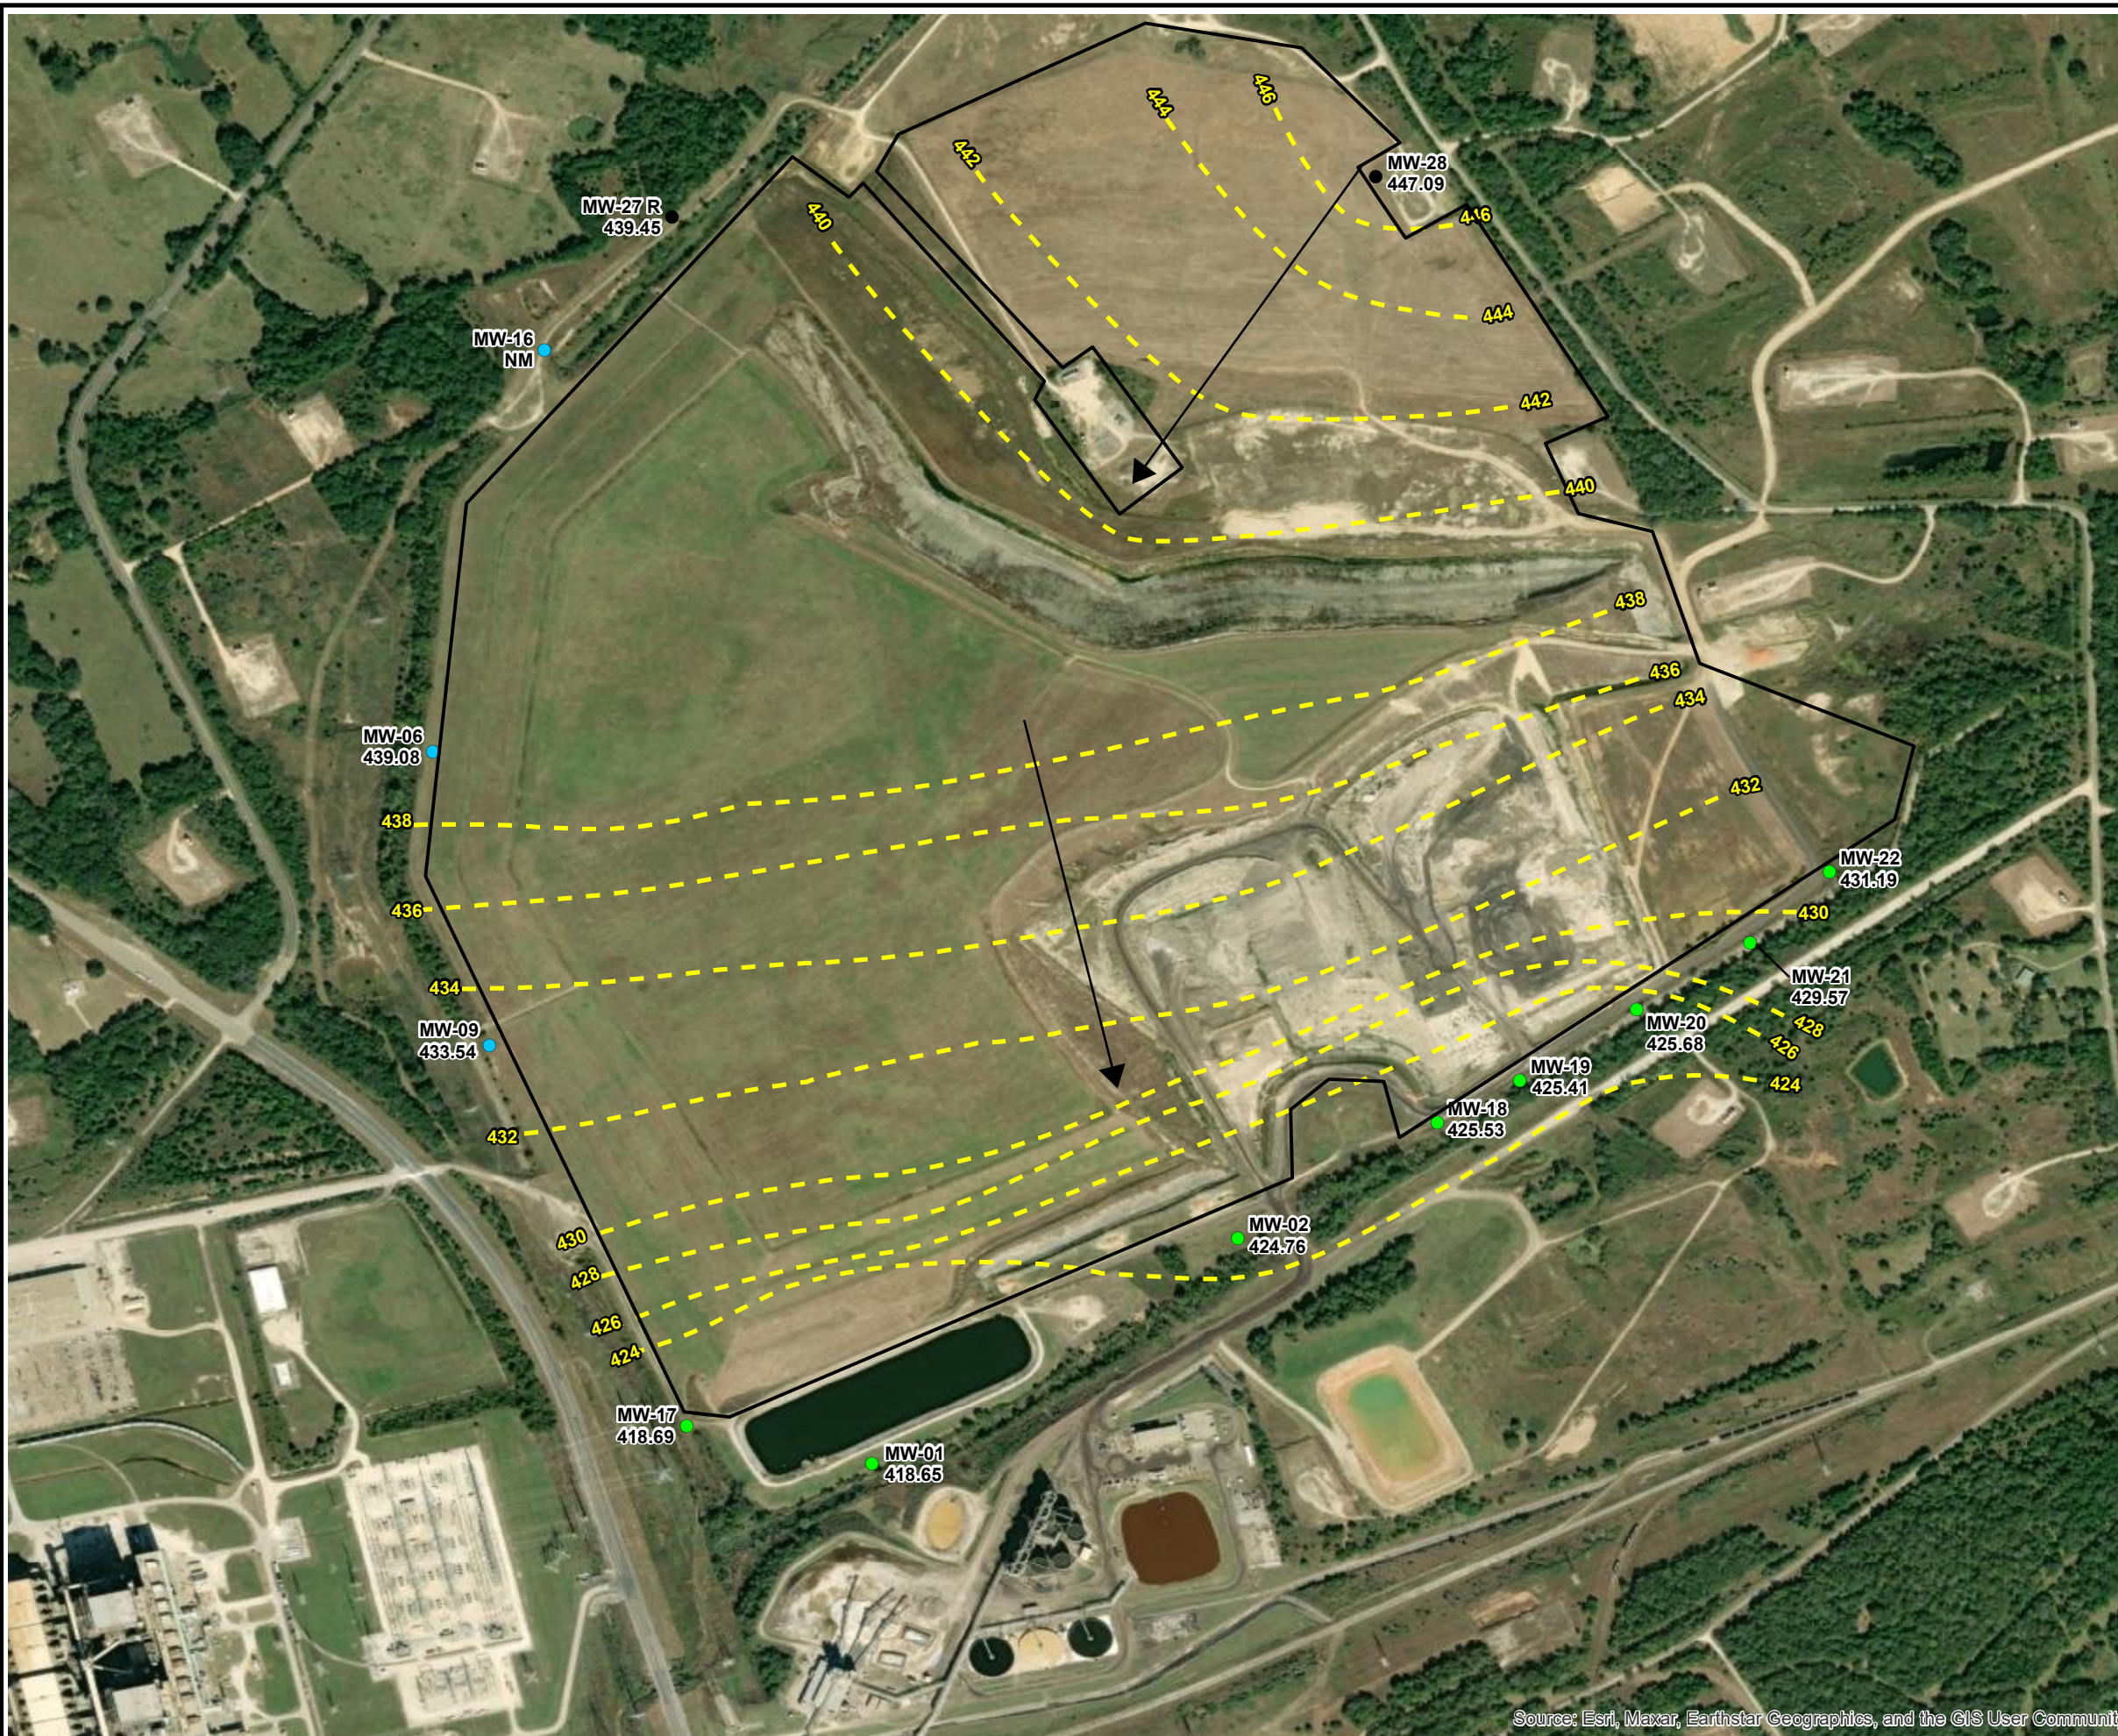
Figure 2-2 Potentiometric Surface, April 2023

- Monitor Well Location
- Landfill CCR Monitor Well
- Landfill Background CCR Monitor Well
- 447.09** Groundwater Elevation (FT MSL)
- NM** Not Measured
- ← Groundwater Flow Direction
- Groundwater Elevation Contour - Dashed where Inferred (FT MSL)
- ▭ CCR Landfill Boundary

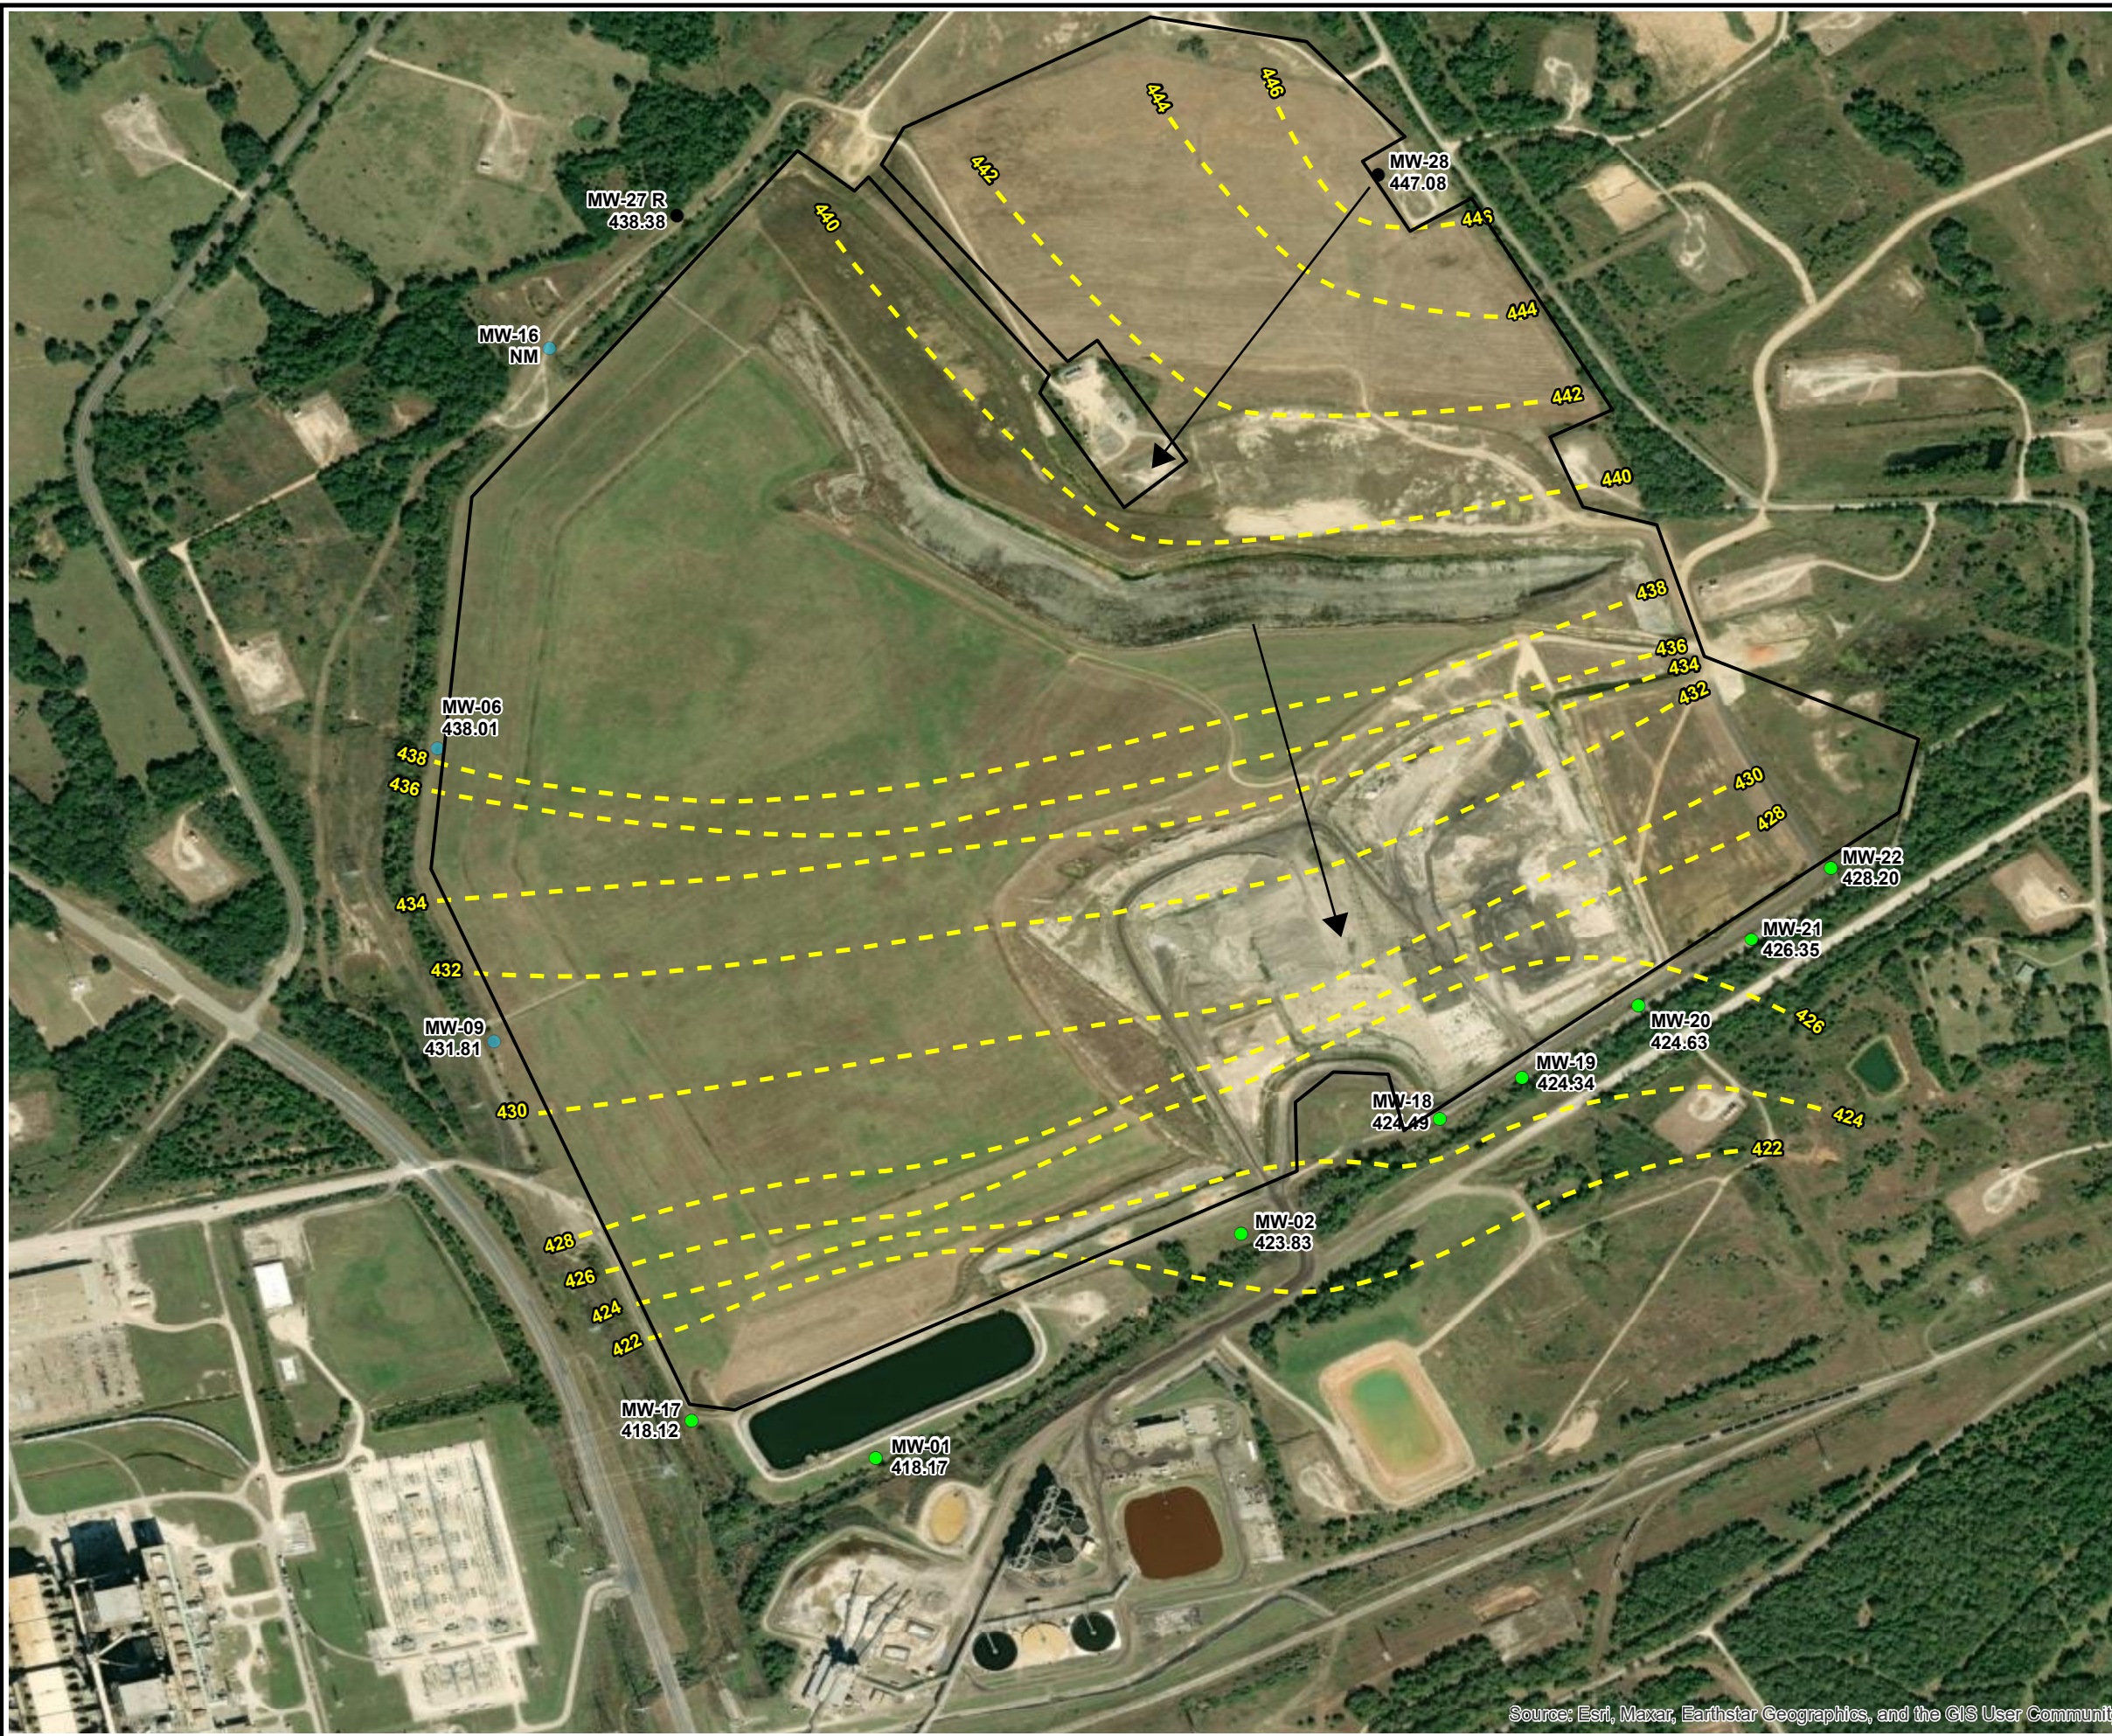
Static groundwater elevations were measured for each monitoring well at the Landfill CCR unit during each of the 2023 semi-annual detection monitoring sampling events prior to sample collection. These measurements are provided in Table 2-1. Groundwater potentiometric surface maps were developed for the April and October detection monitoring events to evaluate groundwater flow directions. The potentiometric surface maps are provided as Figures 2-2, and 2-3.

- Monitor Well Location
- Landfill CCR Monitor Well
- Landfill Background CCR Monitor Well
- 447.08** Groundwater Elevation (FT MSL)
- NM** Not Measured
- ← Groundwater Flow Direction
- Groundwater Elevation Contour - Dashed where Inferred (FT MSL)
- ▭ CCR Landfill Boundary

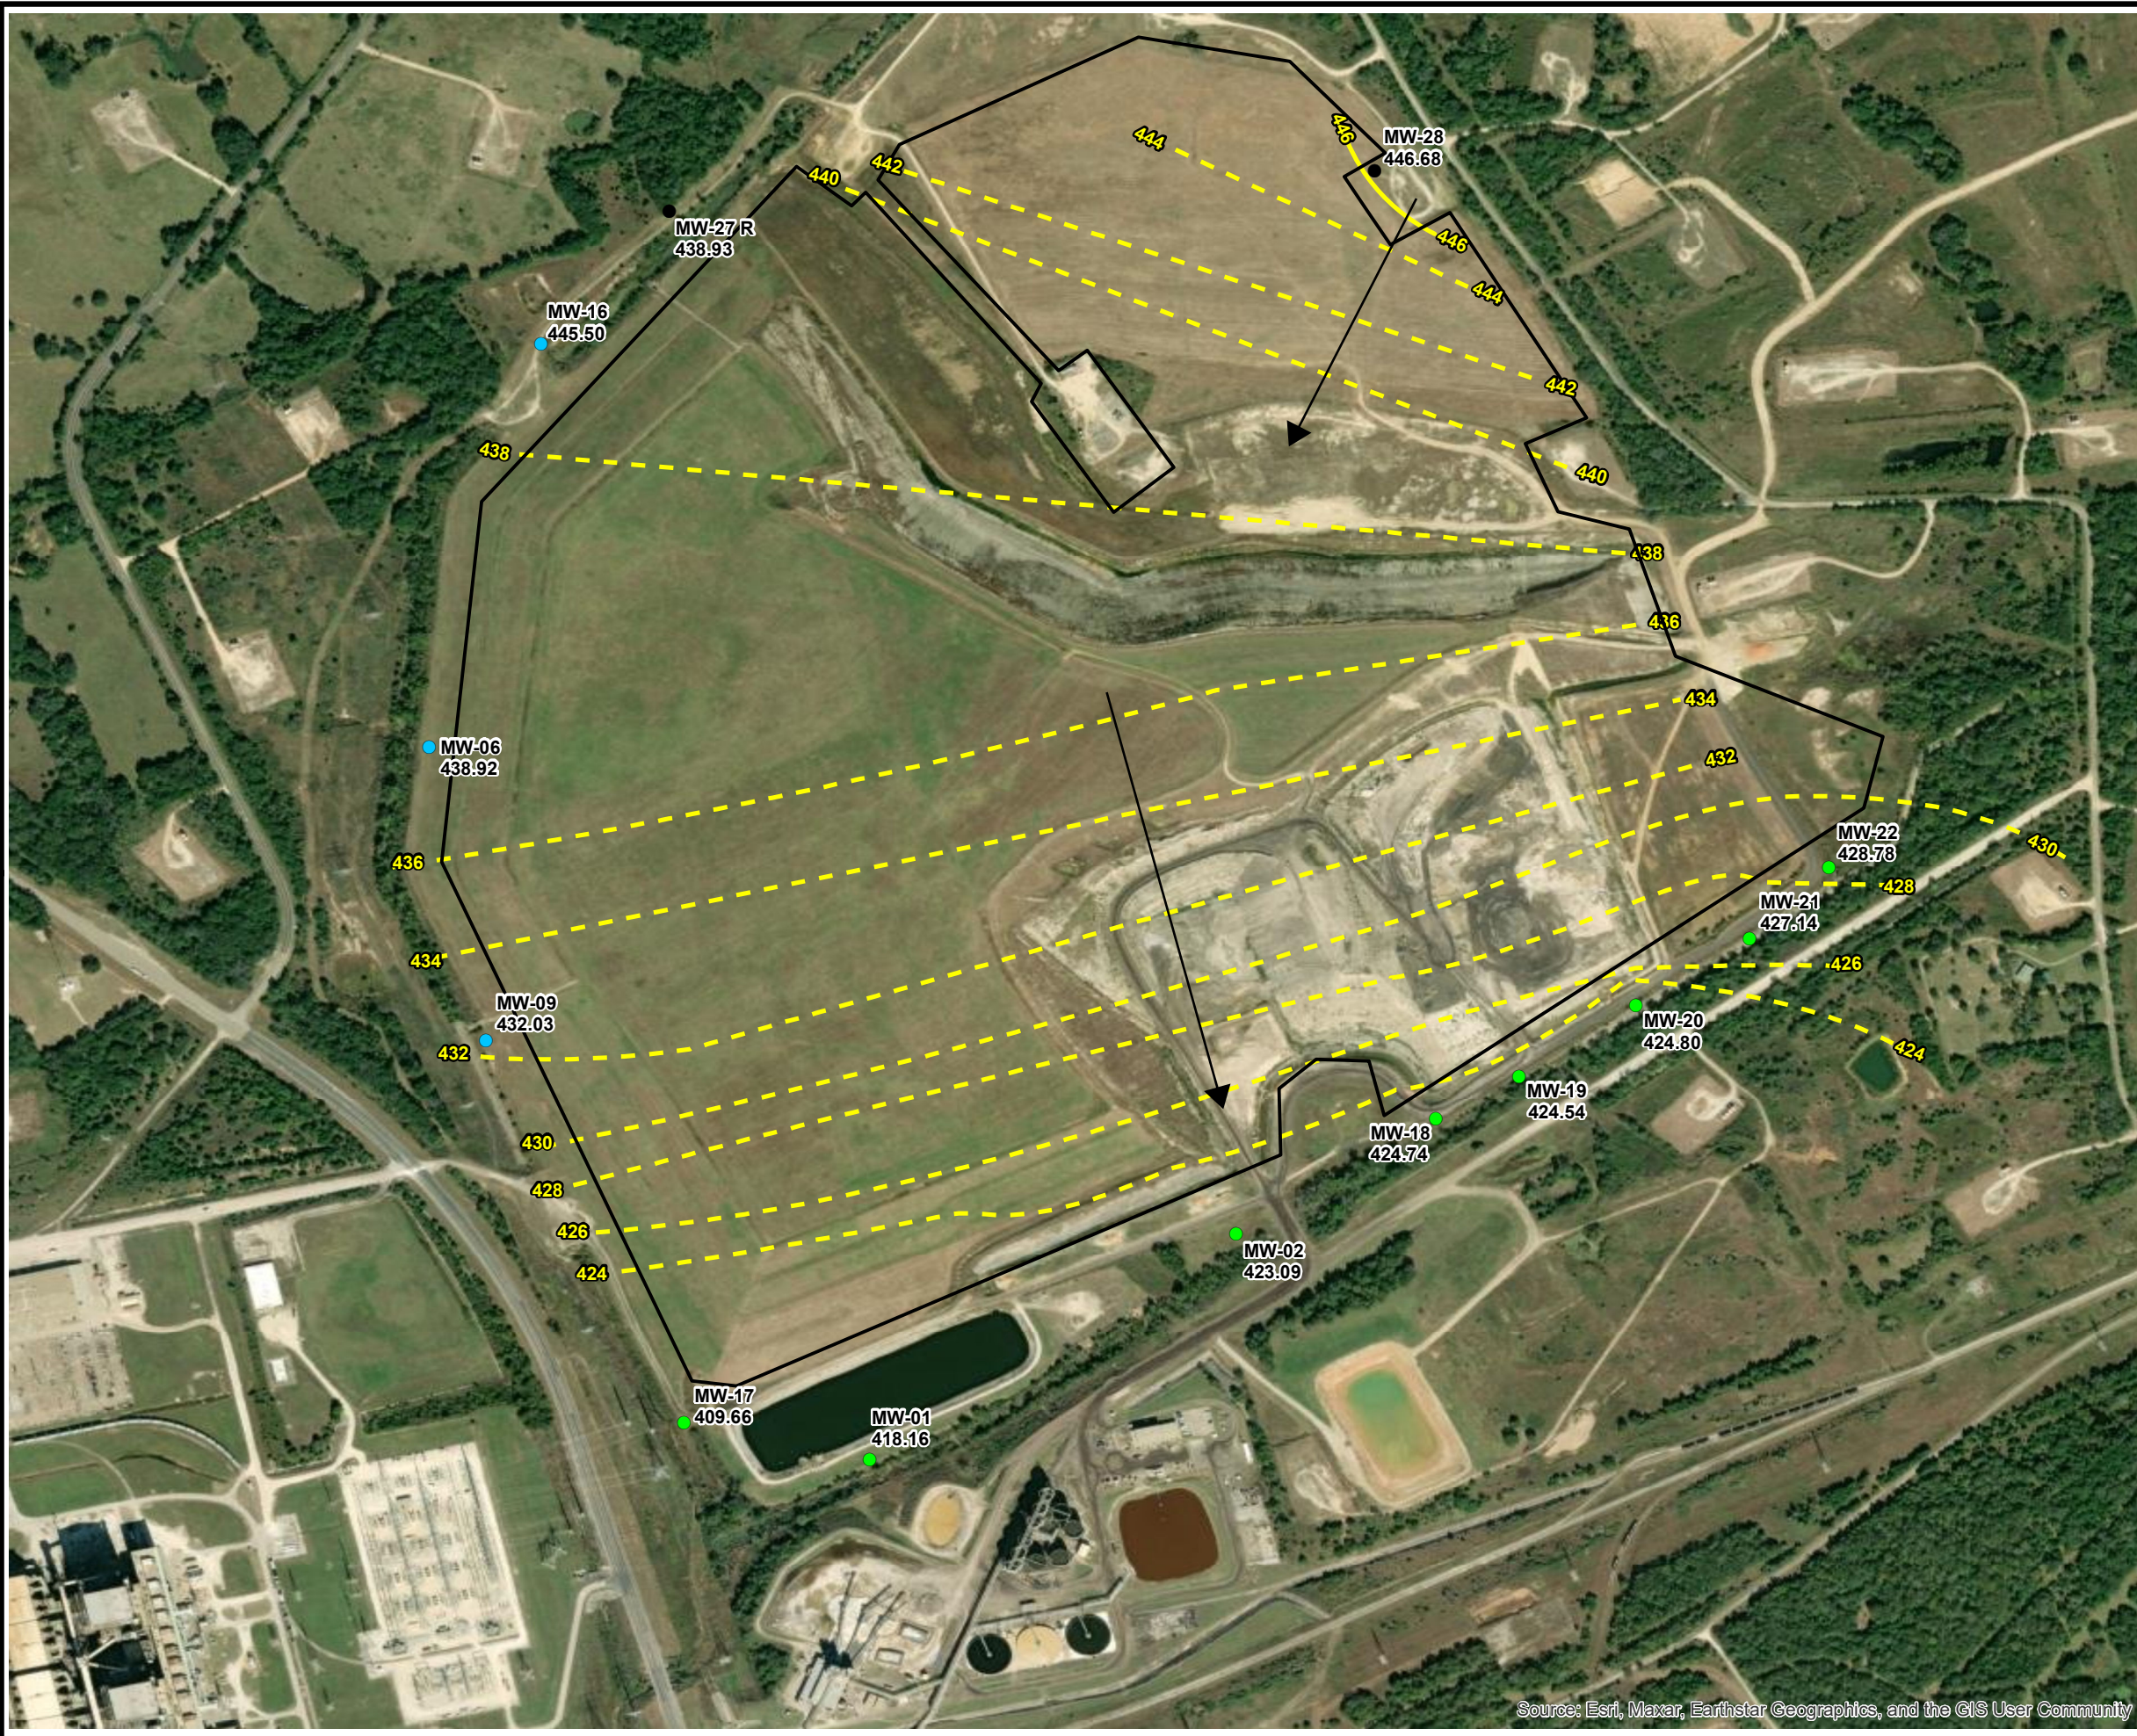
- Monitor Well Location
- Landfill CCR Monitor Well
- Landfill Background CCR Monitor Well
- 446.68** Groundwater Elevation (FT MSL)
- NM** Not Measured
- Groundwater Flow Direction
- Groundwater Elevation Contour - Dashed where Inferred (FT MSL)
- CCR Landfill Boundary

PROJECT:		NRG TEXAS POWER, LLC LIMESTONE JEWETT, TEXAS	
TITLE:		GROUNDWATER POTENTIOMETRIC SURFACE - OCTOBER 2022	
DRAWN BY:	F. YARBROUGH	PROJ. NO.:	477046.0001.0000
CHECKED BY:	J. ATWELL	FIGURE 2	
APPROVED BY:	A. DWORACZYK		
DATE:	JANUARY 2024		
		14701 St. Mary's Lane, Suite 500 Houston, TX, 77079 Phone 281.616.0100 www.trcsolutions.com	
FILE NO.:		477046_2-3_December.mxd
